PG&E Redacted Release

**Investigation Status Update 12/13/2013**

**Exponent**<sup>®</sup>  
*Failure Analysis Associates*<sup>®</sup>

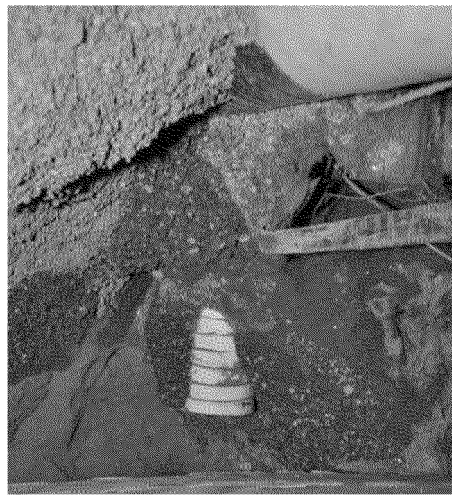
4" gas main and water line

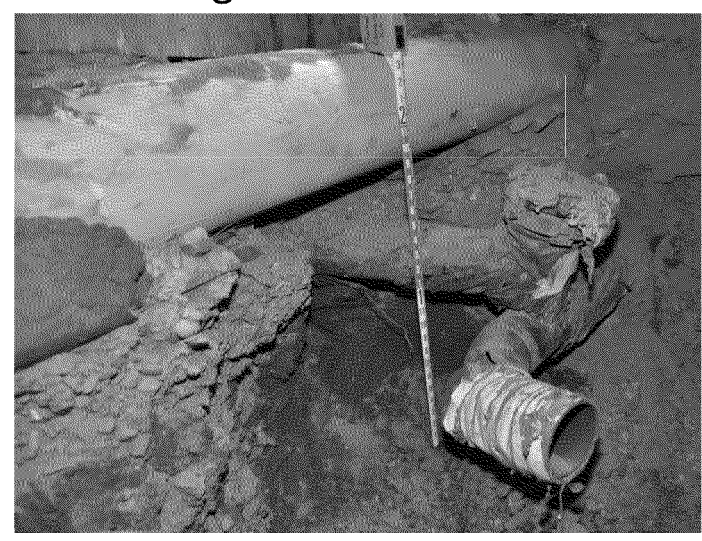
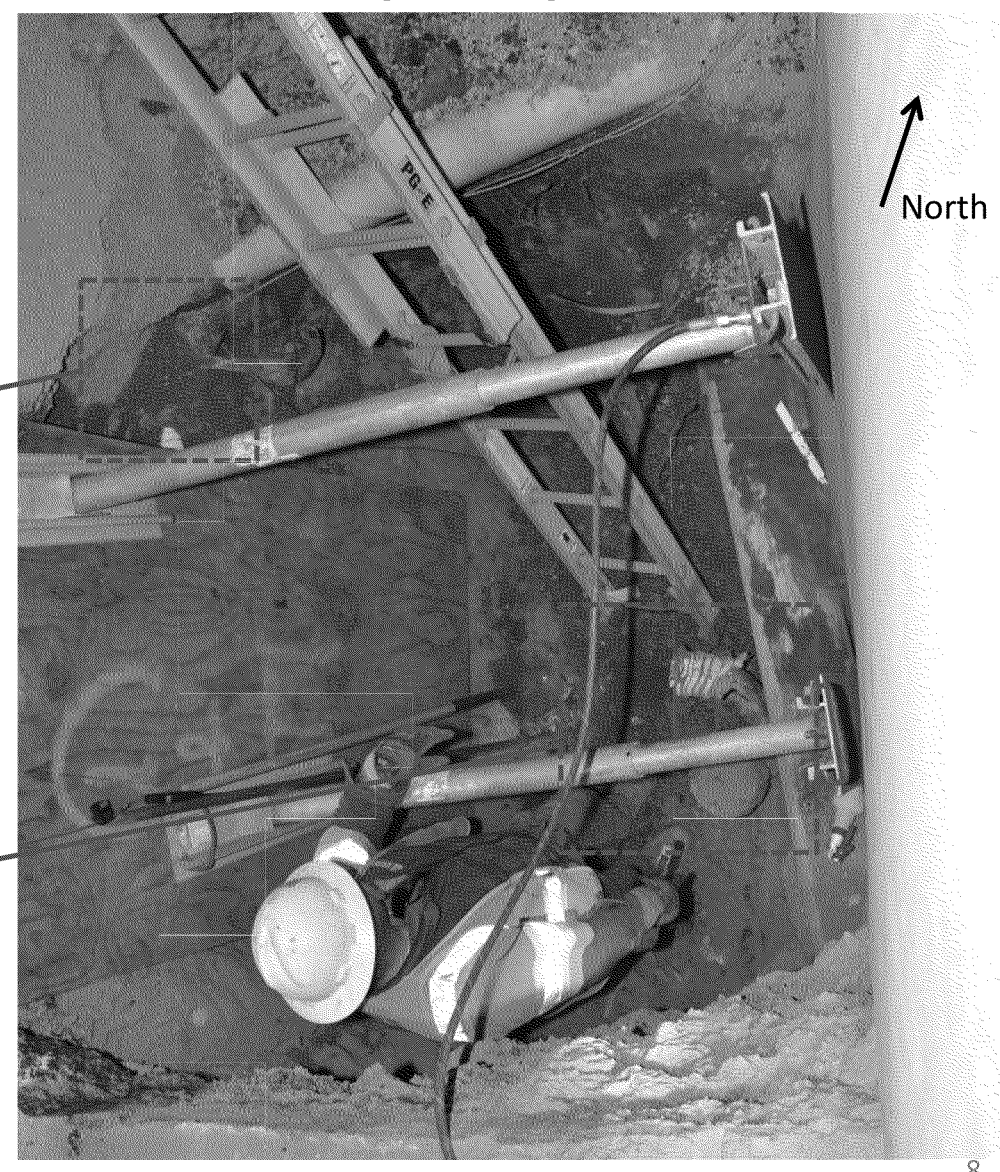
3" and 4" gas mains and sewer line

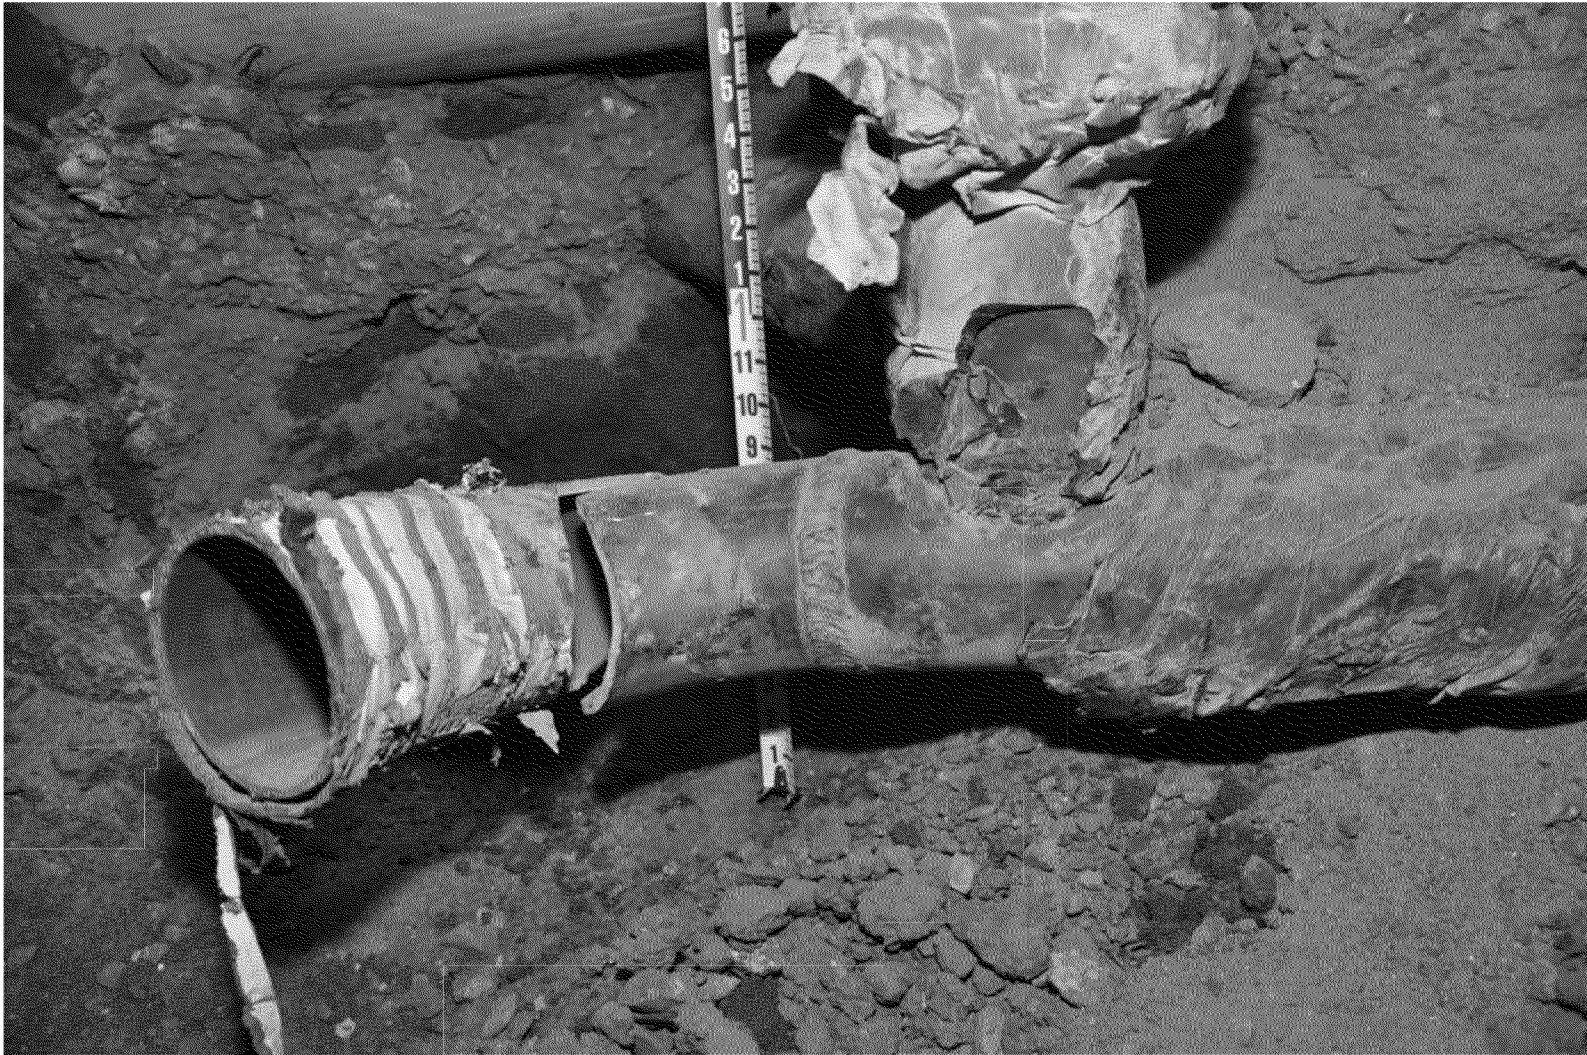
# Failed Elbow Before Removal

- The component that failed is a 4” diameter, 90 degree manufactured steel elbow that was installed in 1946.
- Immediately upstream the failed elbow, a 3” diameter tee was installed in 1965 that fed the Fontaine Street main.
- Downstream of the failed elbow, the 4” line was cut and capped in 1987 and an upward transition was added to feed a plastic line that continued down Golf Links Road.
- The construction documents from 1946 and 1987 accurately reflect the as-installed conditions.

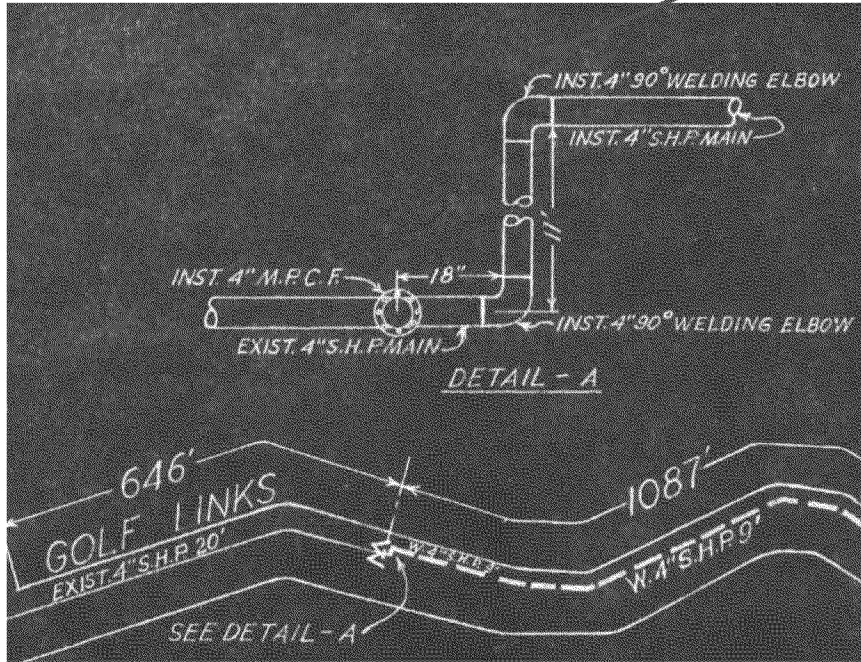
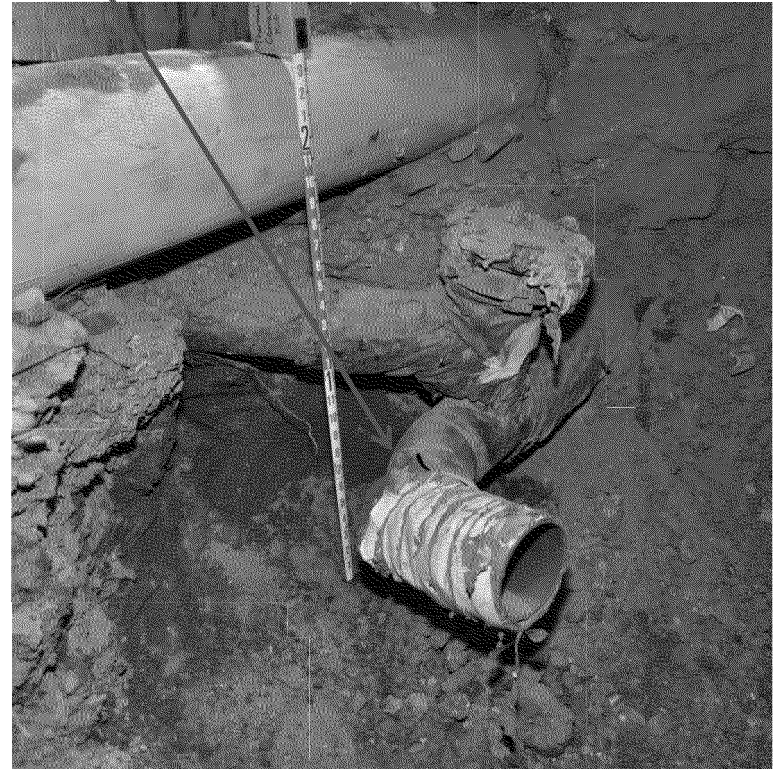
# G.M.G. 82435 (1946)

- The 1946 construction drawing shows the installation of 4" 90° elbows and a steel distribution line
- Detail A is consistent with the intersection of Redacted and Redacted
- The location of the 4" 90° elbows is consistent with "existing" features shown in later construction drawings

Installed 4" elbow and 4" main (1946)

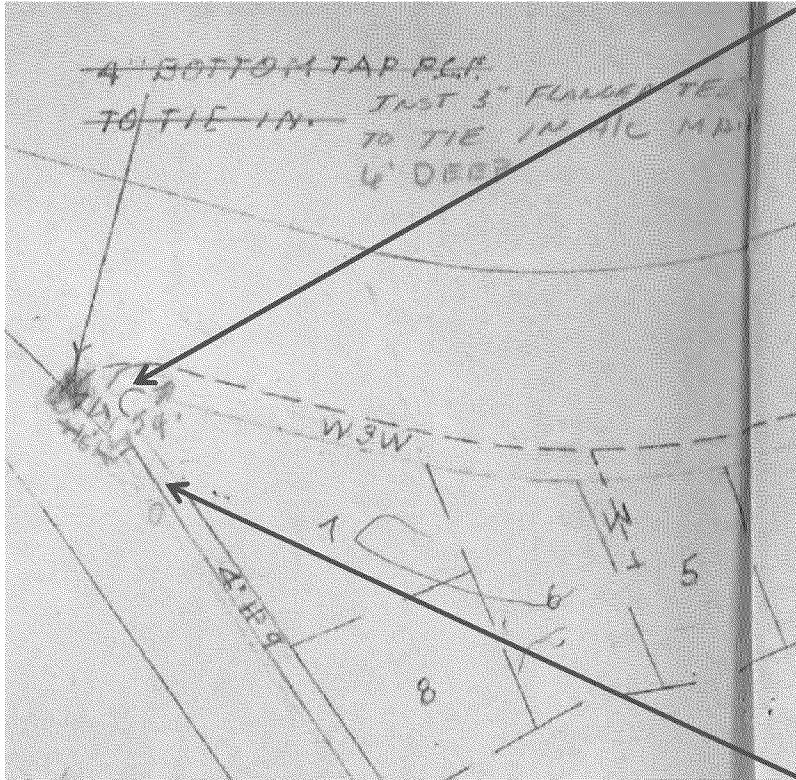
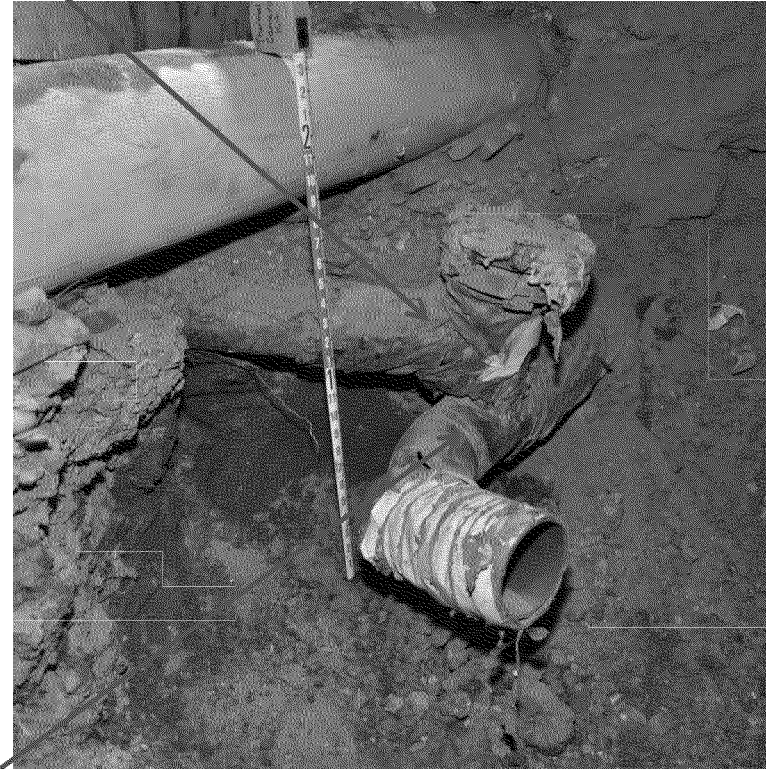
# W.O. 4747 (1965)

Installed 3" flanged tee and 3" main (1965)

Existing 4" main (1946)

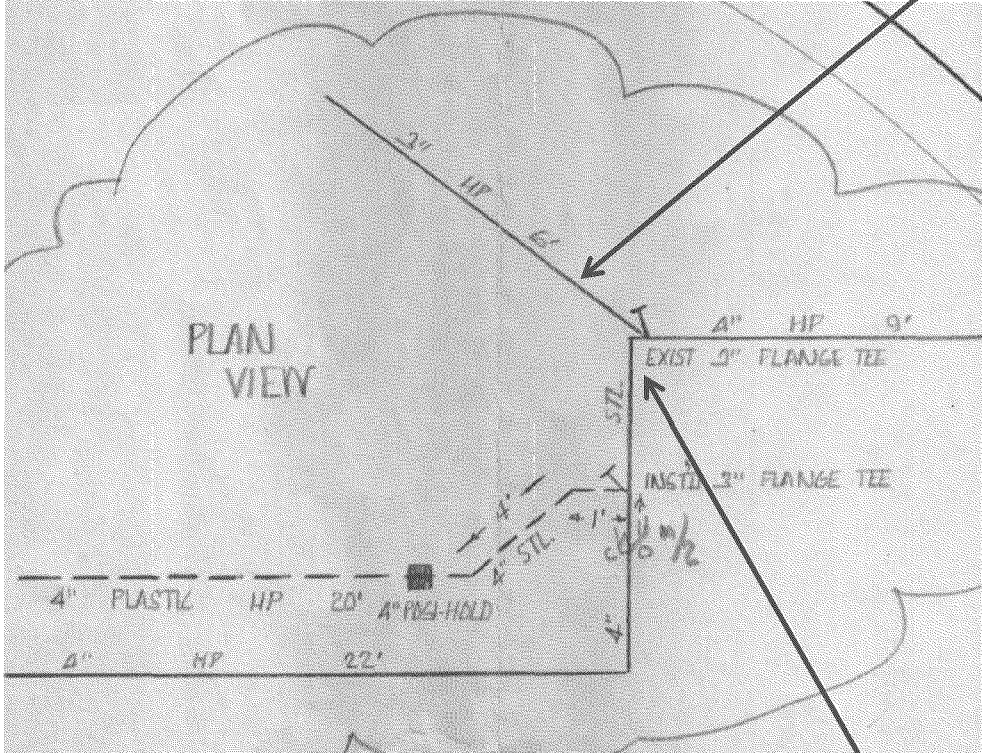
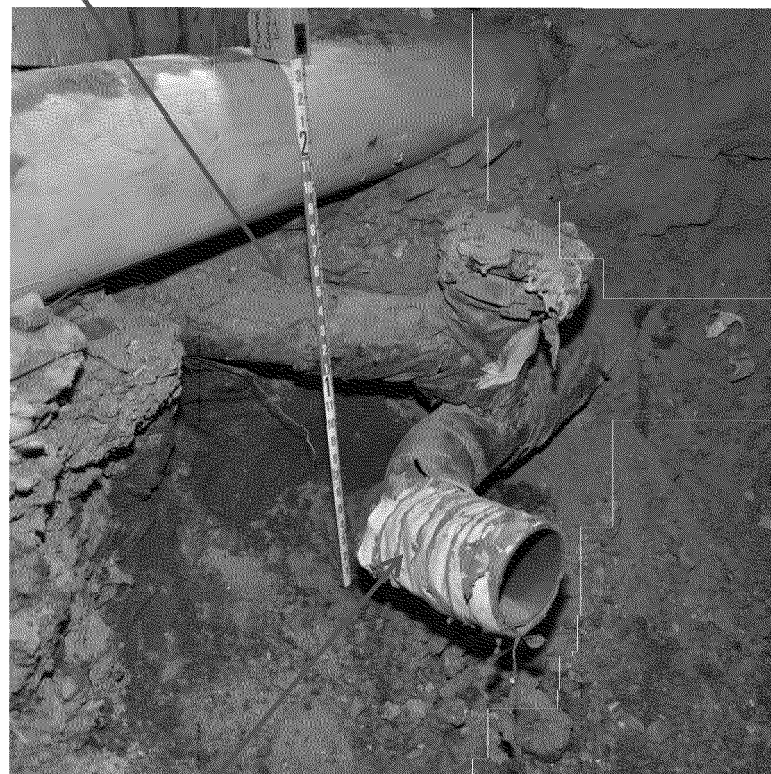
As-built construction drawing from GM 4564829 (1987)

Existing 3" line and flanged tee (1965)

Existing 4" line and elbow (1946)

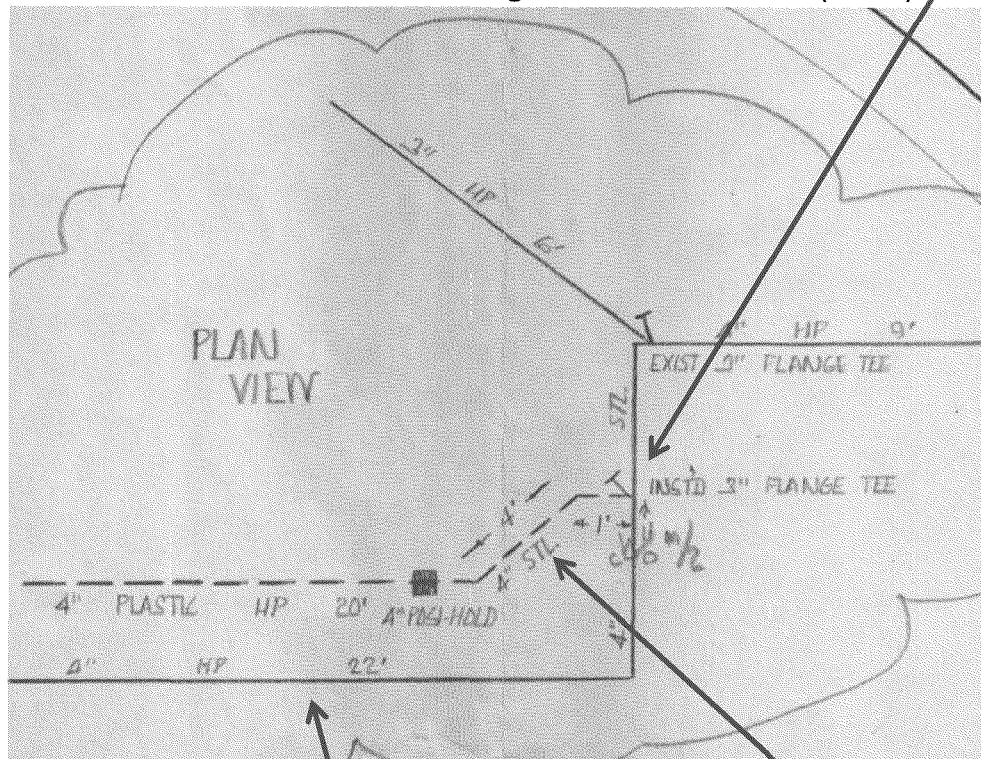
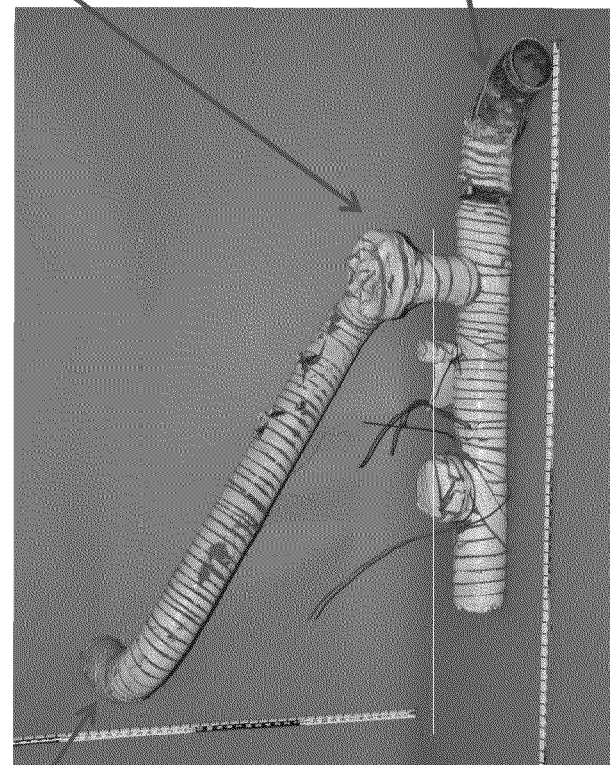
As-built construction drawing from GM 4564829 (1987)

Installed flanged tee (1987)

Existing elbow (1946)

Existing 4" line deactivated in 1987

Installed 4" line and elbows (1987)

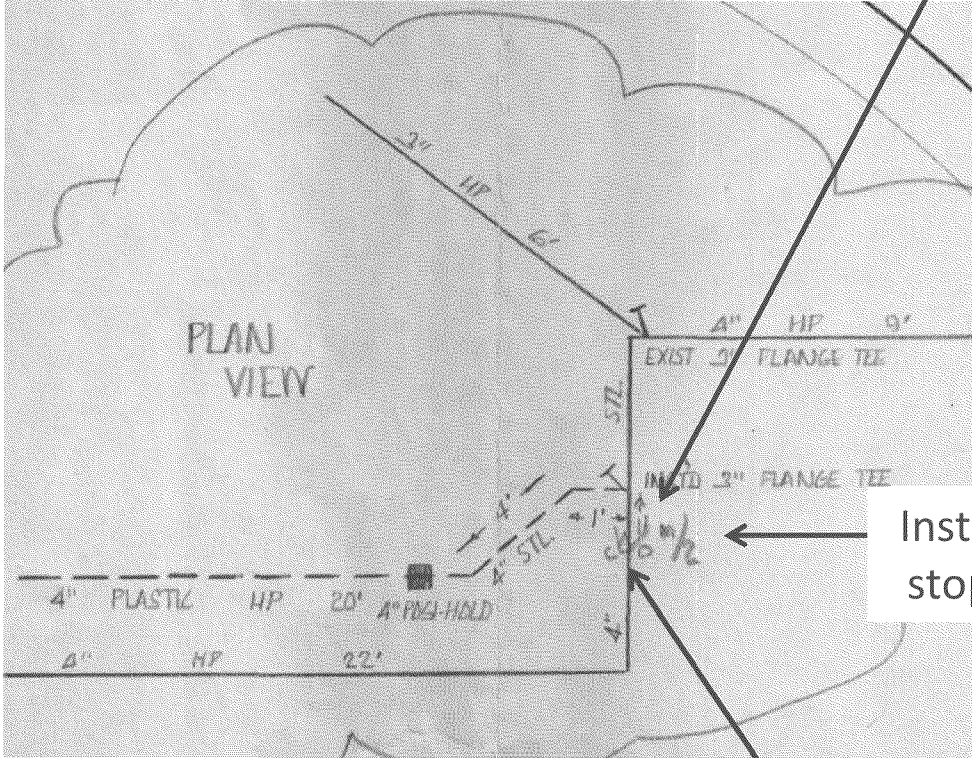
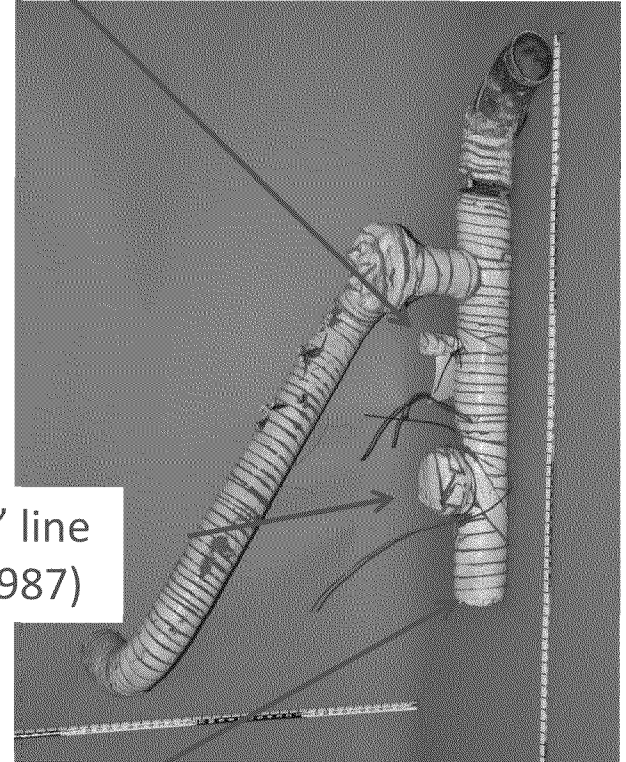
As built construction drawing from GM 4564829 (1987)

Installed sav-a-valve (1987)

Installed 4\" line stopper (1987)

Installed 4\" cap (1987)

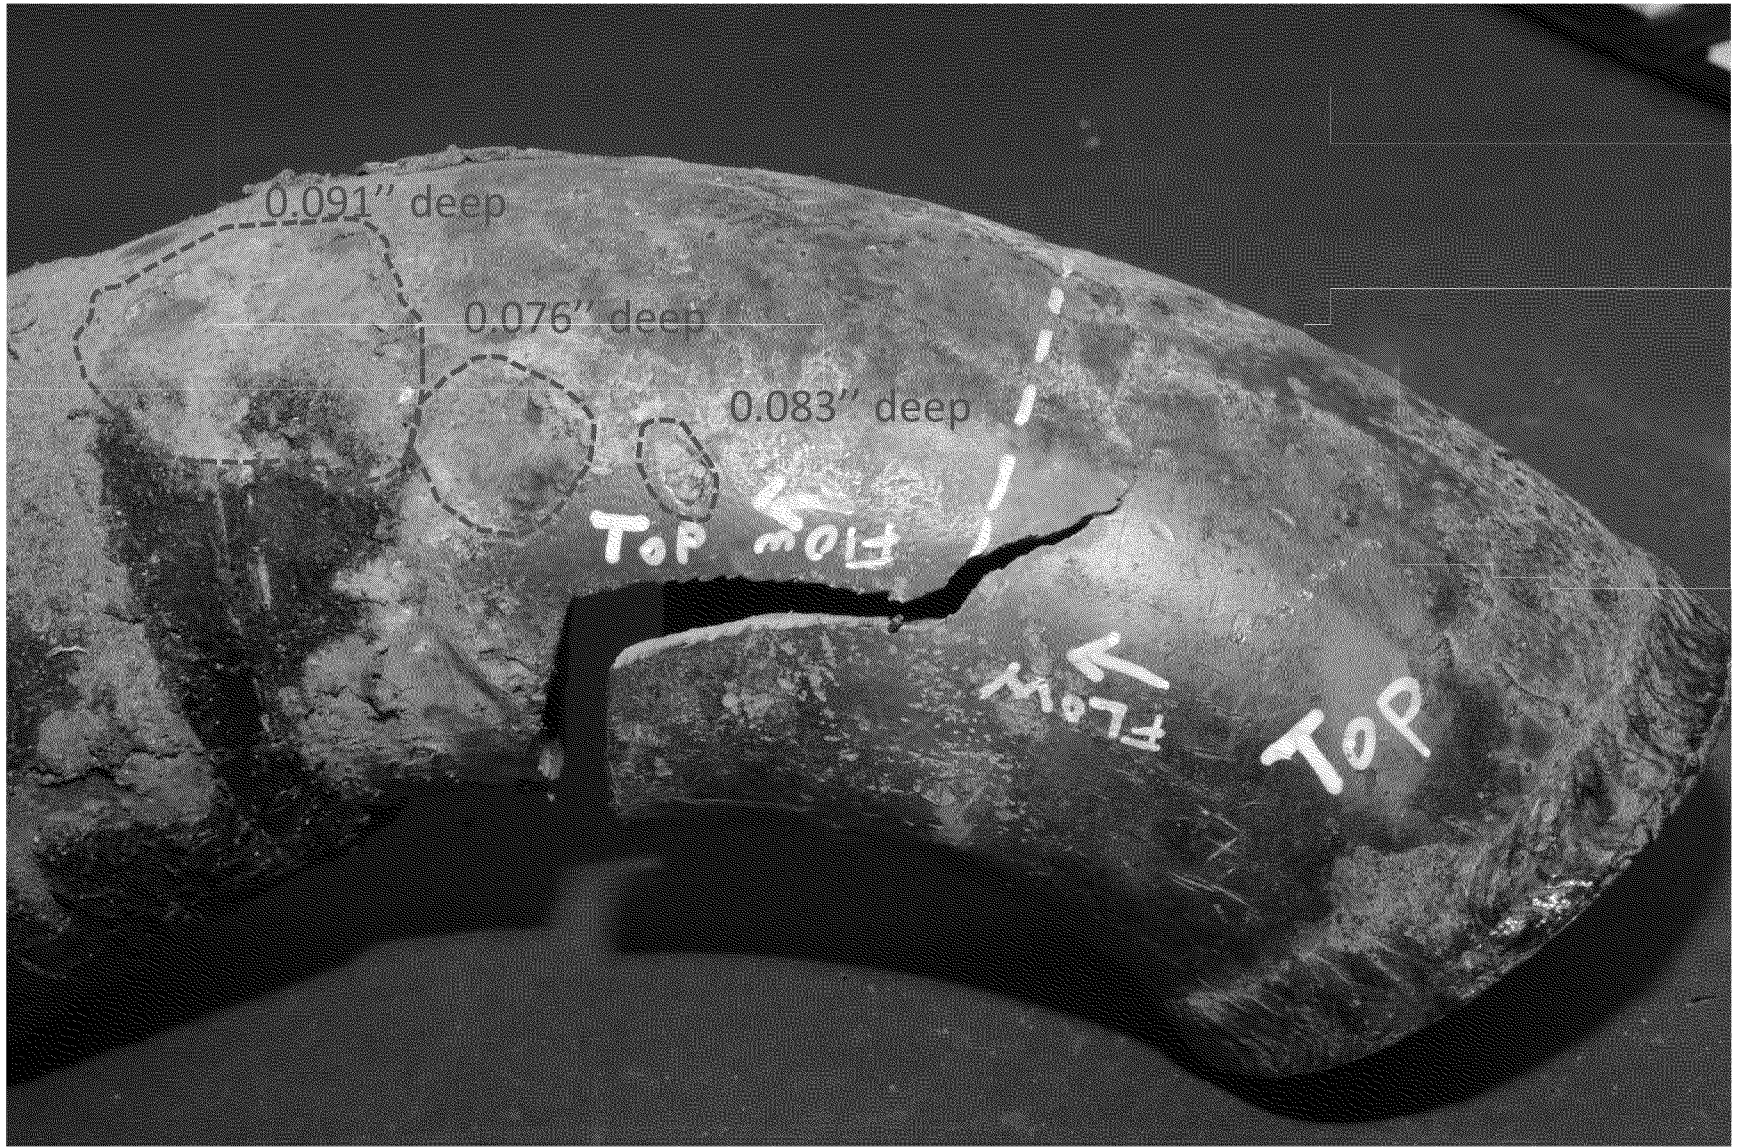
# Dimensional Analysis: Corrosion

- The subject elbow fracture was caused by a single, overload event
- Brittle (cleavage) fracture morphology was observed
- No evidence of progressive fracture (such as fatigue or stress corrosion cracking) was observed
- The fracture was not associated with a mechanical, corrosion-induced, or metallurgical defect
- The elbow exhibited the expected “ferrite-pearlite” microstructure
- The elbow hardness was measured to be 193 HV, roughly equivalent to a UTS of 92 ksi

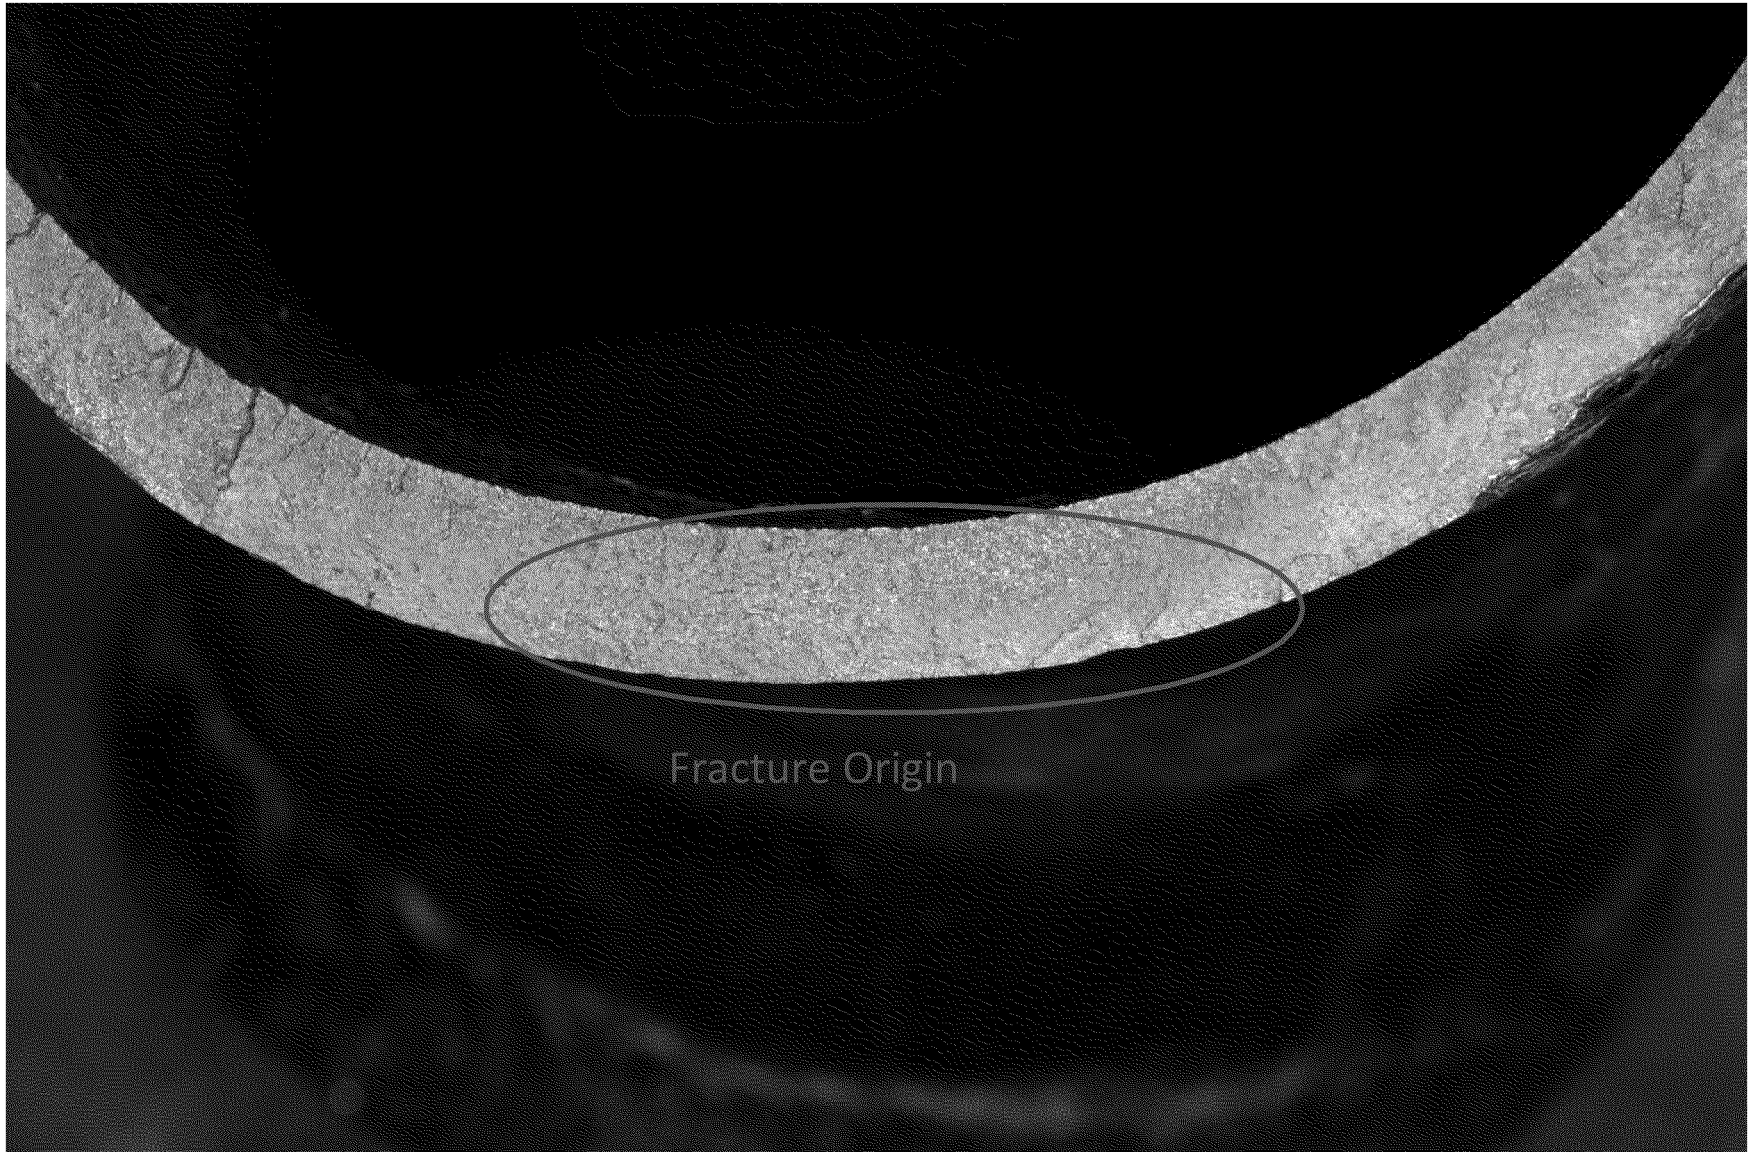
# Visual Inspection

Fracture Origin
