**PACIFIC GAS AND ELECTRIC COMPANY
Spaulding Hydroelectric Powerhouse
Data Response – December 19, 2013**

PG&E Data Request No.:	SED2013-12-04		
PG&E File Name:	SHP_DR_SED20131204.doc		
Request Date:	12-04-2013	Requester DR No.:	N/A
Date Sent:	12-19-2013	Requesting Party:	SED
PG&E Contact:	Redacted	Requester:	James Cheng

The CPUC would like to request a copy of the following information associated with the injury accident that occurred on 11/15/2013 at the Spaulding Hydroelectric Powerhouse.

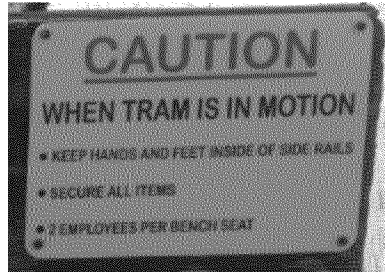
2. A new caution sign was installed on the tram in view of all the passengers containing the following verbiage:

CAUTION
WHEN TRAM IS IN MOTION

- KEEP HANDS AND FEET INSIDE SIDE RAILS
- SECURE ALL ITEMS
- 2 EMPLOYEES PER BENCH SEAT
