Re: Update - Oakland Incident of December 10, 2013

Pacific Gas and Electric (PG&E) has retained Exponent Failure Analysis Associates (Exponent) to conduct a failure analysis investigation of an elbow that fractured as part of a four-inch natural gas distribution line on December 10, 2013 [Redacted] [Redacted] in Oakland, California. Our investigation to-date has included inspection of the leak site, review of PG&E's historical construction documents, a fire cause and origin study, metallurgical analysis, geotechnical analysis, analysis of other leak locations within the immediate area, and finite element-based stress analyses of ground movement and stresses on the subject elbow and associated piping.

Exponent's analyses indicate that the most likely root cause of the subject elbow fracture was from stresses that developed over time due to creep along the Hayward Fault.

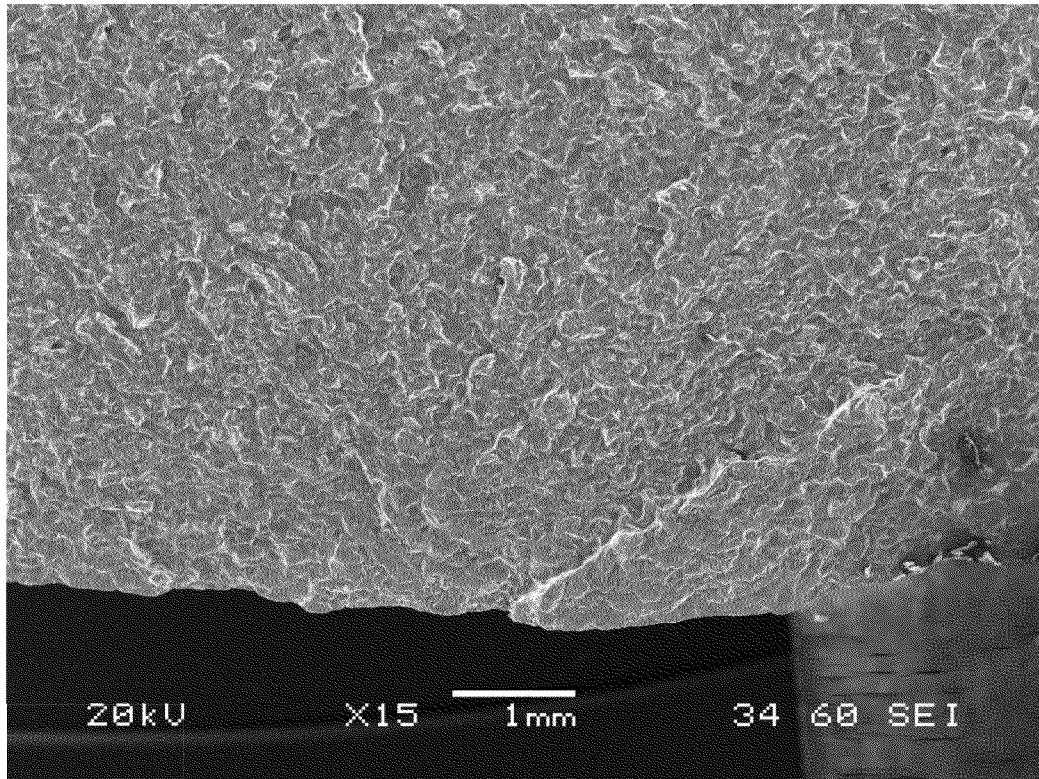
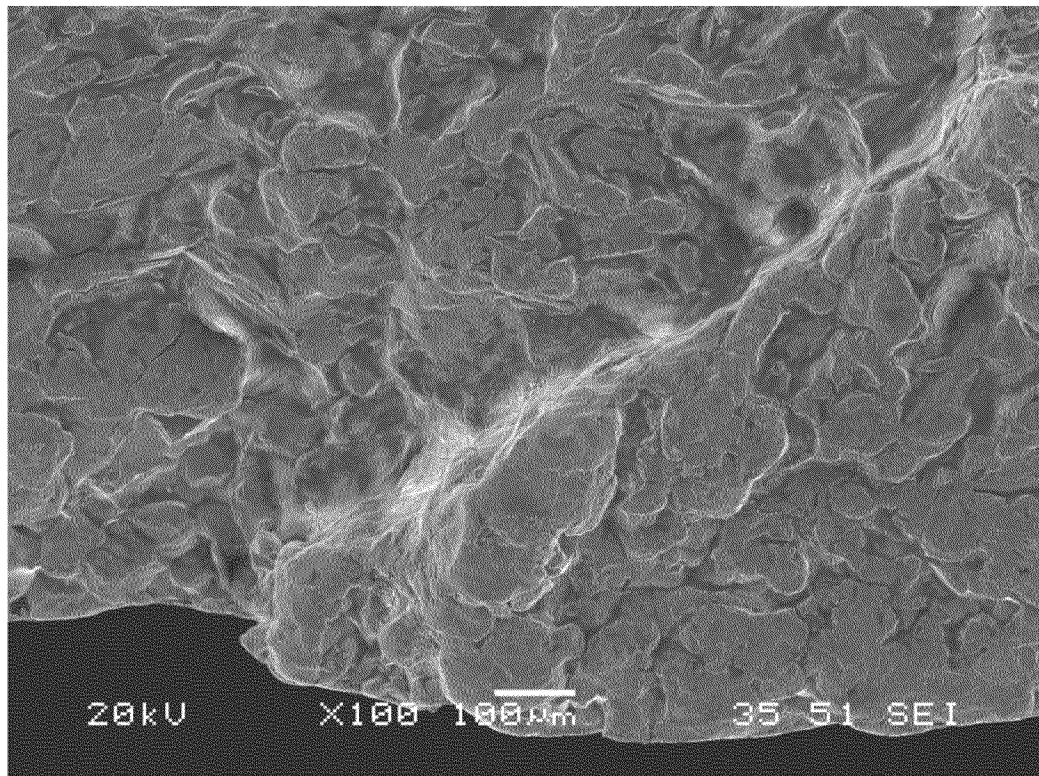
Consistent with our visual and optical microscope fractographic analysis, no evidence of progressive fracture, such as fatigue or stress corrosion cracking (SCC) was observed. Energy dispersive spectroscopy (EDS) showed no evidence of anomalous elemental species (not shown).

Figure 21. SEM images of the fracture origin showing brittle fracture and erosion from gas release.
