**Golf Links Road (Oakland)
Incident Analysis**

Prepared for

Sumeet Singh
Pacific Gas and Electric Company
6111 Bollinger Canyon Road
San Ramon, CA 94583

January 2014
Revised January 20, 2014

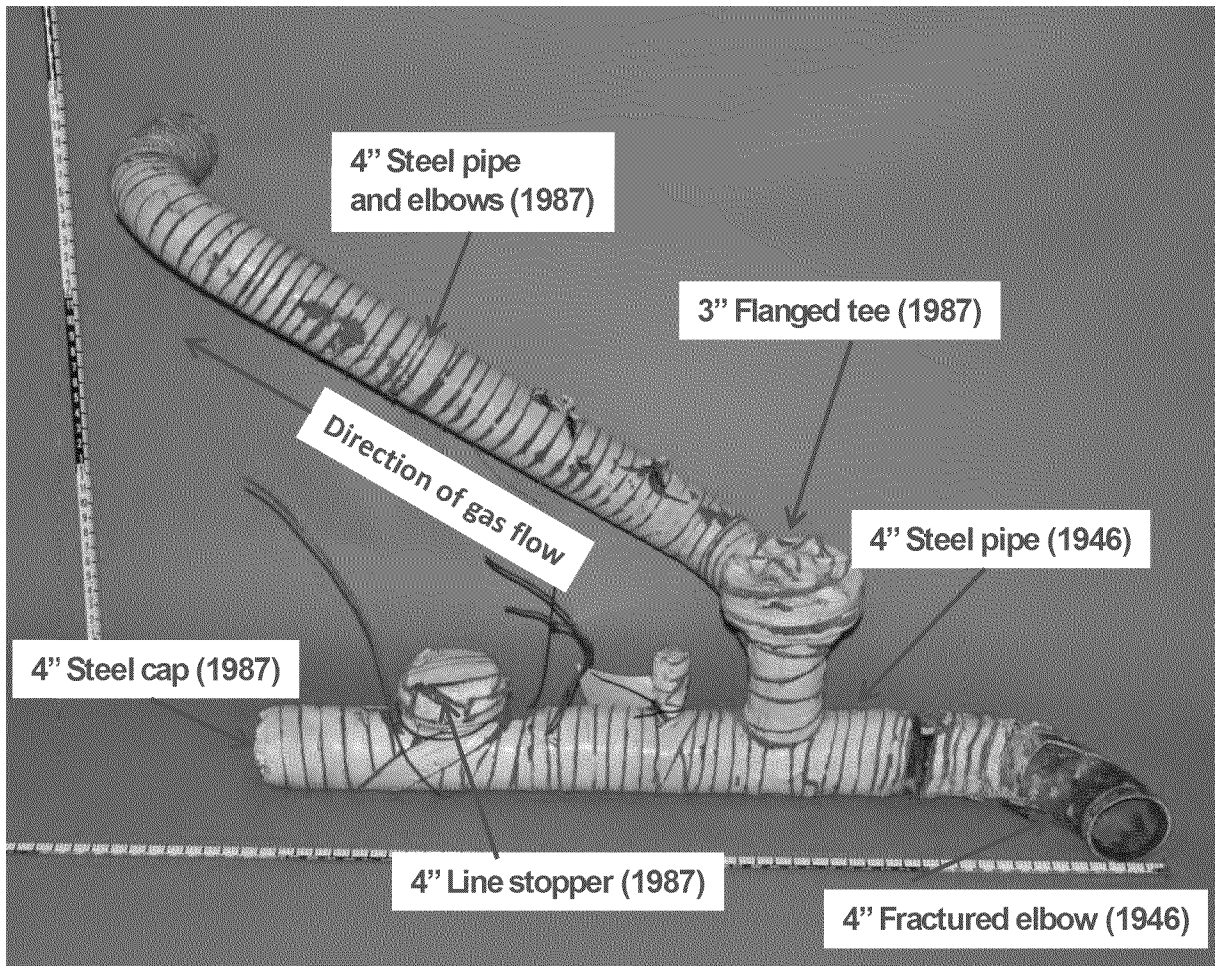
Figure 5. Fractured elbow and adjacent features after removal, with piping photographed as if viewer is looking downstream.

The ruptured elbow and piping downstream from the break was removed from the leak site as shown in Figure 5, and was brought to Exponent's Menlo Park, California laboratories for analysis. The break occurred at the elbow intrados, as shown in Figure 15. The fracture plane was primarily perpendicular to the gas flow direction and located near the center of the elbow. This fracture orientation is consistent with bending of the elbow, rather than a pressure-induced break. Comparison of the ruptured elbow before and after excavation (Figure 4 and Figure 15) showed that the fracture opened during the excavation process. This is consistent with reports of witnesses on site during the excavation process.

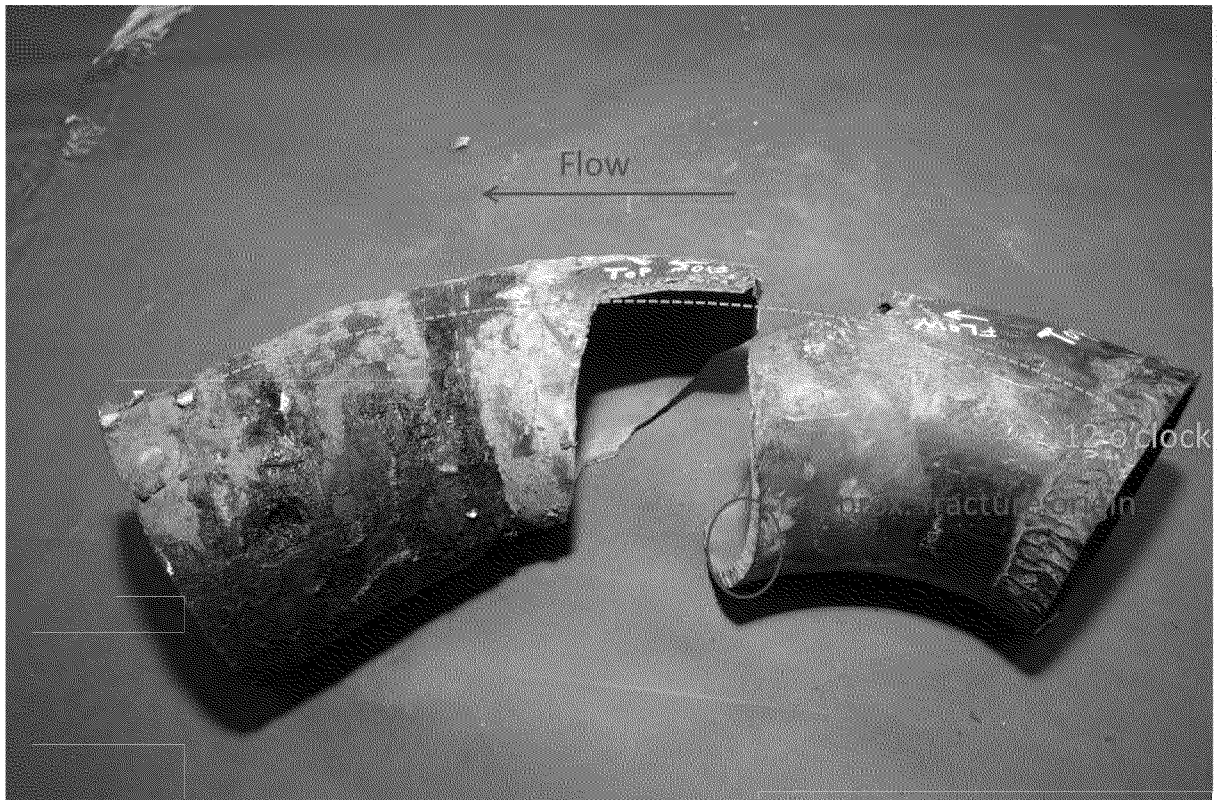
Fractographic analysis was conducted to help determine the cause of the rupture. The elbow was sectioned across the remaining intact area near the break to better expose the fracture surfaces for examination, as shown in Figure 18. To help remove the soil that obscured the surface, the fracture faces were cleaned in a warm Alconox (detergent and water) solution and scrubbed with a nylon brush. Following cleaning, the fracture surface was examined visually as well as using optical and scanning electron microscopy (SEM) techniques. A photograph of the cleaned fracture surface is shown in Figure 19. No dark areas, associated with long-term corrosion, or evidence of progressive fracture (such as beach marks) were observed. The fracture origin area was relatively flat with little ductility. Examination of tear ridges and chevron marks (which point back to the initiation point), shown in Figure 19 and Figure 20, indicated that the fracture origin was located at roughly the 10 o'clock position.

Figure 18. Image that shows the elbow after sectioning. The piece on the right (upstream) was subjected to fractographic and metallographic examination.

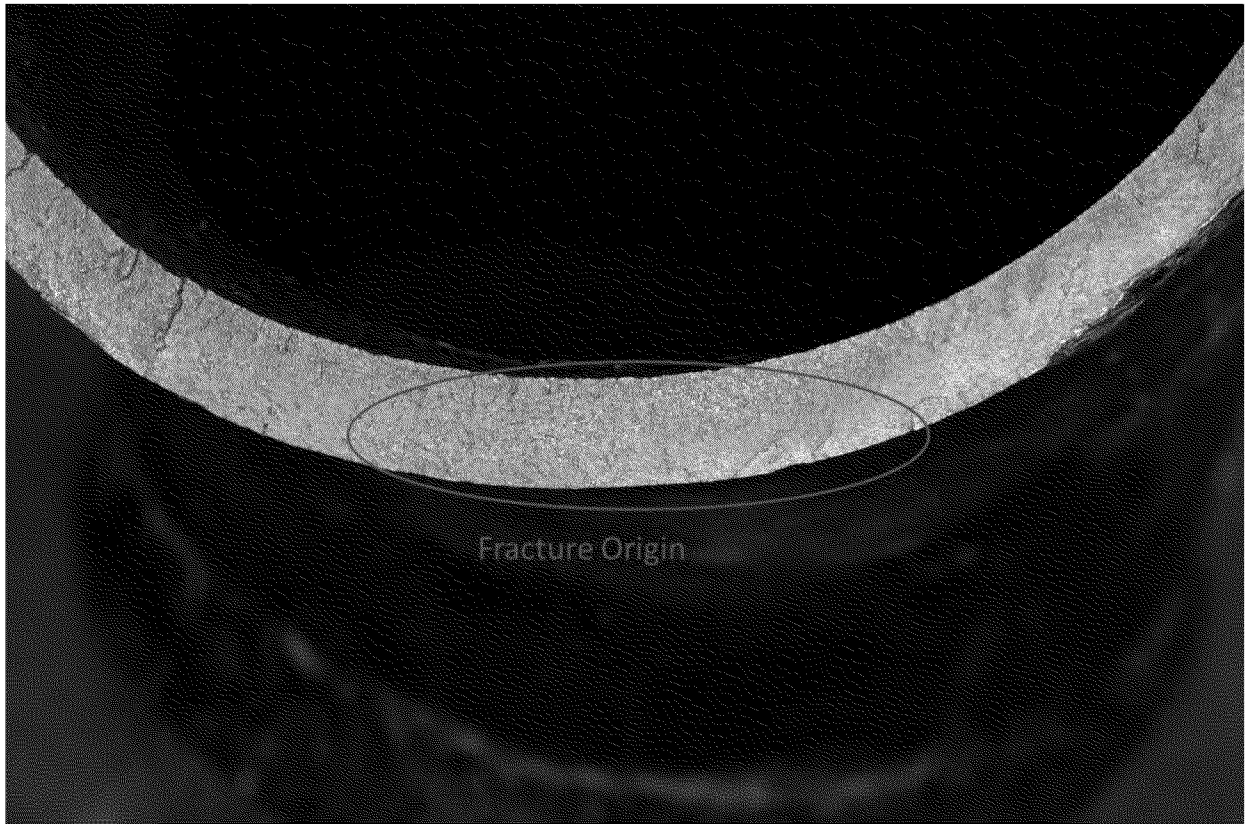
Figure 19. Image that shows the cleaned fracture surface with the fracture origin indicated.

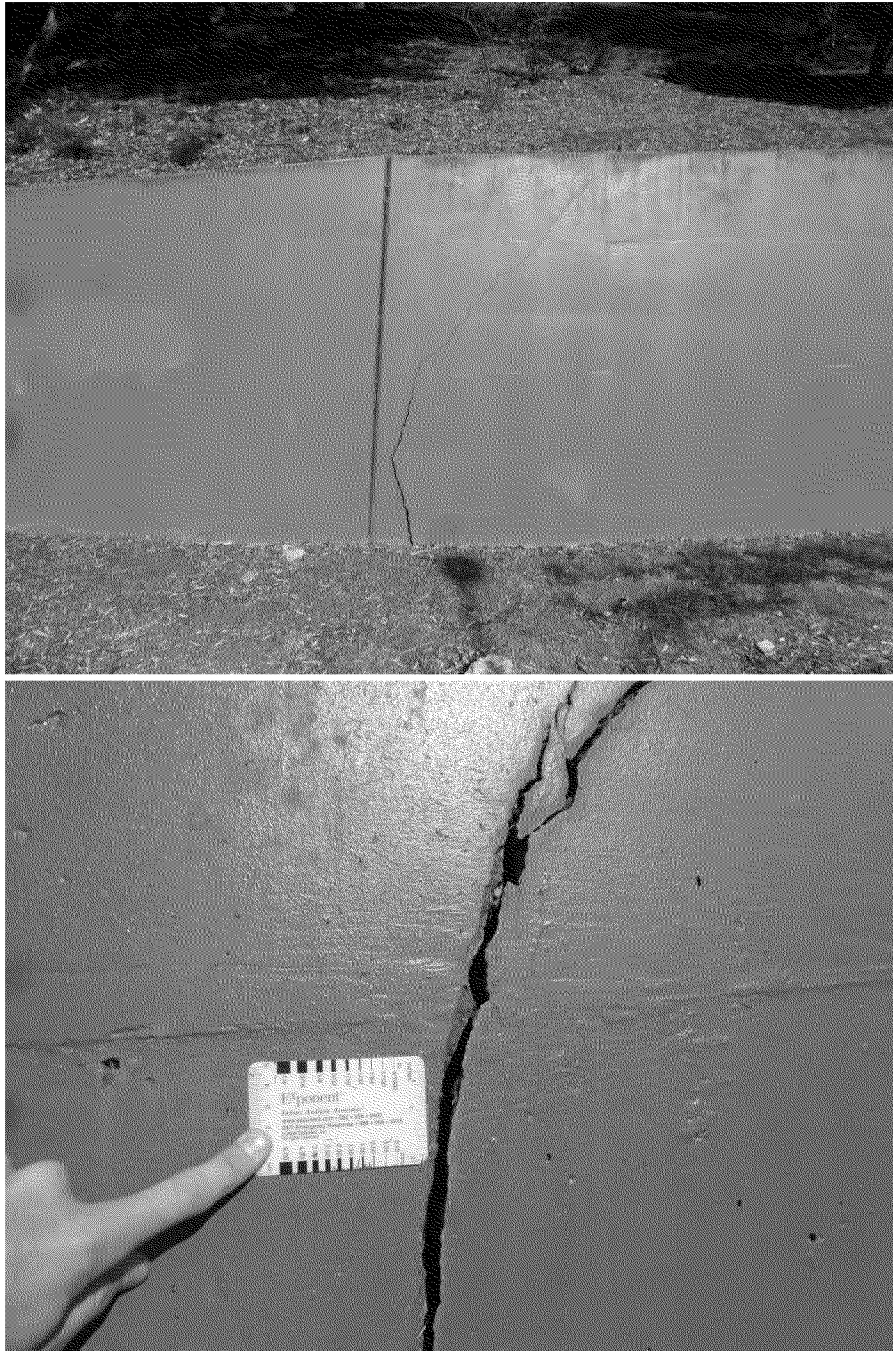
Figure 31. Retaining wall crack, looking north. Photographs by Exponent, December 13, 2013.
