Re: Update - Oakland Incident of December 10, 2013

Failure Analysis Associates

Pacific Gas and Electric (PG&E) has retained Exponent Failure Analysis Associates (Exponent) to conduct a failure analysis investigation of an elbow that fractured as part of a four-inch natural gas distribution line on December 10, 2013 near the intersection of [Redacted] and [Redacted] in Oakland, California. Our investigation to-date has included inspection of the leak site, review of PG&E's historical construction documents, a fire cause and origin study, metallurgical analysis, geotechnical analysis, analysis of other leak locations within the immediate area, and finite element-based stress analyses of ground movement and stresses on the subject elbow and associated piping.

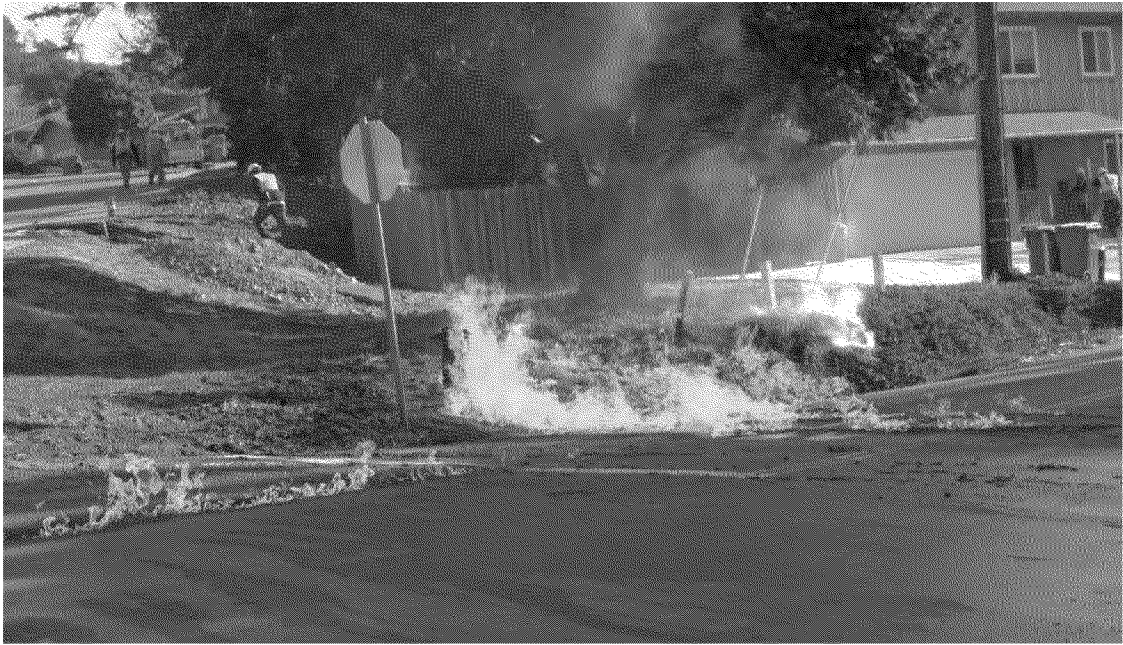
The released gas was ignited and resulted in a gas-fueled fire, which is shown in Figure 2. The fire was first reported to PG&E at approximately 8:39 a.m. and at 8:44 a.m. PG&E personnel arrived on site. The responding fire crews allowed the fire to burn in order to prevent an explosive accumulation of gas from forming. The fire continued to burn until after the upstream flow of gas was shut off at approximately 11:35 a.m. by cutting, capping, and welding the 4-inch main in three locations. No injuries or fatalities occurred and the total damages were reported to be less than \$50,000.

Figure 2. Image of the fire resulting from gas release. Source: PG&E

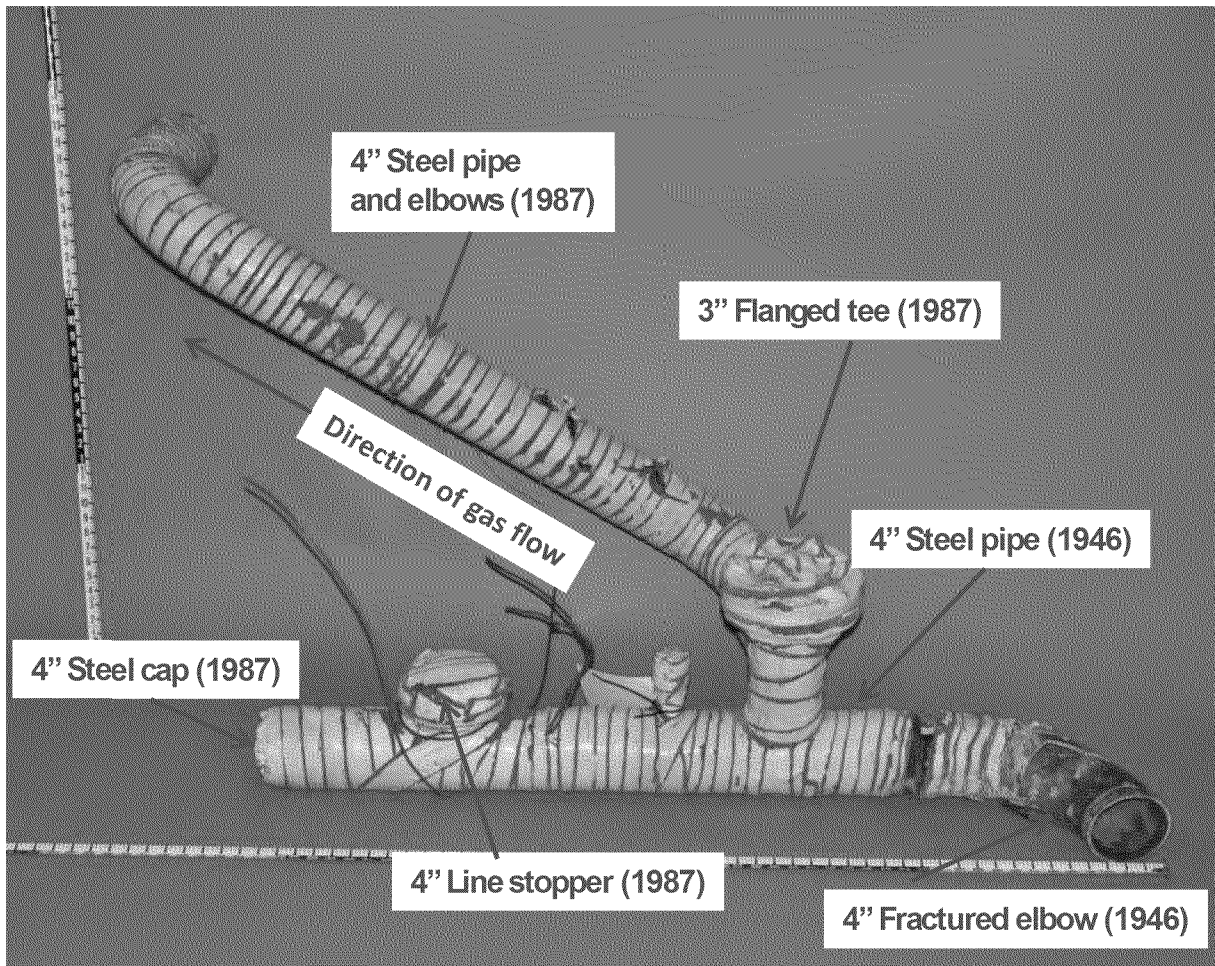
Figure 5. Fractured elbow and adjacent features after removal, with piping photographed as if viewer is looking downstream.

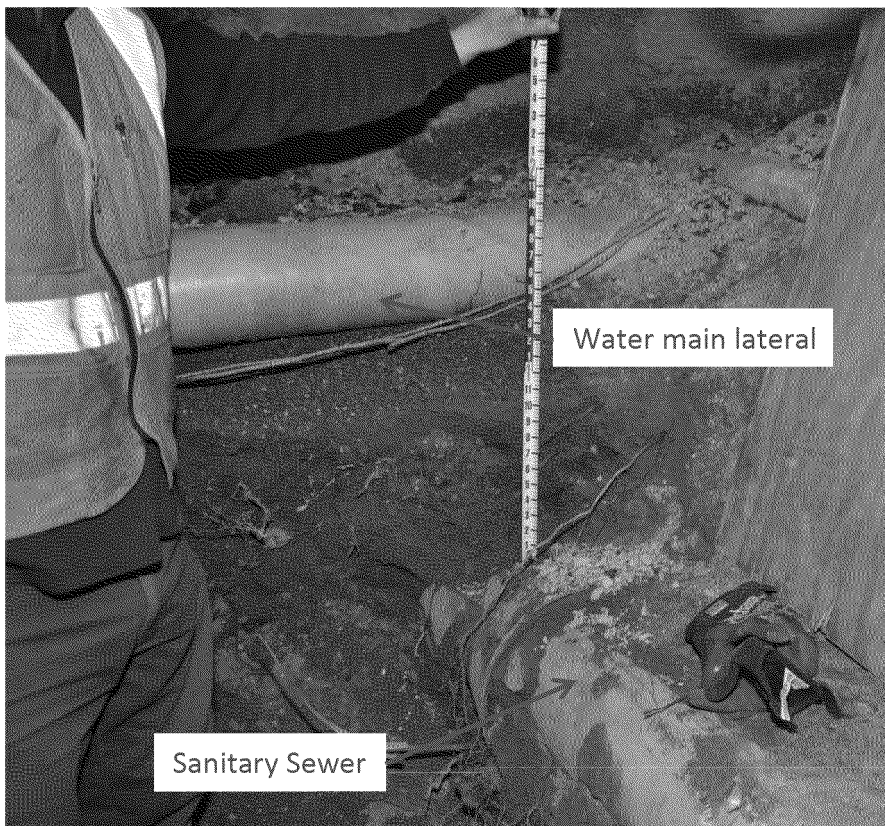
The nearby water main lateral, shown in Figure 3 and Figure 13, was located near the 4-inch steel gas main that was installed in 1987. This water line likely feeds a fire hydrant adjacent to the gas release site. The water lines in the area are owned by the East Bay Municipal Utility District (EBMUD). Per information provided to PG&E by EBMUD, there are three water mains under Golf Links Road: an 8-inch main installed in 1961, a 36-inch diameter main installed in 1957, and a 48-inch diameter main installed in 1962. EBMUD has reportedly experienced water main failures in the immediate vicinity about once every ten years. EBMUD believes that landslides and the Hayward Fault are the primary external loading factors that contributed to the failures.

Figure 13. Water main lateral and sanitary sewer.

The nearby sanitary sewer line, shown in Figure 4 and Figure 13, was located near the 3-inch steel gas main that was installed in 1965. The existing sewer line appears to have been installed by slip lining or pipe bursting an older clay sewer pipe. Pieces of broken red clay pipe were observed to surround the plastic sewer main as shown in Figure 4 and Figure 13. Sewer maps from the City of Oakland, last revised on 8-25-2004, indicate that the sanitary sewer at [Redacted] and [Redacted] was rehabilitated and the City of Oakland has records indicating the as-built date as 2003.

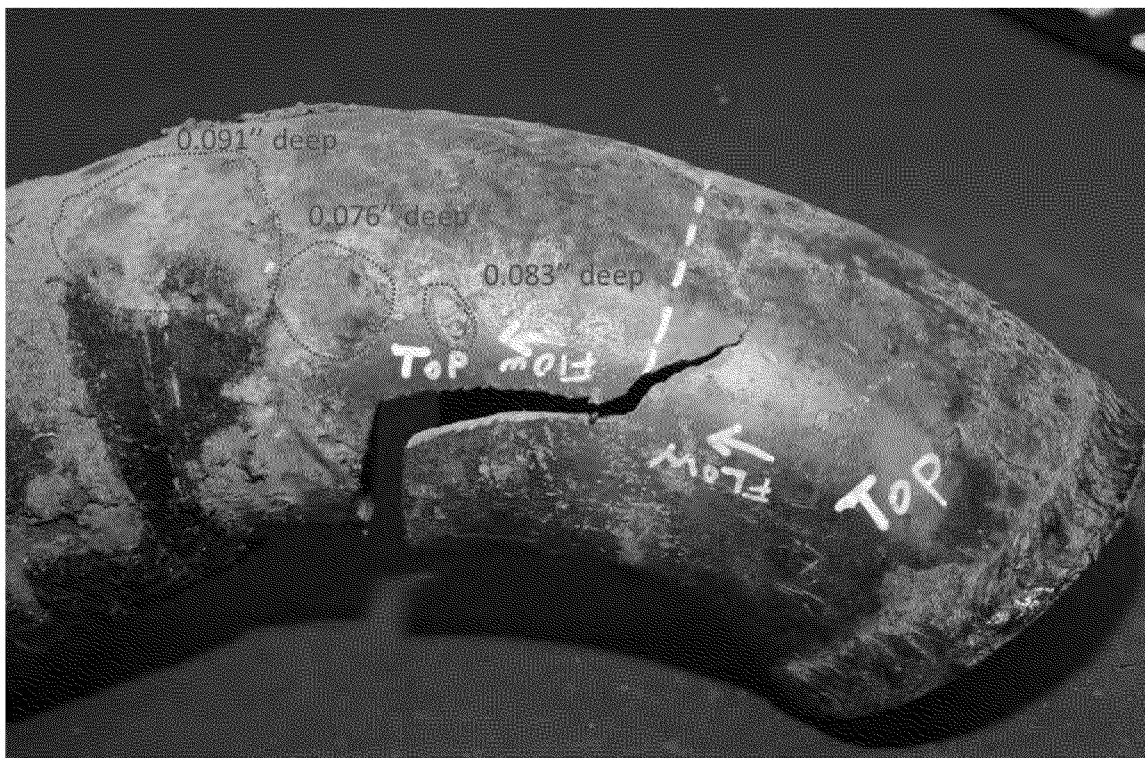
Figure 16. Photograph of the fractured elbow with pipe coating removed showing several corrosion pits, with their depths indicated.

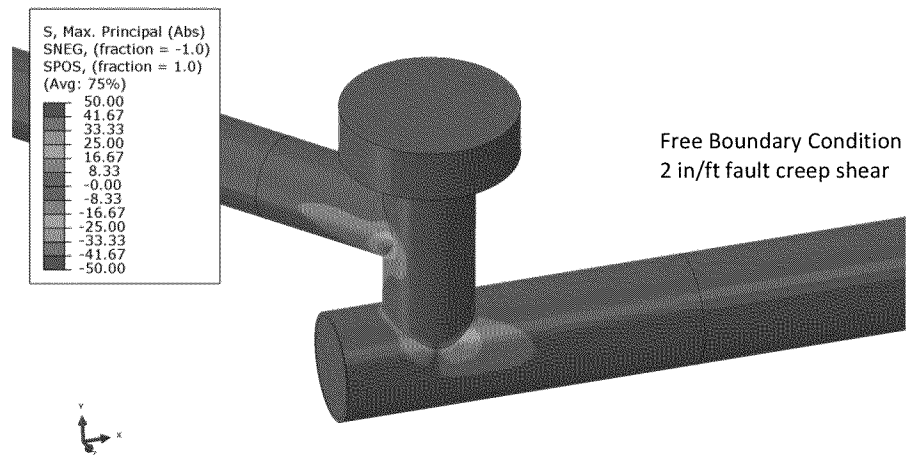
After the failure, the connection between the [Redacted] pipe and the [Redacted] pipe remains intact. Exponent's stress analysis indicates that local stresses likely remain in the existing configuration. As more fault creep occurs in the future, these stresses are expected to increase. Exponent recommends the current connection be replaced to relieve the current stresses.

Figure 52. Tensile stresses after the post-failure repair in the flange tee neighboring the incident elbow for different boundary conditions on the Fontaine Street pipe. Note that the models have decreasing amount of shear despite increasing stresses. Units are ksi.
