**Golf Links Road (Oakland)
Incident Analysis**

Prepared for

Sumeet Singh
Pacific Gas and Electric Company
6111 Bollinger Canyon Road
San Ramon, CA 94583

January 2014
Revised January 20, 2014

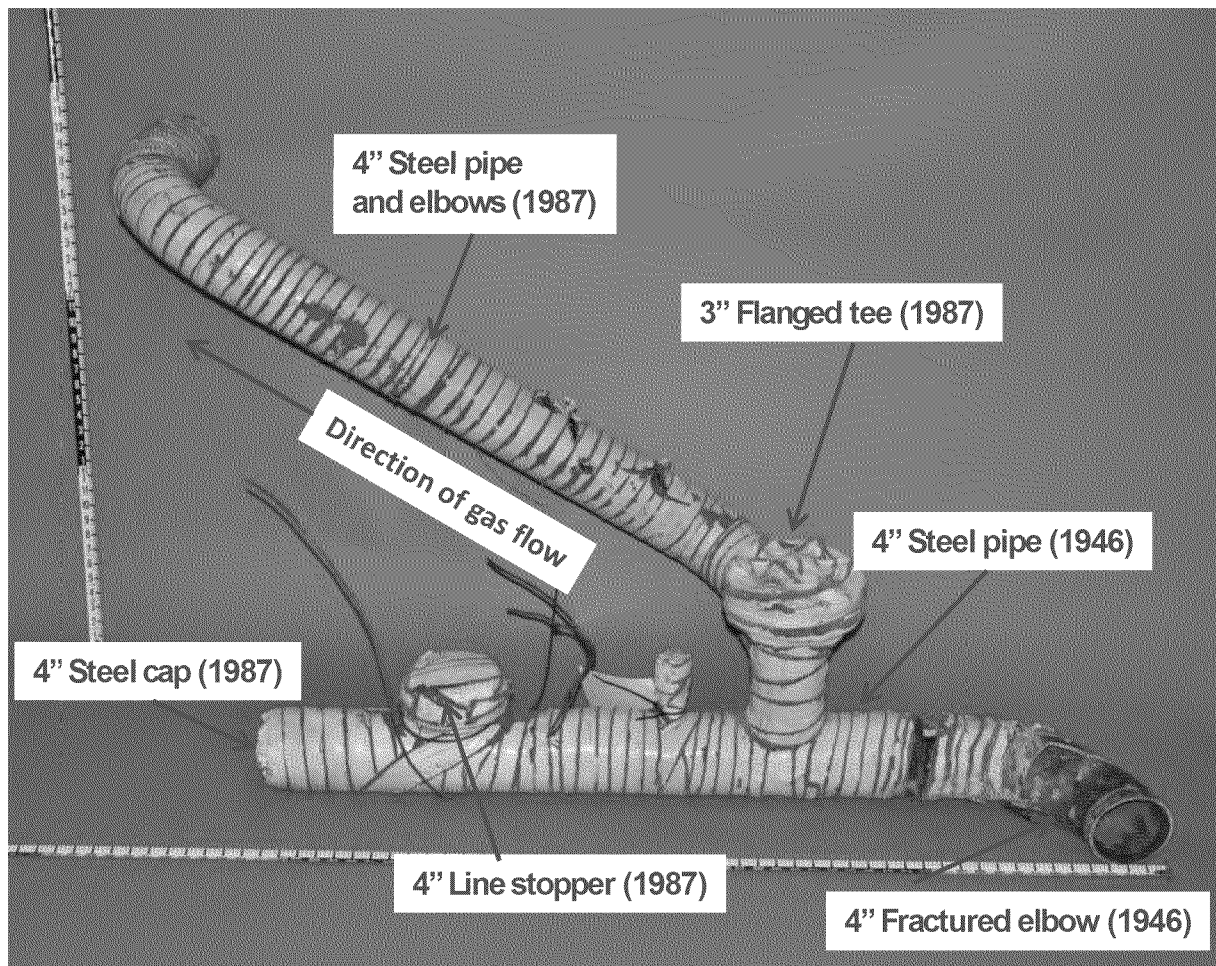
Figure 5. Fractured elbow and adjacent features after removal, with piping photographed as if viewer is looking downstream.

The ruptured elbow and piping downstream from the break was removed from the leak site as shown in Figure 5, and was brought to Exponent's Menlo Park, California laboratories for analysis. The break occurred at the elbow intrados, as shown in Figure 15. The fracture plane was primarily perpendicular to the gas flow direction and located near the center of the elbow. This fracture orientation is consistent with bending of the elbow, rather than a pressure-induced break. Comparison of the ruptured elbow before and after excavation (Figure 4 and Figure 15) showed that the fracture opened during the excavation process. This is consistent with reports of witnesses on site during the excavation process.

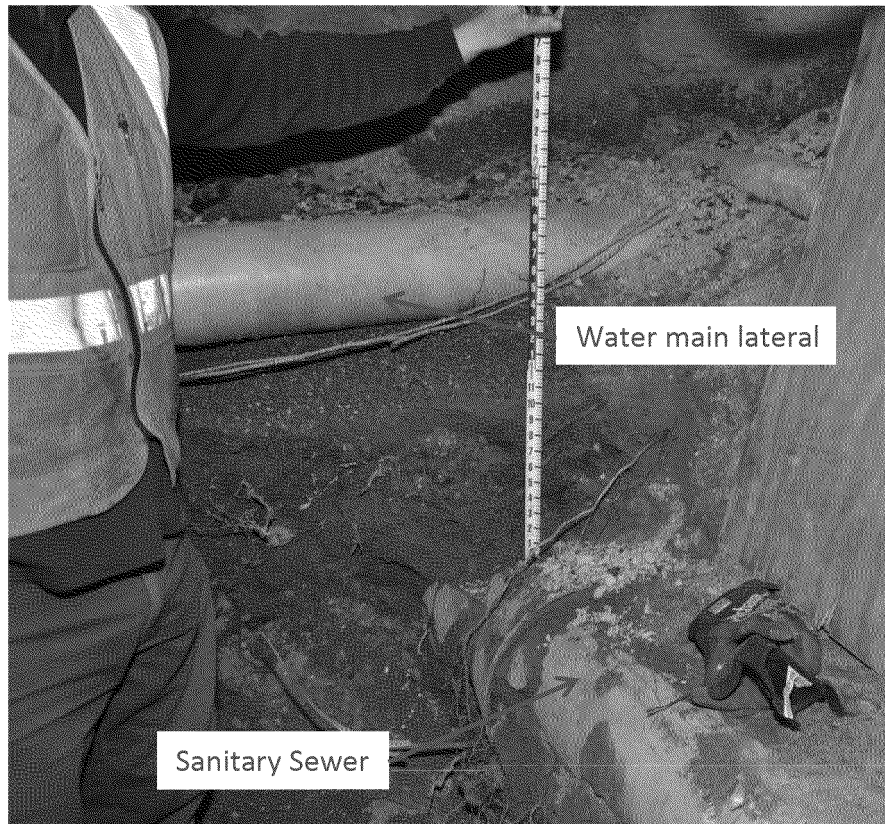
The nearby water main lateral, shown in Figure 3 and Figure 13, was located near the 4-inch steel gas main that was installed in 1987. This water line likely feeds a fire hydrant adjacent to the gas release site. The water lines in the area are owned by the East Bay Municipal Utility District (EBMUD). Per information provided to PG&E by EBMUD, there are three water mains under Golf Links Road: an 8-inch main installed in 1961, a 36-inch diameter main installed in 1957, and a 48-inch diameter main installed in 1962. EBMUD has reportedly experienced water main failures in the immediate vicinity about once every ten years. EBMUD believes that landslides and the Hayward Fault are the primary external loading factors that contributed to the failures.

Figure 13. Water main lateral and sanitary sewer.

The nearby sanitary sewer line, shown in Figure 4 and Figure 13, was located near the 3-inch steel gas main that was installed in 1965. The existing sewer line appears to have been installed by slip lining or pipe bursting an older clay sewer pipe. Pieces of broken red clay pipe were observed to surround the plastic sewer main as shown in Figure 4 and Figure 13. Sewer maps from the City of Oakland, last revised on 8-25-2004, indicate that the sanitary sewer at Golf Links Road and Fontaine Street was rehabilitated and the City of Oakland has records indicating the as-built date as 2003.

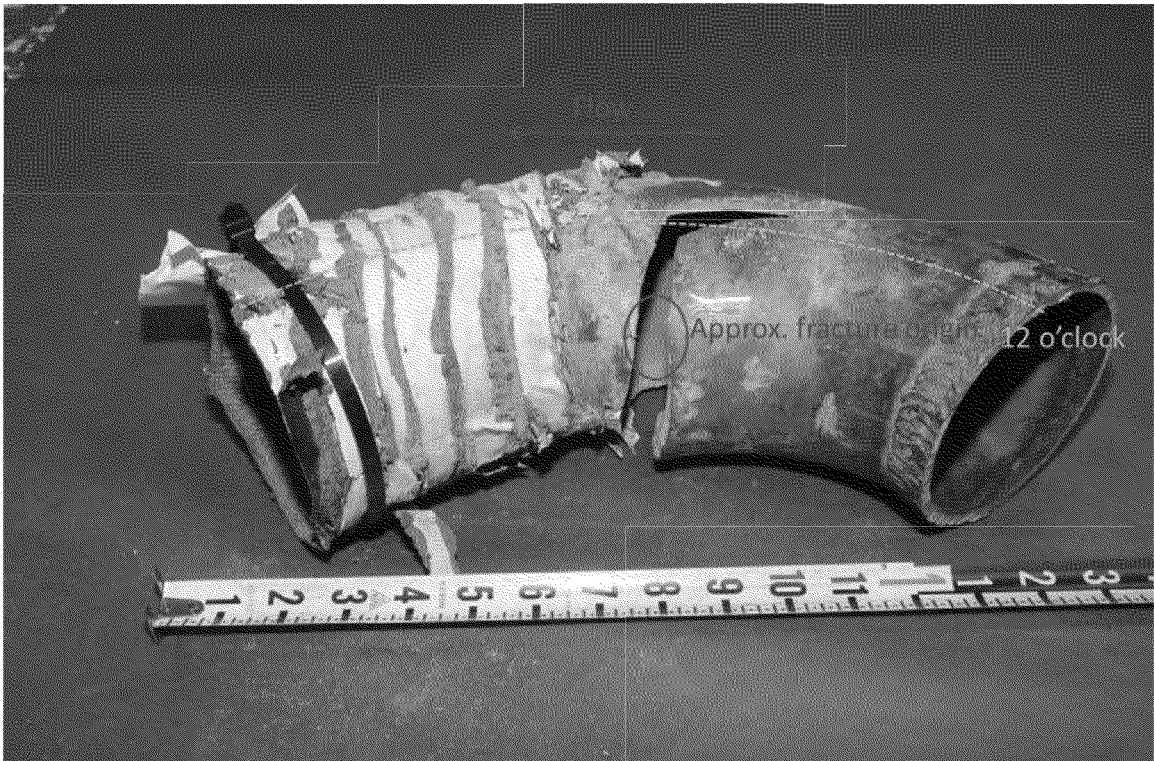
Figure 15. Image of fractured elbow.

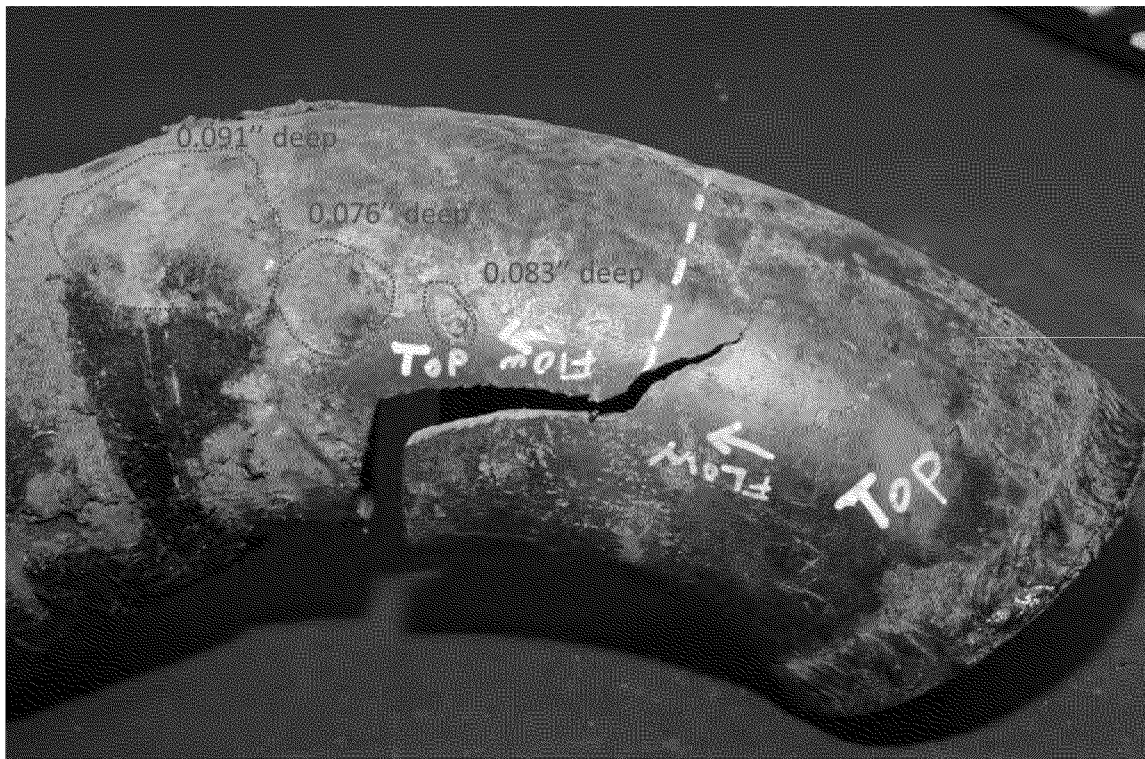
The pipe coating was manually removed from the subject to allow better visual inspection and measurements of the pipe thickness. Areas of pitting corrosion were observed near the top of the elbow, as shown in Figure 16. However, these pitted areas occurred well away from the fracture. No evidence of mechanical damage was observed. No other defects, cracks, seams, weld issues, or anomalies were observed.

Figure 16. Photograph of the fractured elbow with pipe coating removed showing several corrosion pits, with their depths indicated.

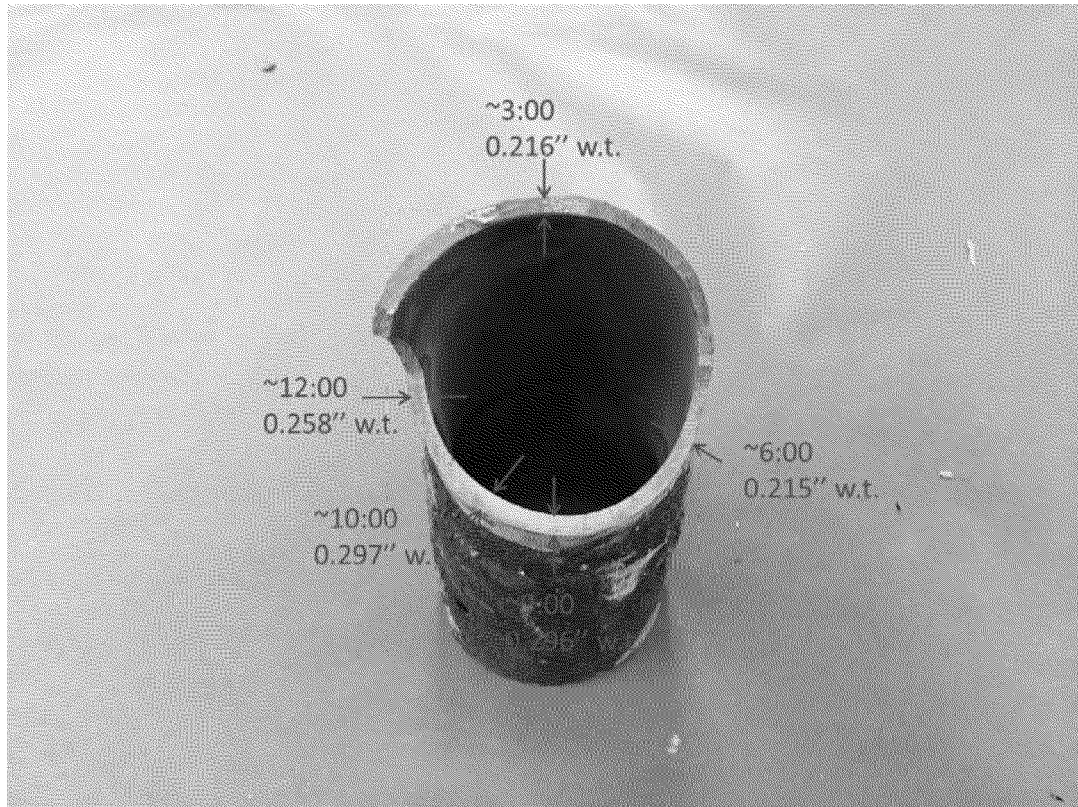
The subject elbow was sectioned to allow fractographic and metallographic examination, as well as elbow wall thickness measurements. The minimum wall thickness was 0.215-inch at the 6 o'clock position, and the maximum thickness was 0.297-inch, located at the 10 o'clock position, as shown in Figure 17. All clock positions reported are looking downstream. PG&E construction documents from 1946 and fitting specifications indicated that the subject elbow was specified to have a wall thickness of 0.237-inch, and to be fabricated from ASTM A 106 Grade A or B material. Note that the elbow fractured at the location of greatest wall thickness.

Figure 17. Cross-sectional measurements of pipe thickness around the circumference of the subject elbow at the fracture location.

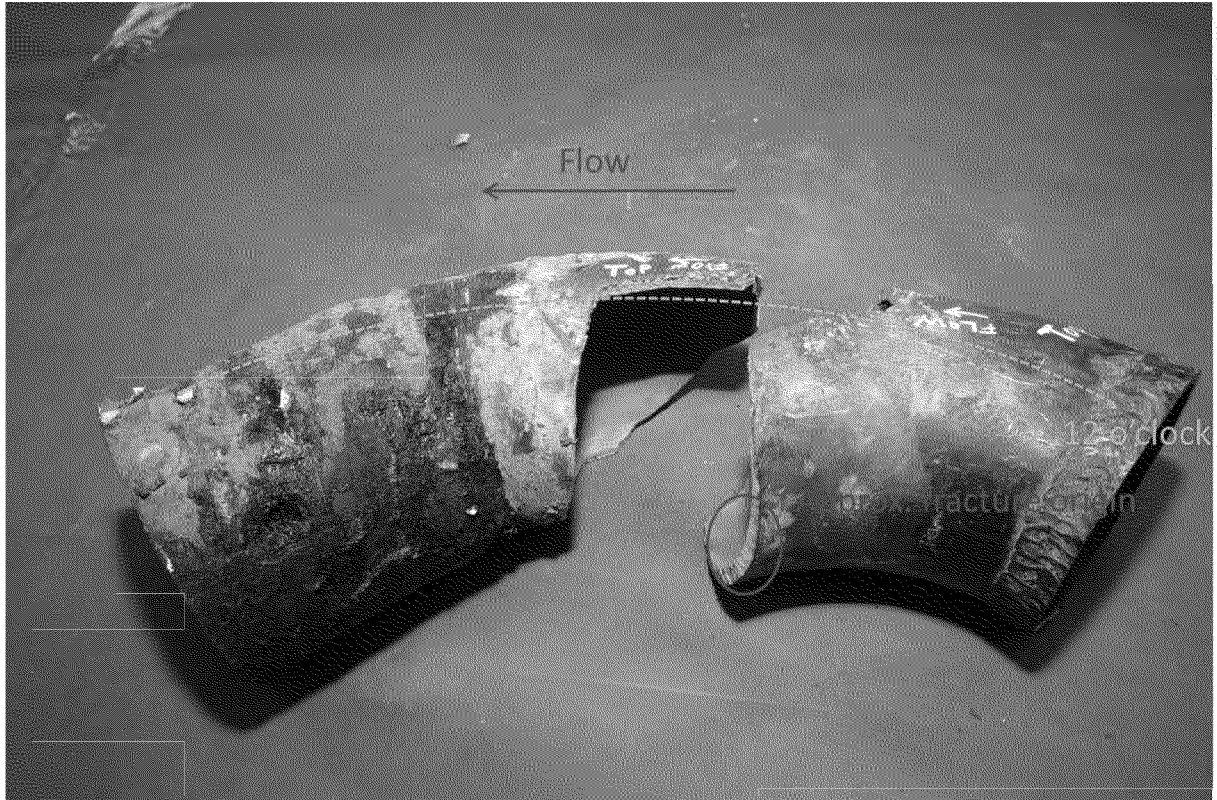
Fractographic analysis was conducted to help determine the cause of the rupture. The elbow was sectioned across the remaining intact area near the break to better expose the fracture surfaces for examination, as shown in Figure 18. To help remove the soil that obscured the surface, the fracture faces were cleaned in a warm Alconox (detergent and water) solution and scrubbed with a nylon brush. Following cleaning, the fracture surface was examined visually as well as using optical and scanning electron microscopy (SEM) techniques. A photograph of the cleaned fracture surface is shown in Figure 19. No dark areas, associated with long-term corrosion, or evidence of progressive fracture (such as beach marks) were observed. The fracture origin area was relatively flat with little ductility. Examination of tear ridges and chevron marks (which point back to the initiation point), shown in Figure 19 and Figure 20, indicated that the fracture origin was located at roughly the 10 o'clock position.

Figure 18. Image that shows the elbow after sectioning. The piece on the right (upstream) was subjected to fractographic and metallographic examination.

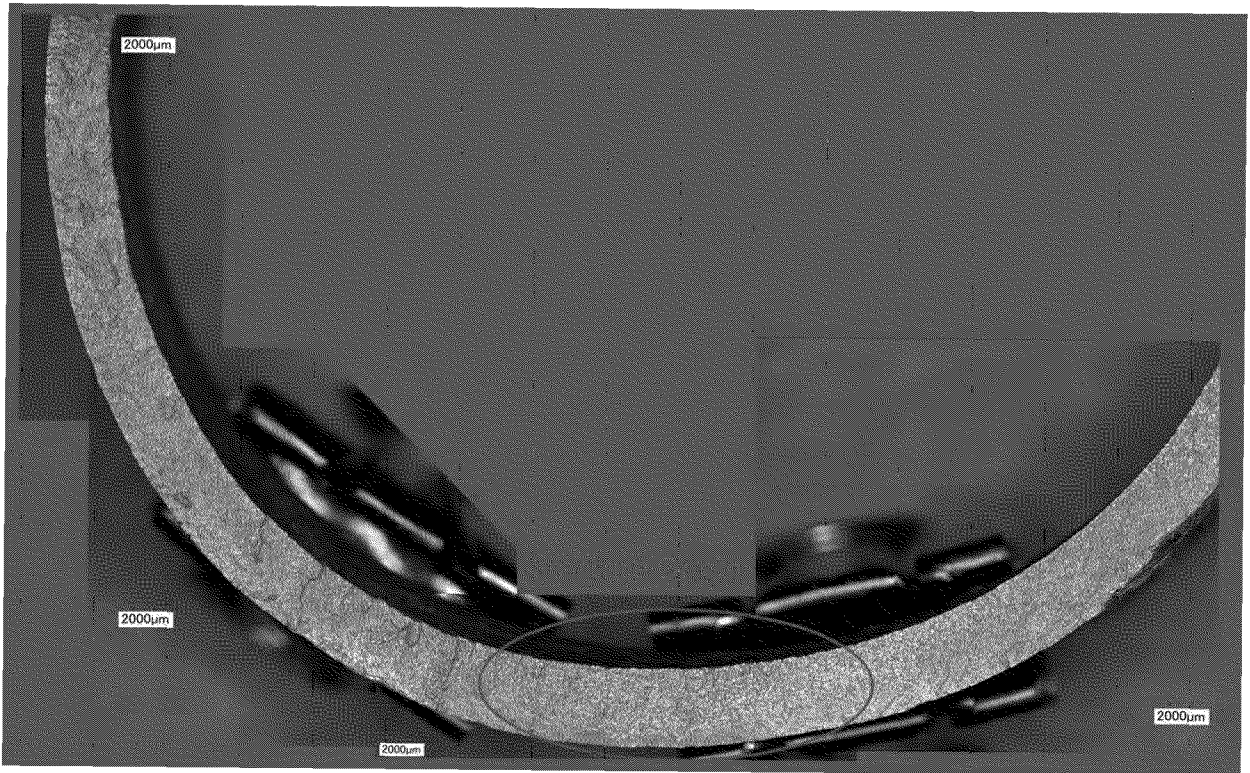
Figure 20. Optical microscope photo montage that shows the fracture surface with the origin indicated.

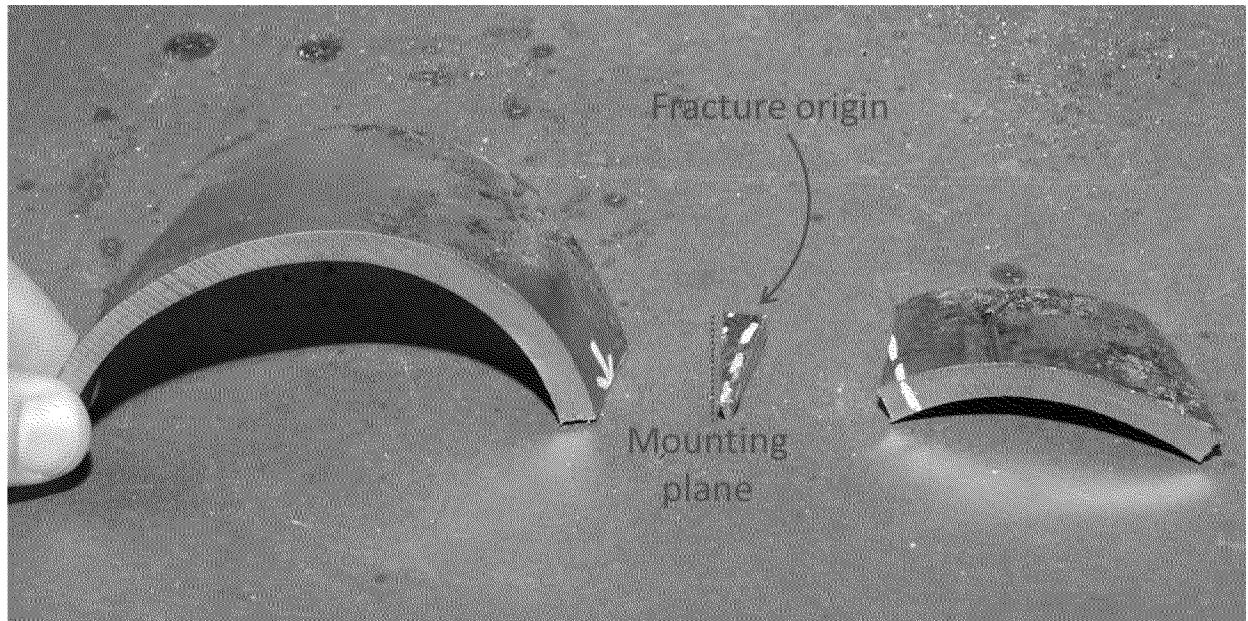
A portion of the fracture origin was sectioned to allow metallographic examination, shown in Figure 23. The sample was mounted perpendicular to the fracture plane (i.e., along the longitudinal direction along the elbow), and was ground, polished, and etched using typical metallographic procedures. The elbow exhibited a typical ferrite and pearlite microstructure, including at the fracture origin, as shown in Figure 24. Microhardness testing was conducted on the metallographic sample: the average hardness was measured to be 193 HV.

Figure 23. A photograph that shows the metallographic specimen from the origin area.

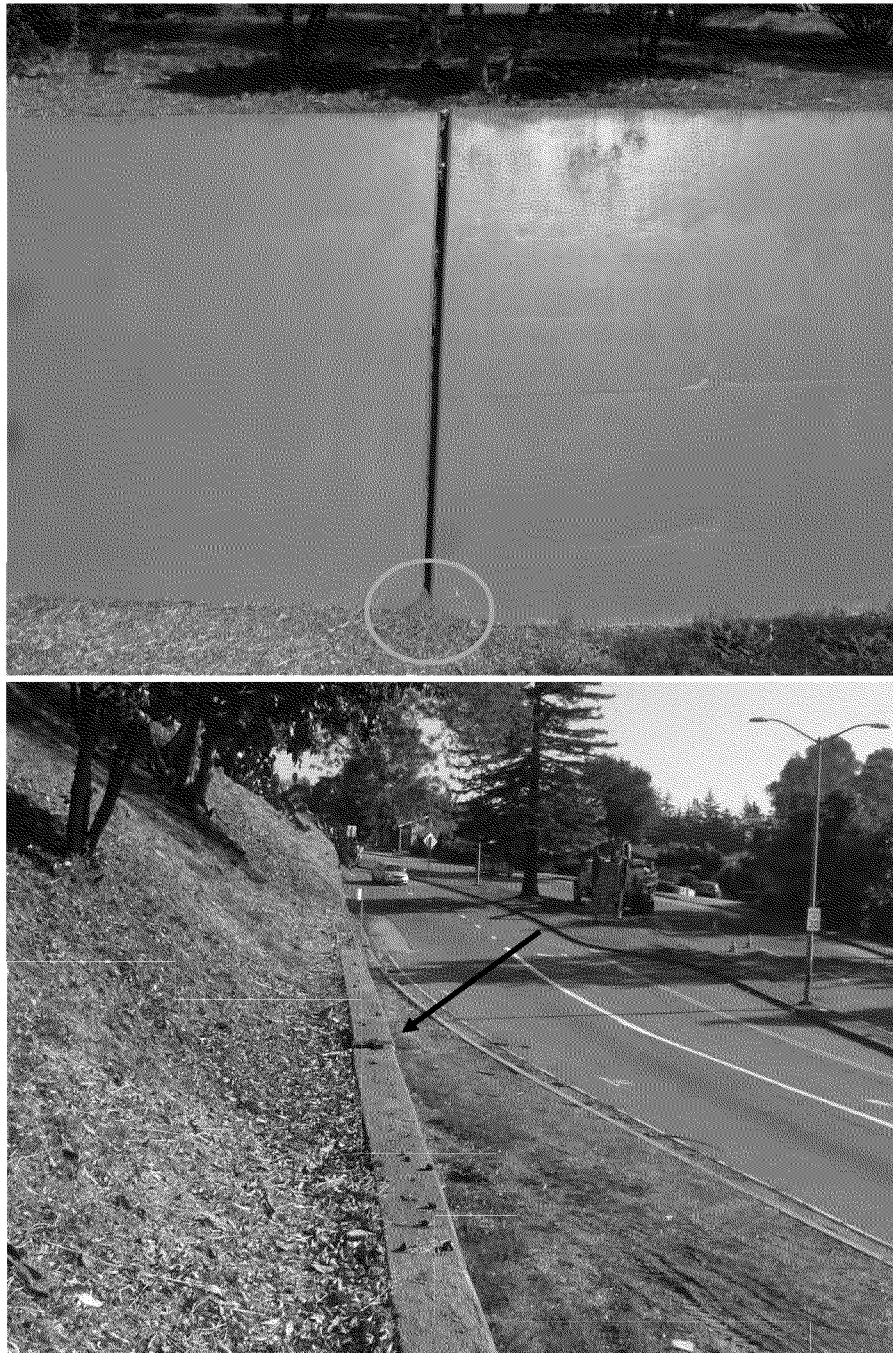
Figure 32. Displaced retaining wall joint. Oval encloses observed recent soil deposits near the base of the wall. Arrow indicates right-lateral displacement at top of wall. Photographs by Exponent, December 13, 2013.

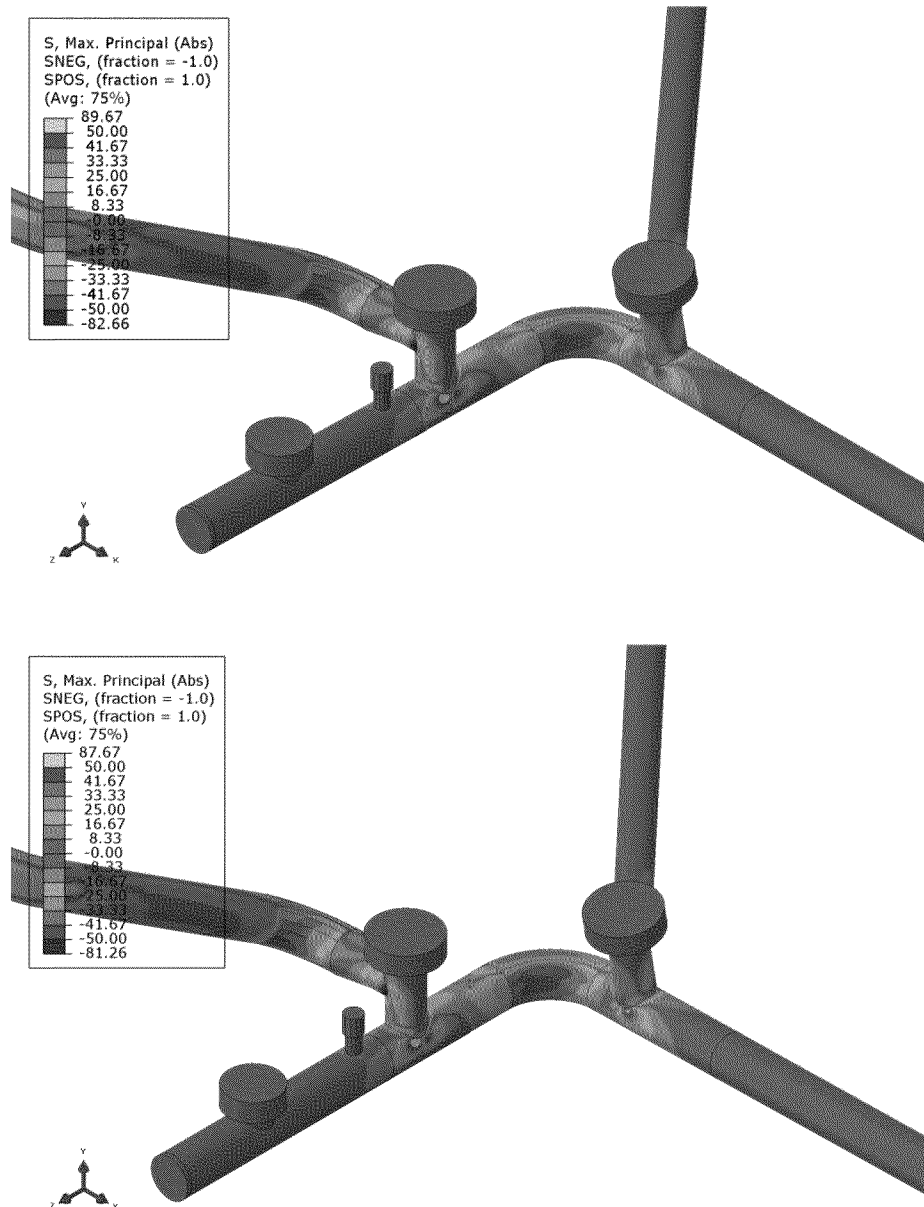
Figure 46. Tensile stresses in the gas pipes when subjected to 0.2 in/ft of shear in the fault creep direction (top) and the landslide shear direction (bottom). Units are ksi.

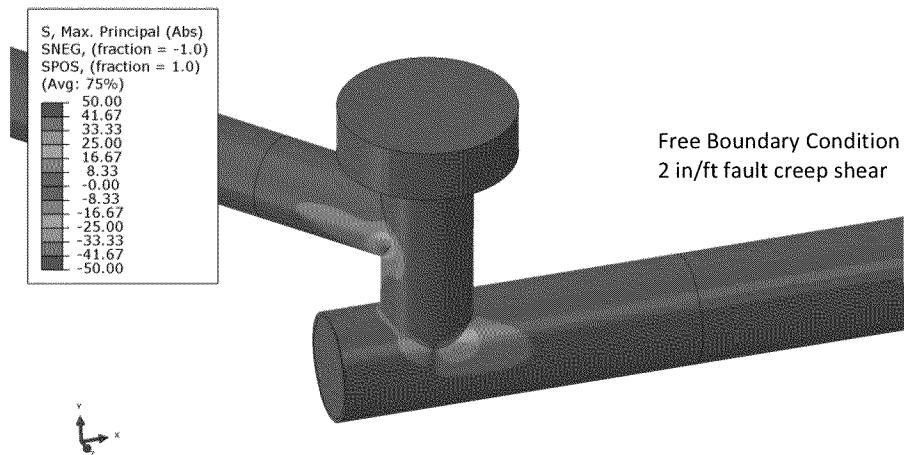
After the failure, the connection between the Fontaine Street pipe and the Golf Links Road pipe remains intact. Exponent's stress analysis indicates that local stresses at this connection may be approximately 30 ksi. As more fault creep occurs in the future, these stresses are expected to increase.

Figure 52. Tensile stresses after the post-failure repair in the flange tee neighboring the incident elbow for different boundary conditions on the Fontaine Street pipe. Note that the models have decreasing amount of shear despite increasing stresses. Units are ksi.
