Re: Update - Oakland Incident of December 10, 2013

Pacific Gas and Electric (PG&E) has retained Exponent Failure Analysis Associates (Exponent) to conduct a failure analysis investigation of an elbow that fractured as part of a four-inch natural gas distribution line on December 10, 2013 near the intersection of [Redacted] and [Redacted] in Oakland, California. Our investigation to-date has included inspection of the leak site, review of PG&E's historical construction documents, a fire cause and origin study, metallurgical analysis, geotechnical analysis, analysis of other leak locations within the immediate area, and finite element-based stress analyses of ground movement and stresses on the subject elbow and associated piping.

Exponent's analyses indicate that the most likely root cause of the subject elbow fracture was from stresses that developed over time due to creep along the Hayward Fault.

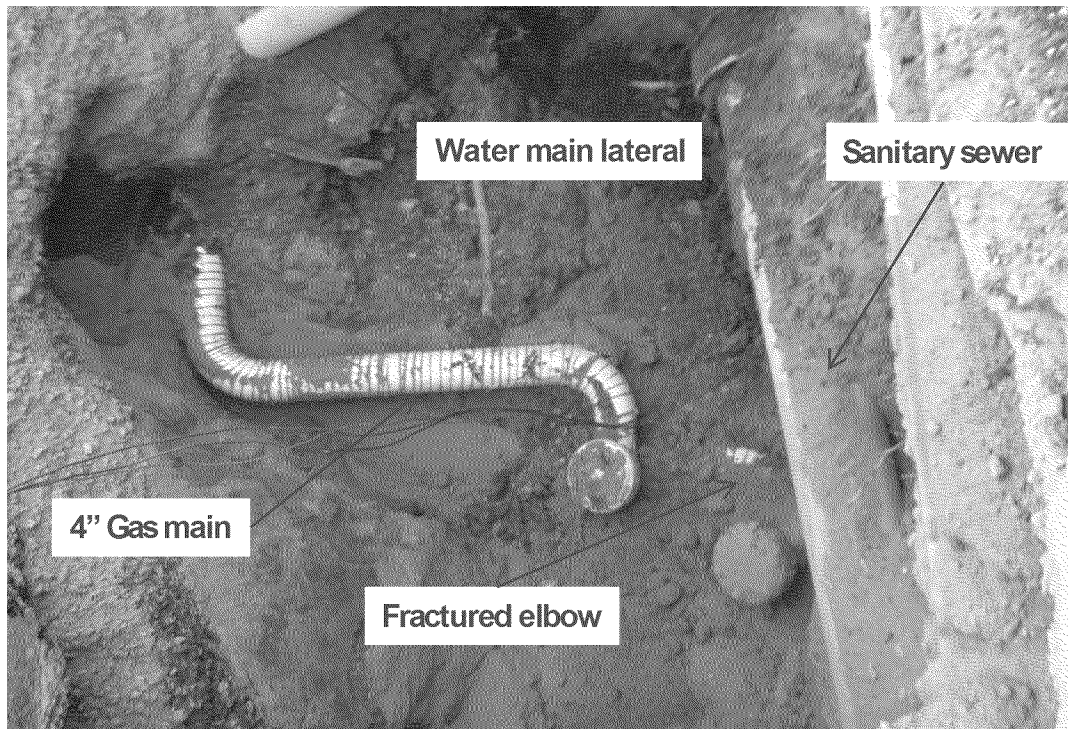
An excavation of the area of the gas release site, shown in Figure 3, revealed steel natural gas distribution mains, a water main lateral, and a sanitary sewer line in the immediate vicinity. Upon visual inspection, it was determined that the source of the gas release was a fractured elbow. A portion of the fractured elbow, while still covered with pipe wrap, is shown partially protruding from the soil in Figure 3. The continuation of the 4-inch gas main, the adjacent water pipe, and the sanitary sewer main are also shown. The fractured elbow is shown prior to removal in Figure 4. The flanged tee and 3-inch pipe shown in Figure 4 were not removed from the ground. Following Exponent's site inspection, the fractured elbow and several adjacent pipeline features were removed and retained by Exponent for laboratory inspection. The gas main features that were removed and their respective installation dates are shown in Figure 5. The features in Figure 5 are shown as they would have been seen if the viewer were facing approximately northwest.

Figure 3. Excavated area of the gas release.

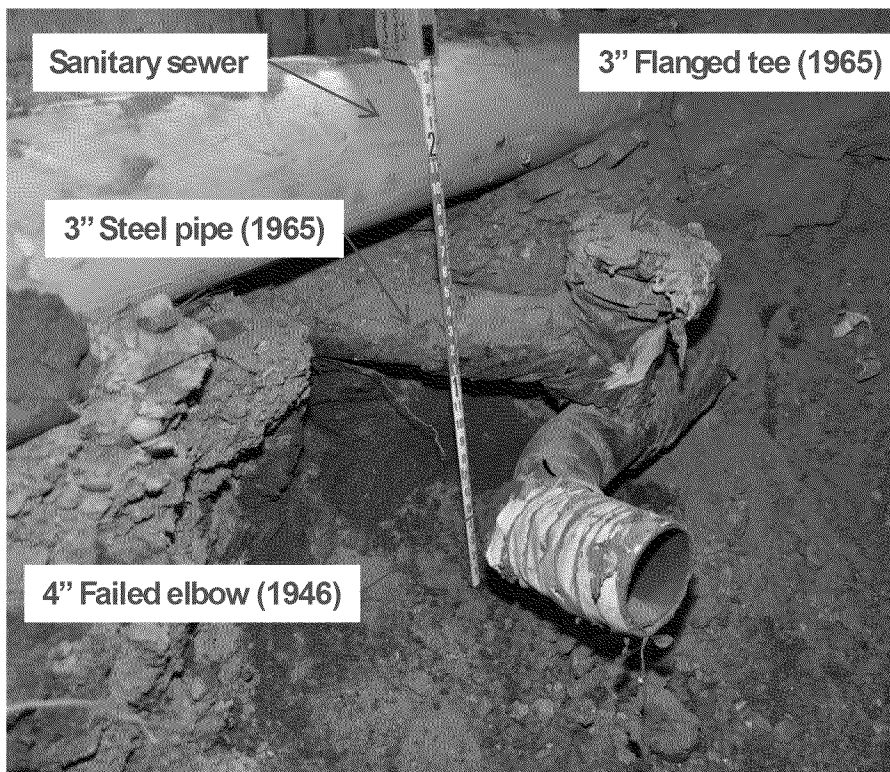
Figure 4. Fractured elbow prior to removal.

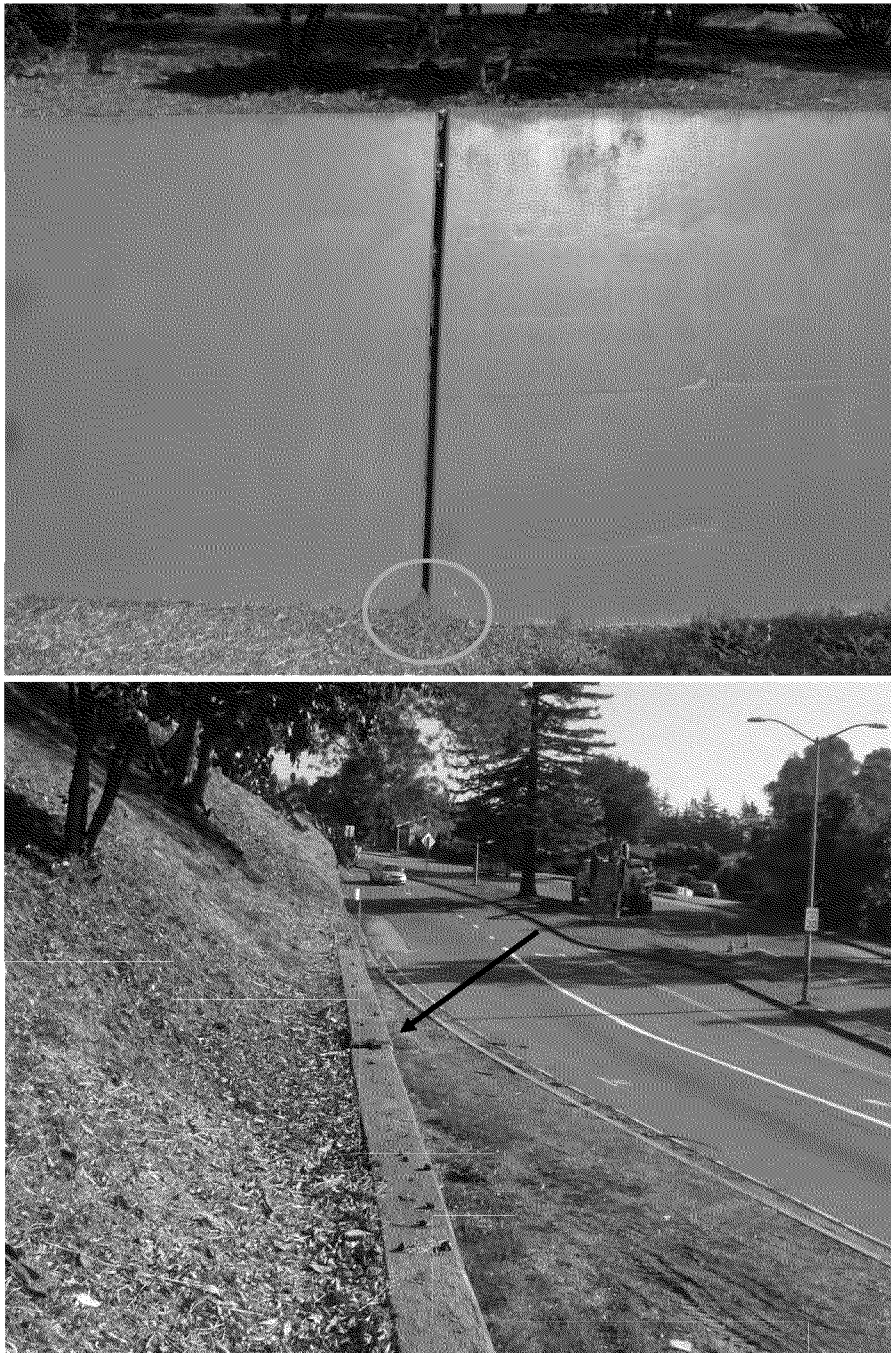
Figure 32. Displaced retaining wall joint. Oval encloses observed recent soil deposits near the base of the wall. Arrow indicates right-lateral displacement at top of wall. Photographs by Exponent, December 13, 2013.
