Re: Update - Oakland Incident of December 10, 2013

This letter is to provide an update on the incident that occurred on December 10, 2013, near [Redacted] and [Redacted] in Oakland. PG&E provided the first update regarding this incident on December 20, 2013. PG&E is now providing a second update to summarize Exponent, Inc.'s final report findings and analysis of the incident, as well as PG&E's next steps. The report, "[Redacted] (Oakland) Incident Analysis," includes an Executive Summary and is provided as an attachment to this letter.

*Failure Analysis Associates*

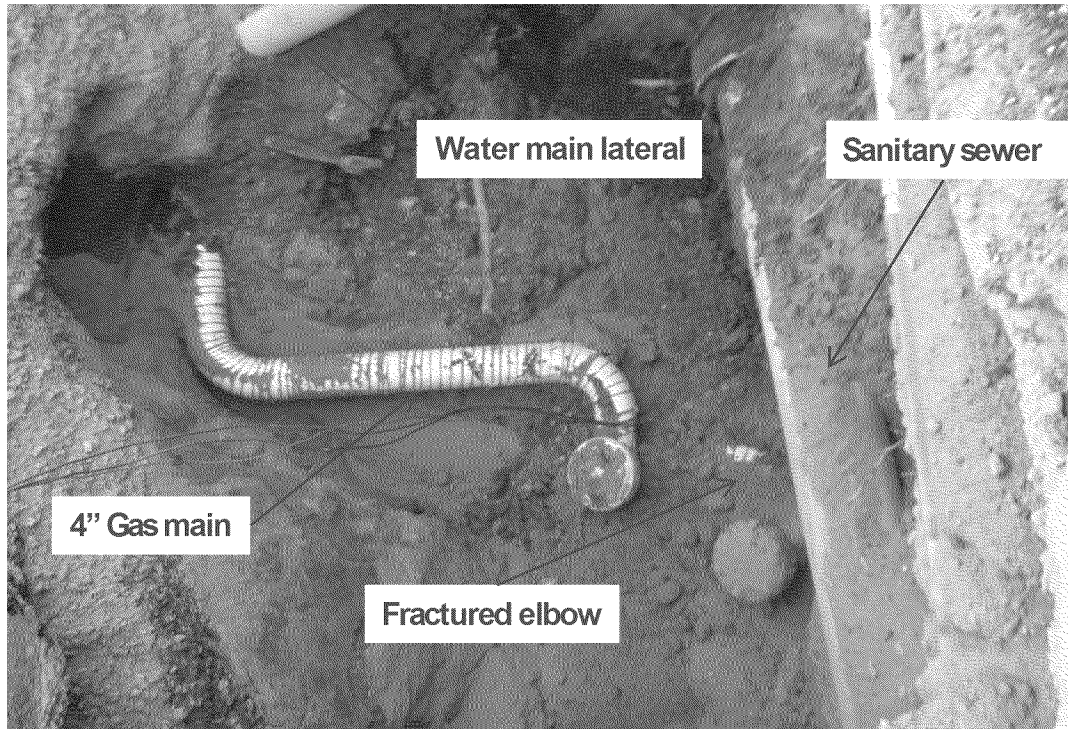
An excavation of the area of the gas release site, shown in Figure 3, revealed steel natural gas distribution mains, a water main lateral, and a sanitary sewer line in the immediate vicinity. Upon visual inspection, it was determined that the source of the gas release was a fractured elbow. A portion of the fractured elbow, while still covered with pipe wrap, is shown partially protruding from the soil in Figure 3. The continuation of the 4-inch gas main, the adjacent water pipe, and the sanitary sewer main are also shown. The fractured elbow is shown prior to removal in Figure 4. The flanged tee and 3-inch pipe shown in Figure 4 were not removed from the ground. Following Exponent's site inspection, the fractured elbow and several adjacent pipeline features were removed and retained by Exponent for laboratory inspection. The gas main features that were removed and their respective installation dates are shown in Figure 5. The features in Figure 5 are shown as they would have been seen if the viewer were facing approximately northwest.

Figure 3. Excavated area of the gas release.

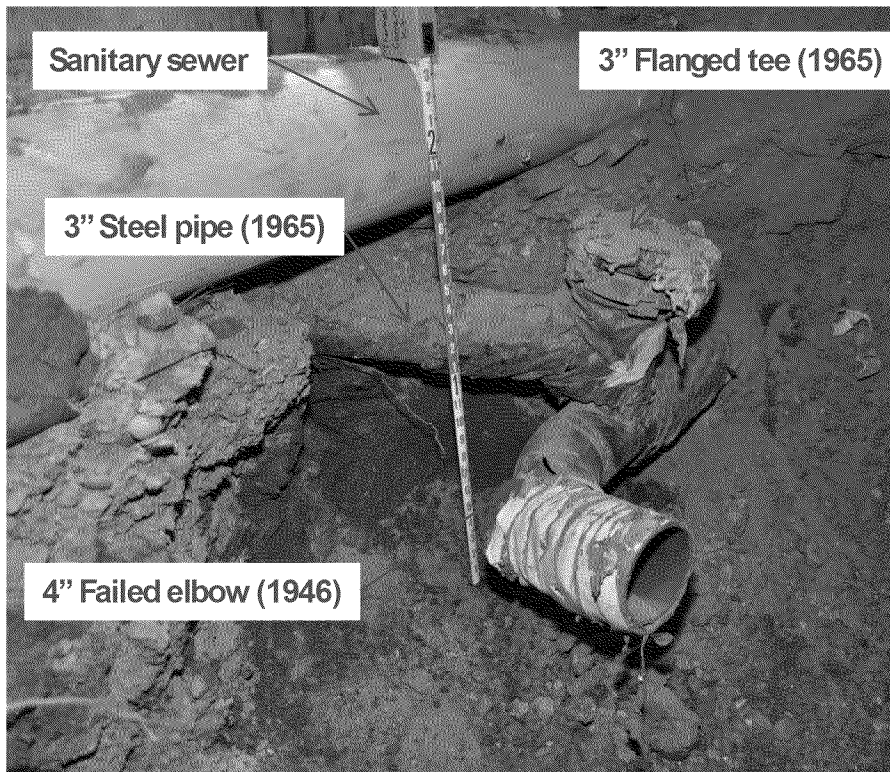
Figure 4. Fractured elbow prior to removal.

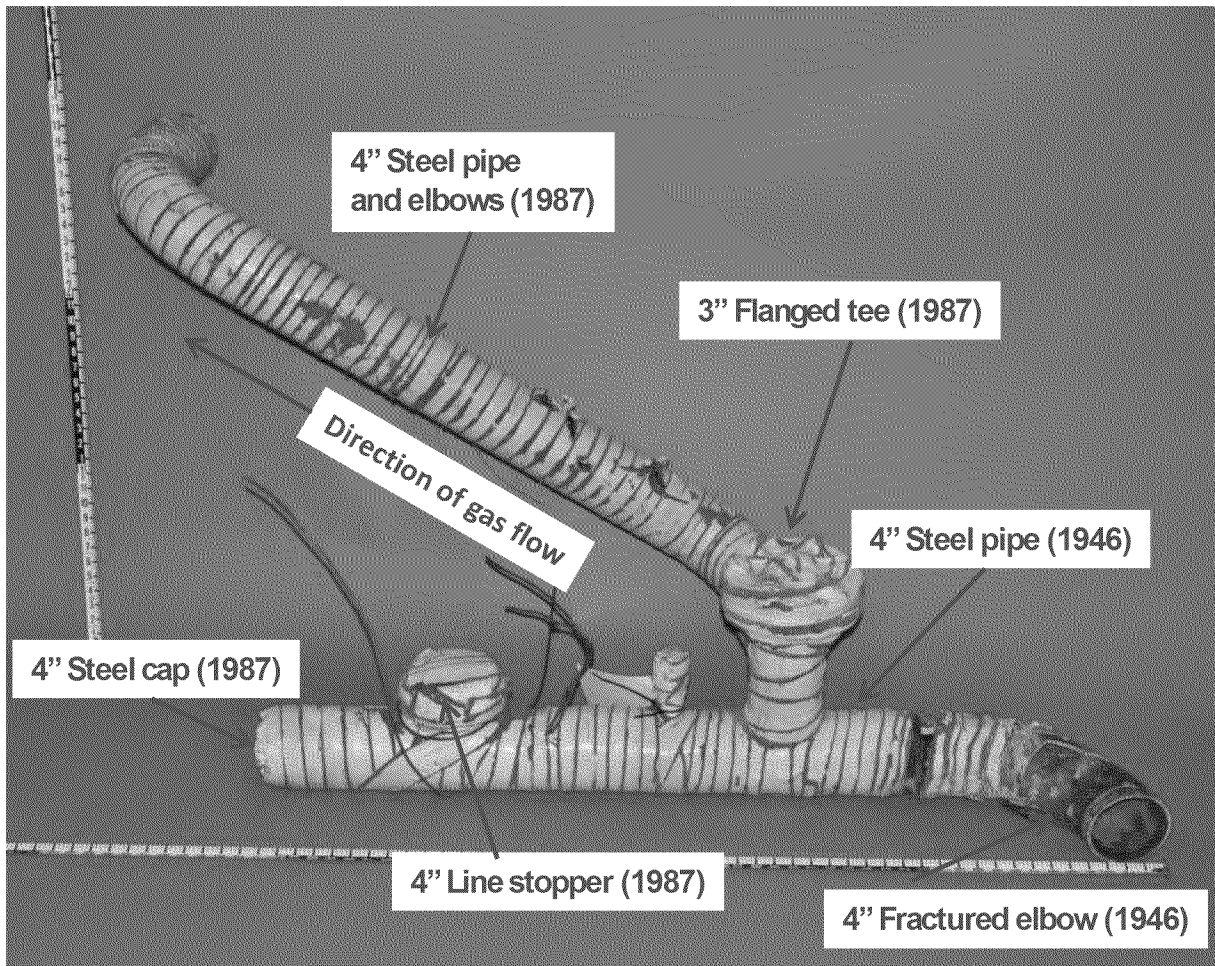
Figure 5. Fractured elbow and adjacent features after removal, with piping photographed as if viewer is looking downstream.

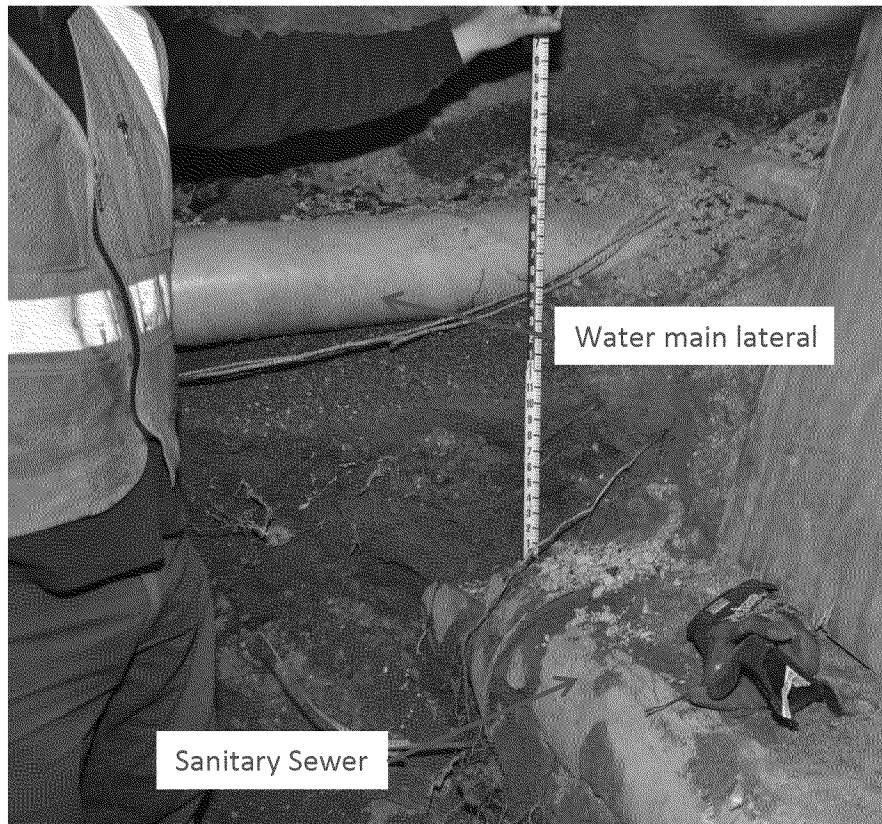
The nearby water main lateral, shown in Figure 3 and Figure 13, was located near the 4-inch steel gas main that was installed in 1987. This water line likely feeds a fire hydrant adjacent to the gas release site. The water lines in the area are owned by the East Bay Municipal Utility District (EBMUD). Per information provided to PG&E by EBMUD, there are three water mains under [Redacted], an 8-inch main installed in 1961, a 36-inch diameter main installed in 1957, and a 48-inch diameter main installed in 1962. EBMUD has reportedly experienced water main failures in the immediate vicinity about once every ten years. EBMUD believes that landslides and the Hayward Fault are the primary external loading factors that contributed to the failures.

Figure 13. Water main lateral and sanitary sewer.

The nearby sanitary sewer line, shown in Figure 4 and Figure 13, was located near the 3-inch steel gas main that was installed in 1965. The existing sewer line appears to have been installed by slip lining or pipe bursting an older clay sewer pipe. Pieces of broken red clay pipe were observed to surround the plastic sewer main as shown in Figure 4 and Figure 13. Sewer maps from the City of Oakland, last revised on 8-25-2004, indicate that the sanitary sewer at [Reda] [Redacted] and [Redacted] was rehabilitated and the City of Oakland has records indicating the as-built date as 2003.

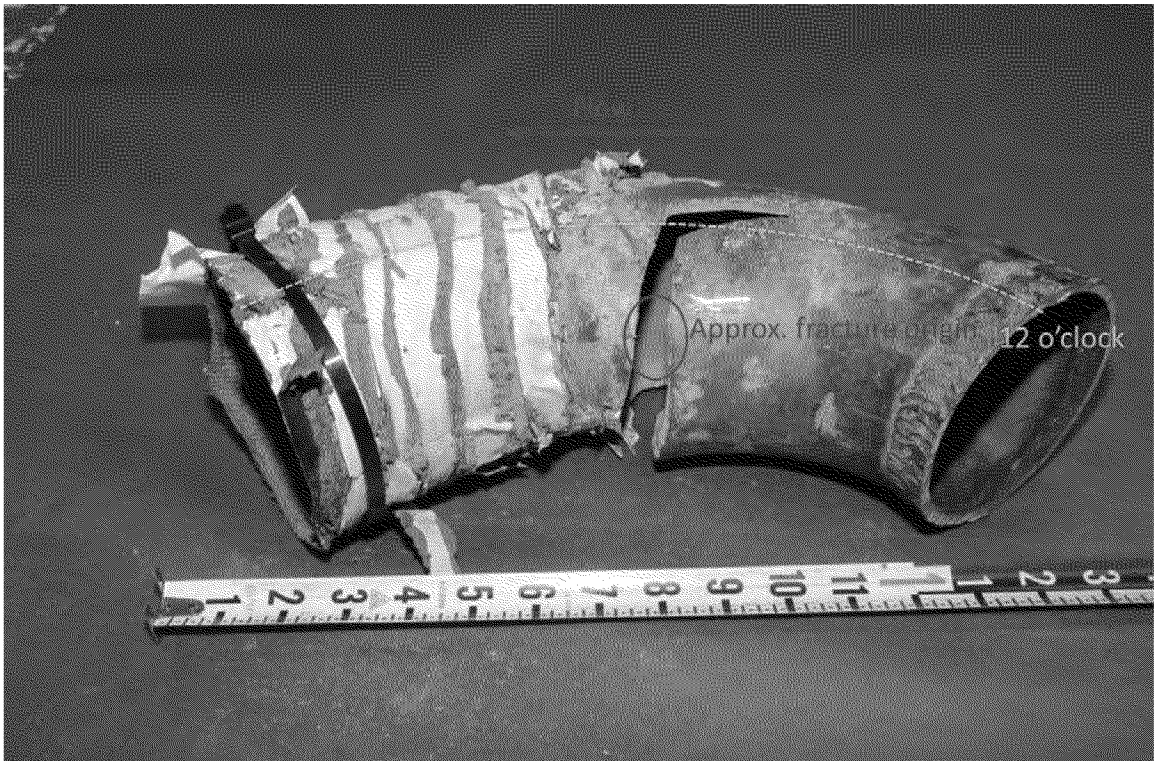
The subject elbow was sectioned to allow fractographic and metallographic examination, as well as elbow wall thickness measurements. The minimum wall thickness was 0.215-inch at the 6 o'clock position, and the maximum thickness was 0.297-inch, located at the 10 o'clock position, as shown in Figure 17. All clock positions reported are looking downstream. PG&E construction documents from 1946 and fitting specifications indicated that the subject elbow was specified to have a wall thickness of 0.237-inch, and to be fabricated from ASTM A 106 Grade A or B material. Note that the elbow fractured at the location of greatest wall thickness.

Figure 15. Image of fractured elbow.

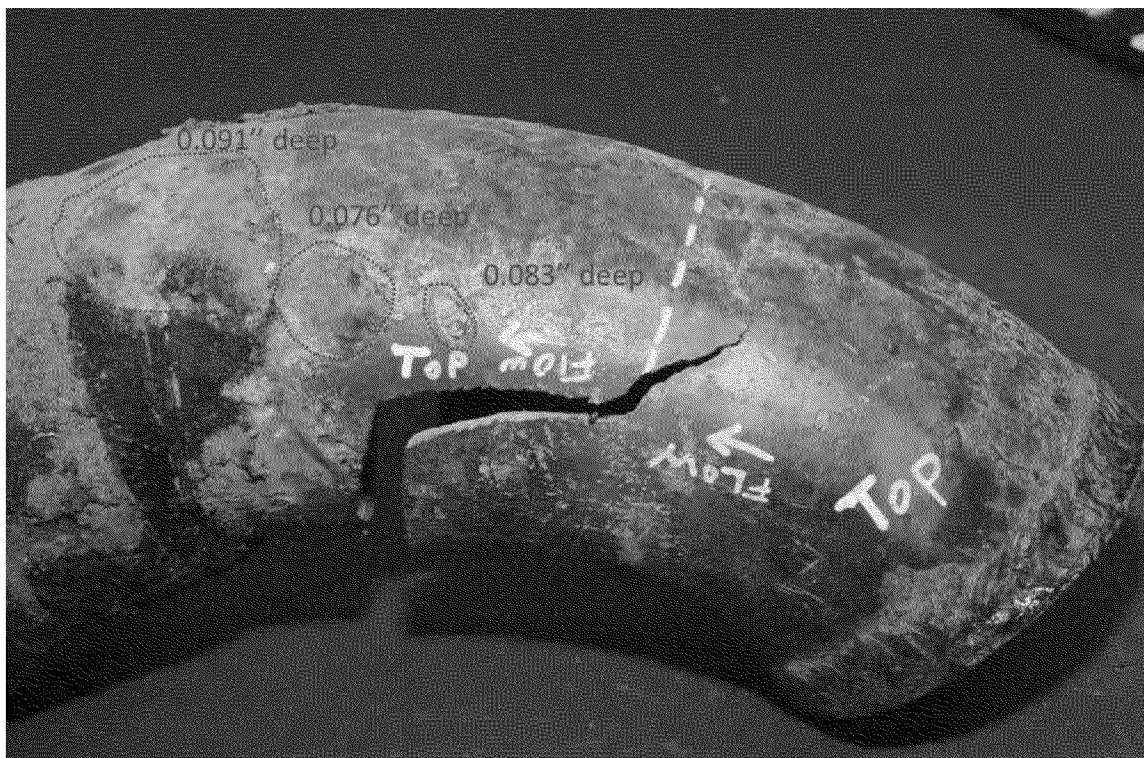
Figure 16. Photograph of the fractured elbow with pipe coating removed showing several corrosion pits, with their depths indicated.

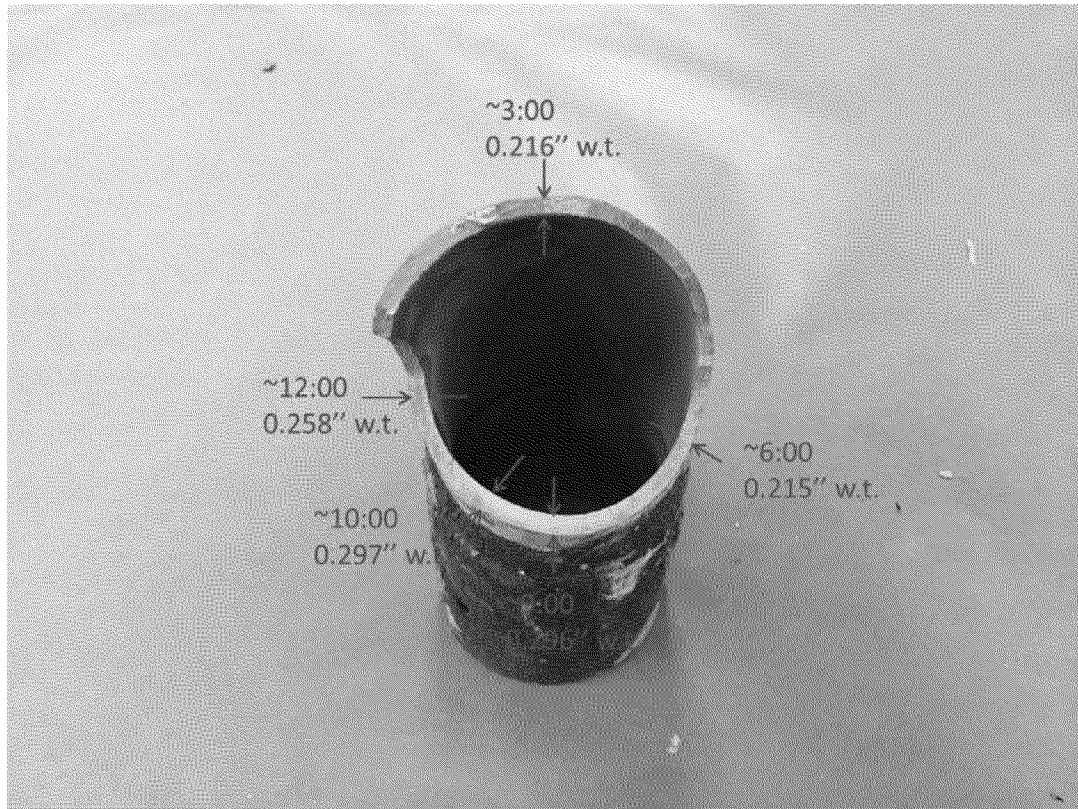
Figure 17. Cross-sectional measurements of pipe thickness around the circumference of the subject elbow at the fracture location.

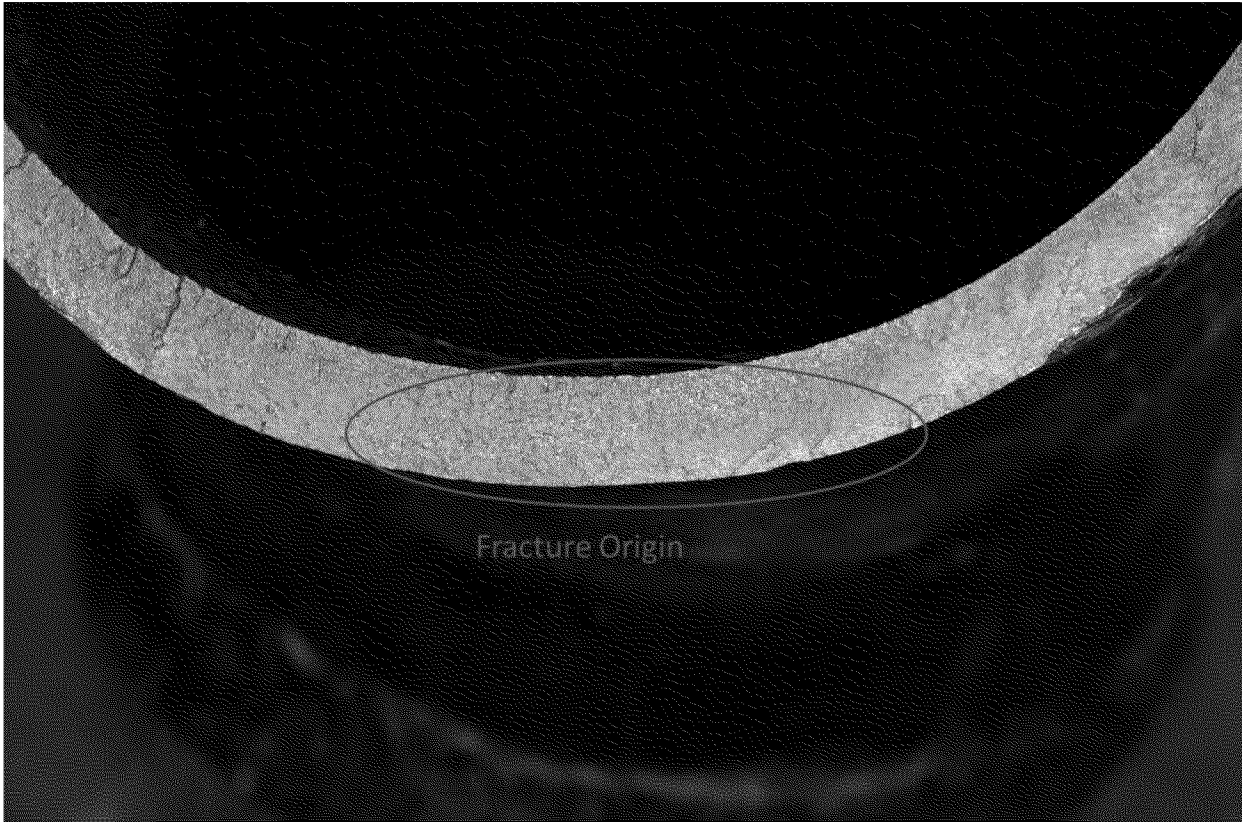
Figure 19. Image that shows the cleaned fracture surface with the fracture origin indicated.

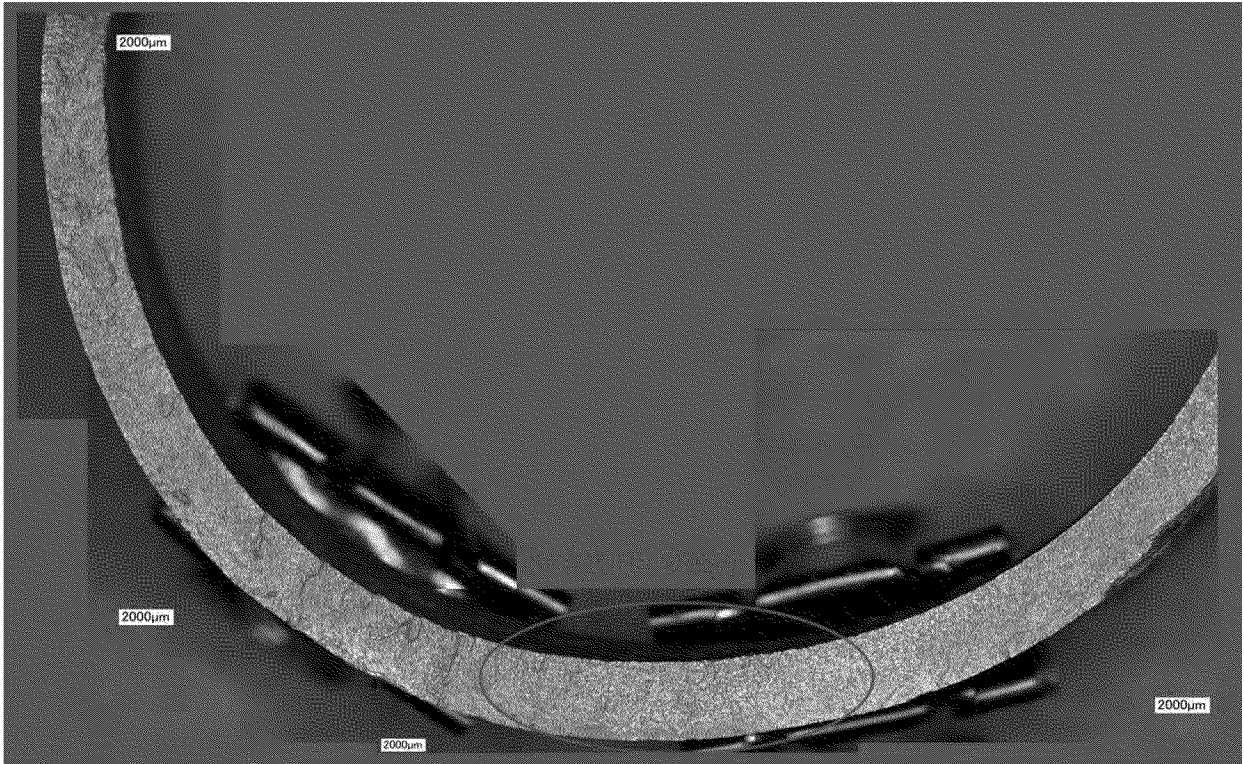
Figure 20. Optical microscope photo montage that shows the fracture surface with the origin indicated.

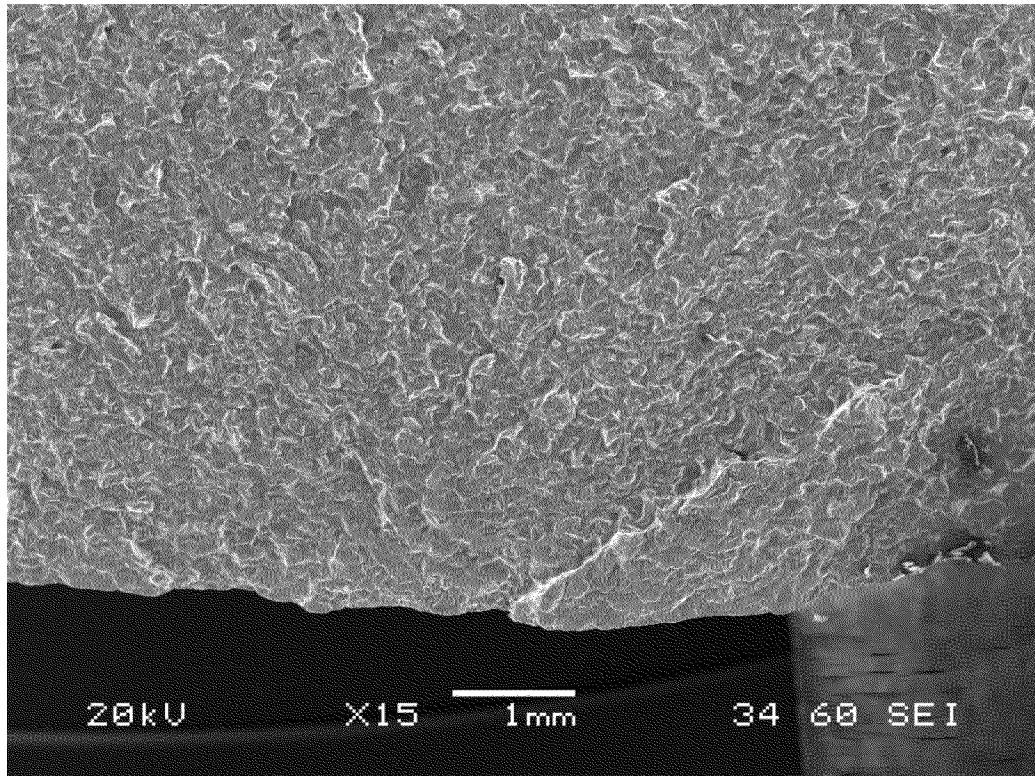
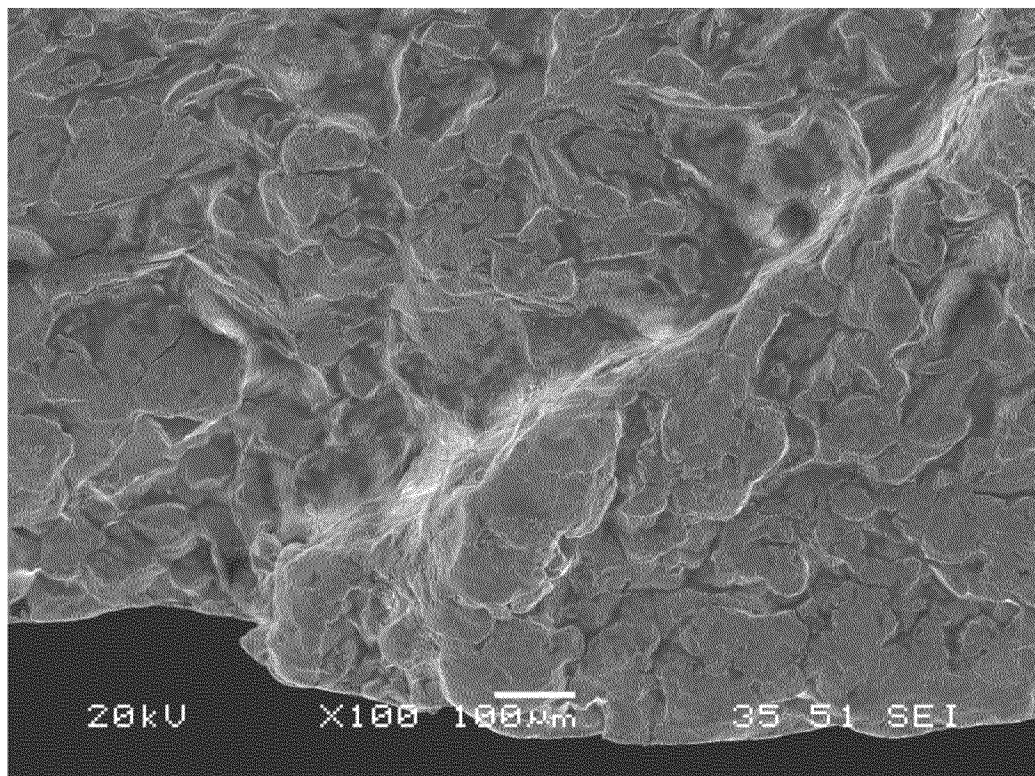
Consistent with our visual and optical microscope fractographic analysis, no evidence of progressive fracture, such as fatigue or stress corrosion cracking (SCC) was observed. Energy dispersive spectroscopy (EDS) showed no evidence of anomalous elemental species (not shown).

Figure 21. SEM images of the fracture origin showing brittle fracture and erosion from gas release.

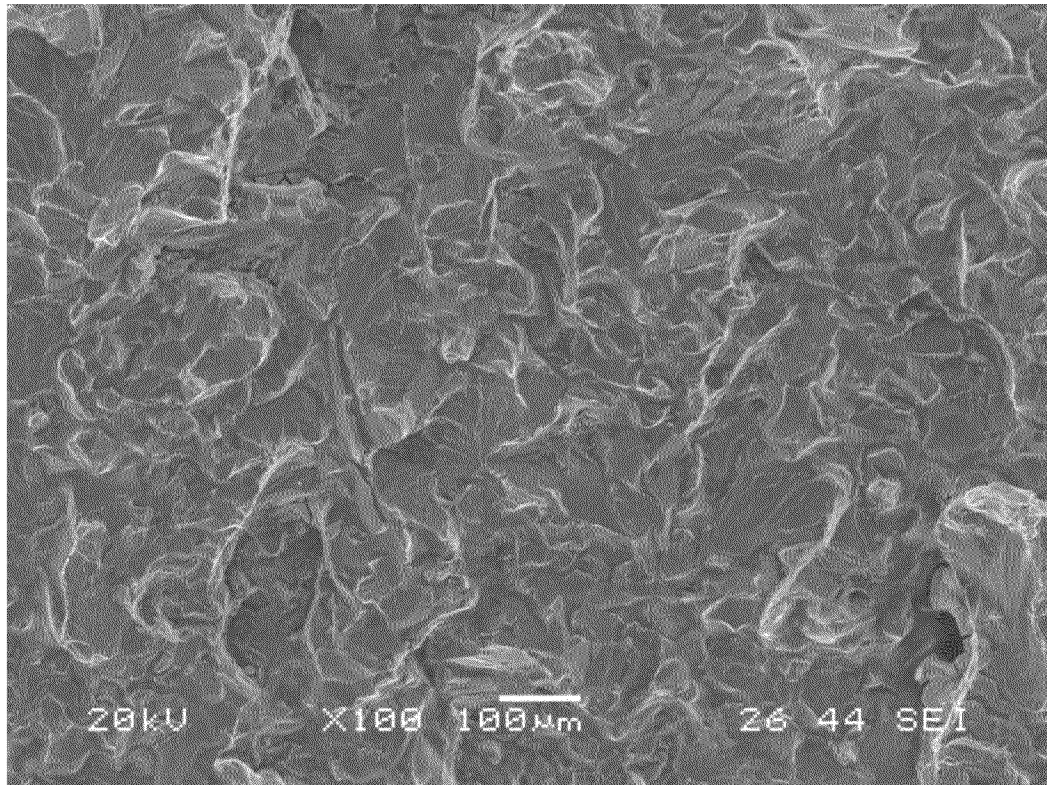
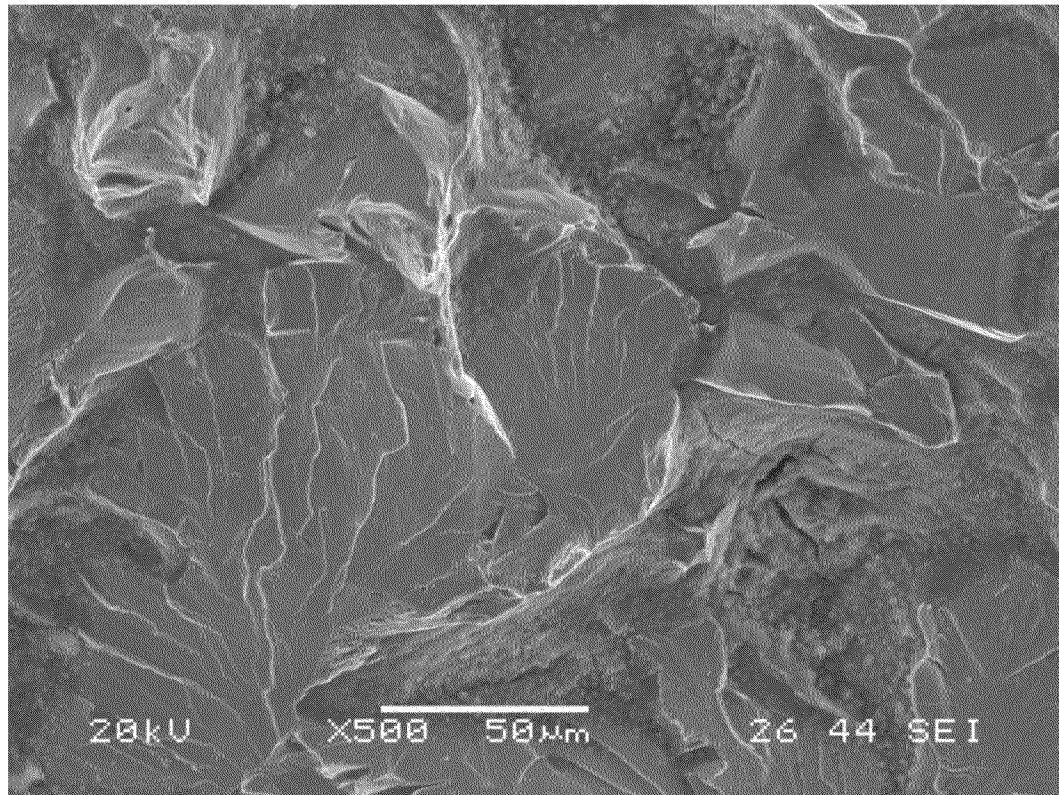
Figure 22. SEM images of varying magnifications of the mid-wall location in the fracture origin region. The fracture morphology shows cleavage, indicative of brittle fracture.

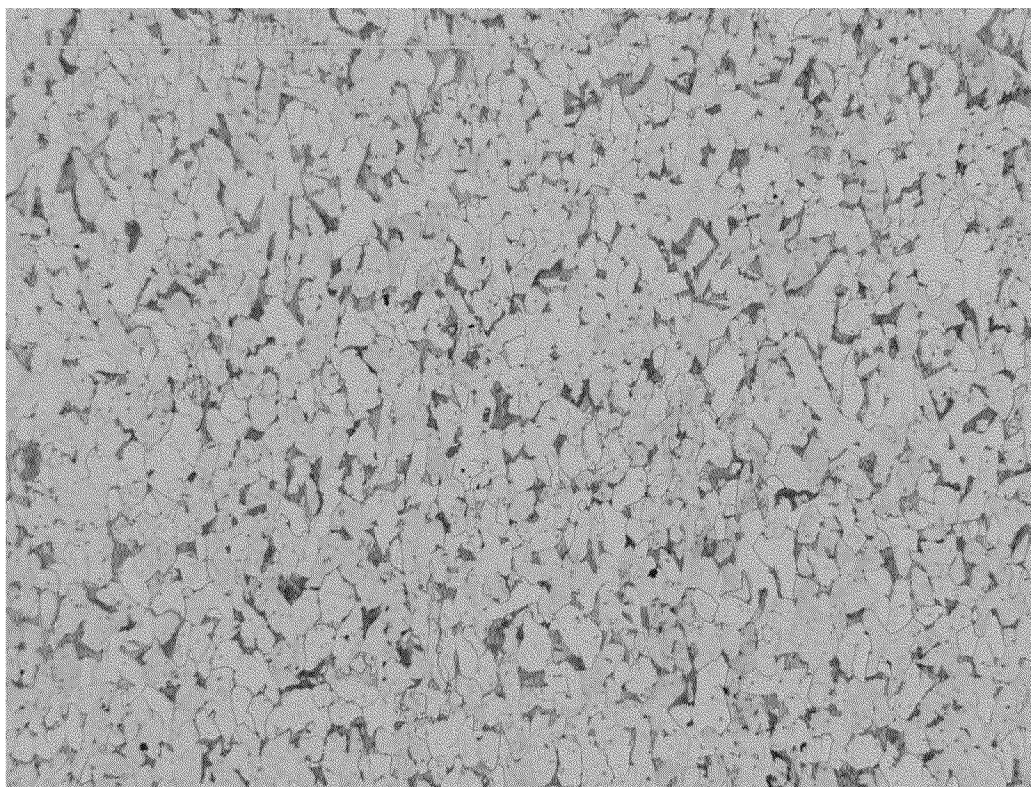
Figure 24. Metallographic image of the elbow ferrite-pearlite microstructure.

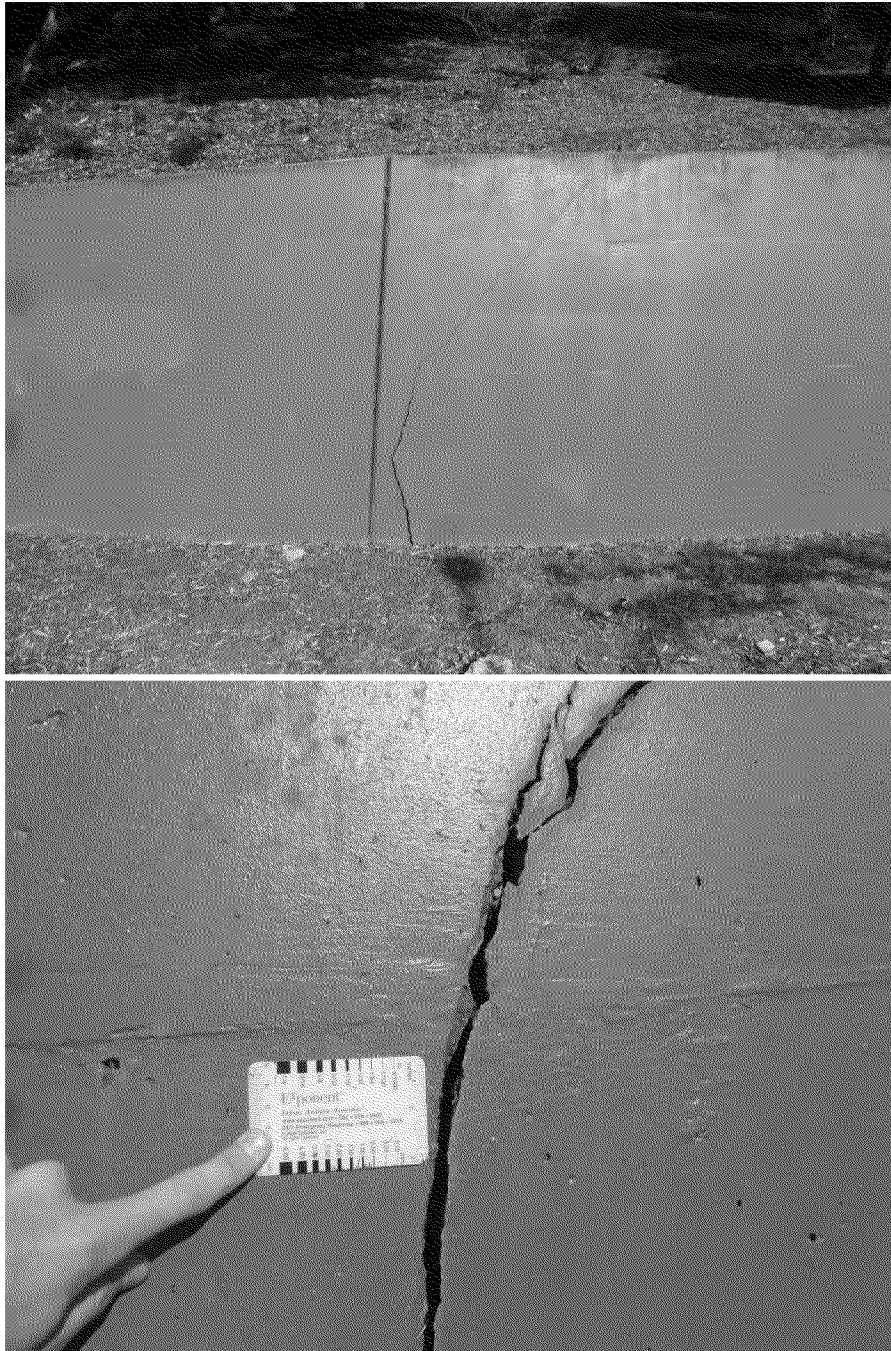
Exponent's project geologist and/or project civil engineer performed visits to the Site on December 13 and 17, 2013, and January 3, 2014 to look for surface evidence of ground movement, including fault creep. No definitive field evidence of creep was present at the Site or on nearby streets that cross the [Redacted]. The southern portion of the retaining wall on the north side of [Redacted] (Figure 29), however, exhibited a prominent crack (Figure 31) and a separation at a joint (Figure 32), both of which had a right-lateral sense of displacement. In the case of the crack, the displacement was greater at the base of the wall (approximately ½-inch) than at the top. This configuration of retaining wall cracking may well represent displacement of the base of the wall by fault creep.

Figure 31. Retaining wall crack, looking north. Photographs by Exponent, December 13, 2013.

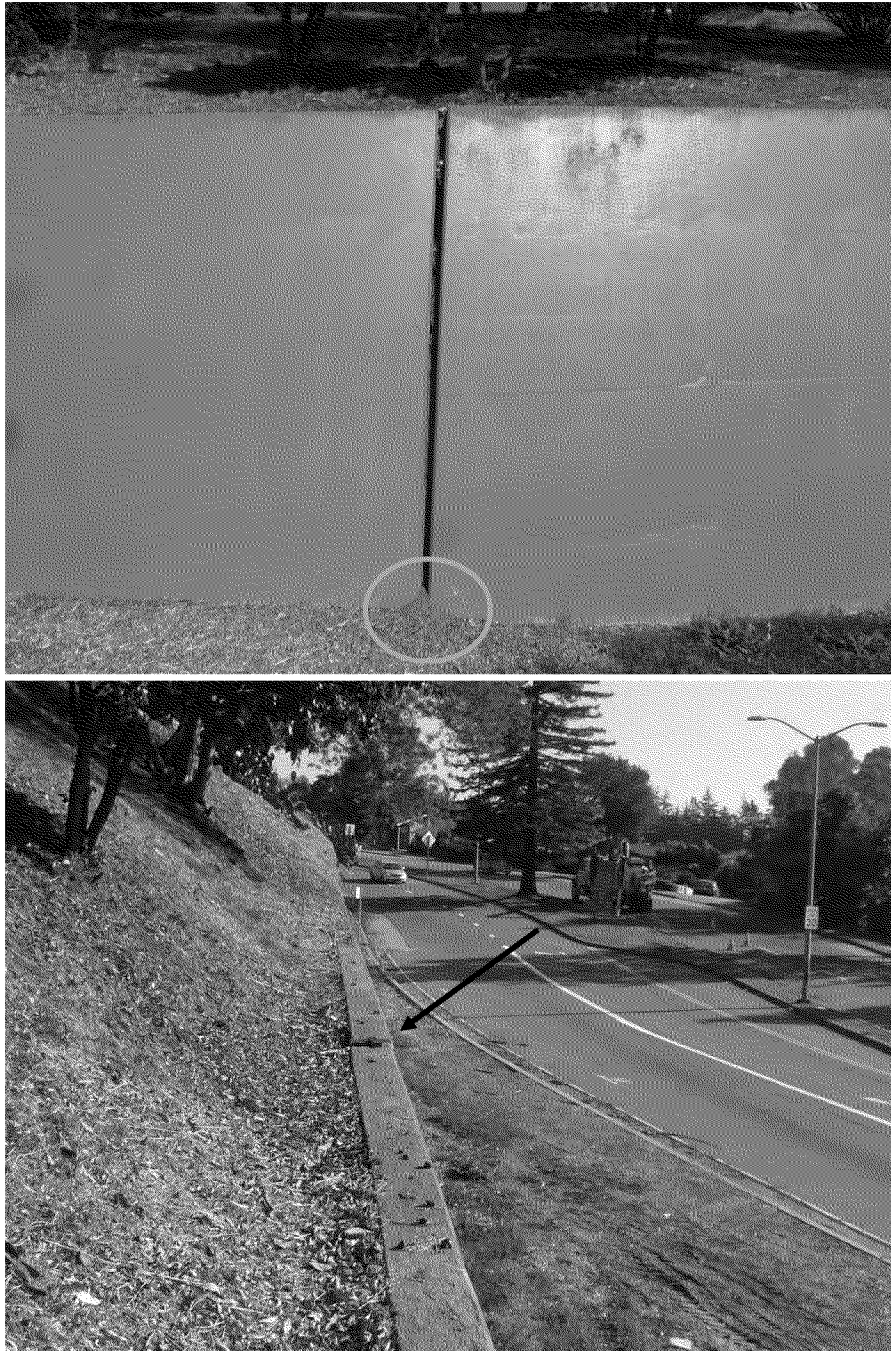
Figure 32. Displaced retaining wall joint. Oval encloses observed recent soil deposits near the base of the wall. Arrow indicates right-lateral displacement at top of wall. Photographs by Exponent, December 13, 2013.

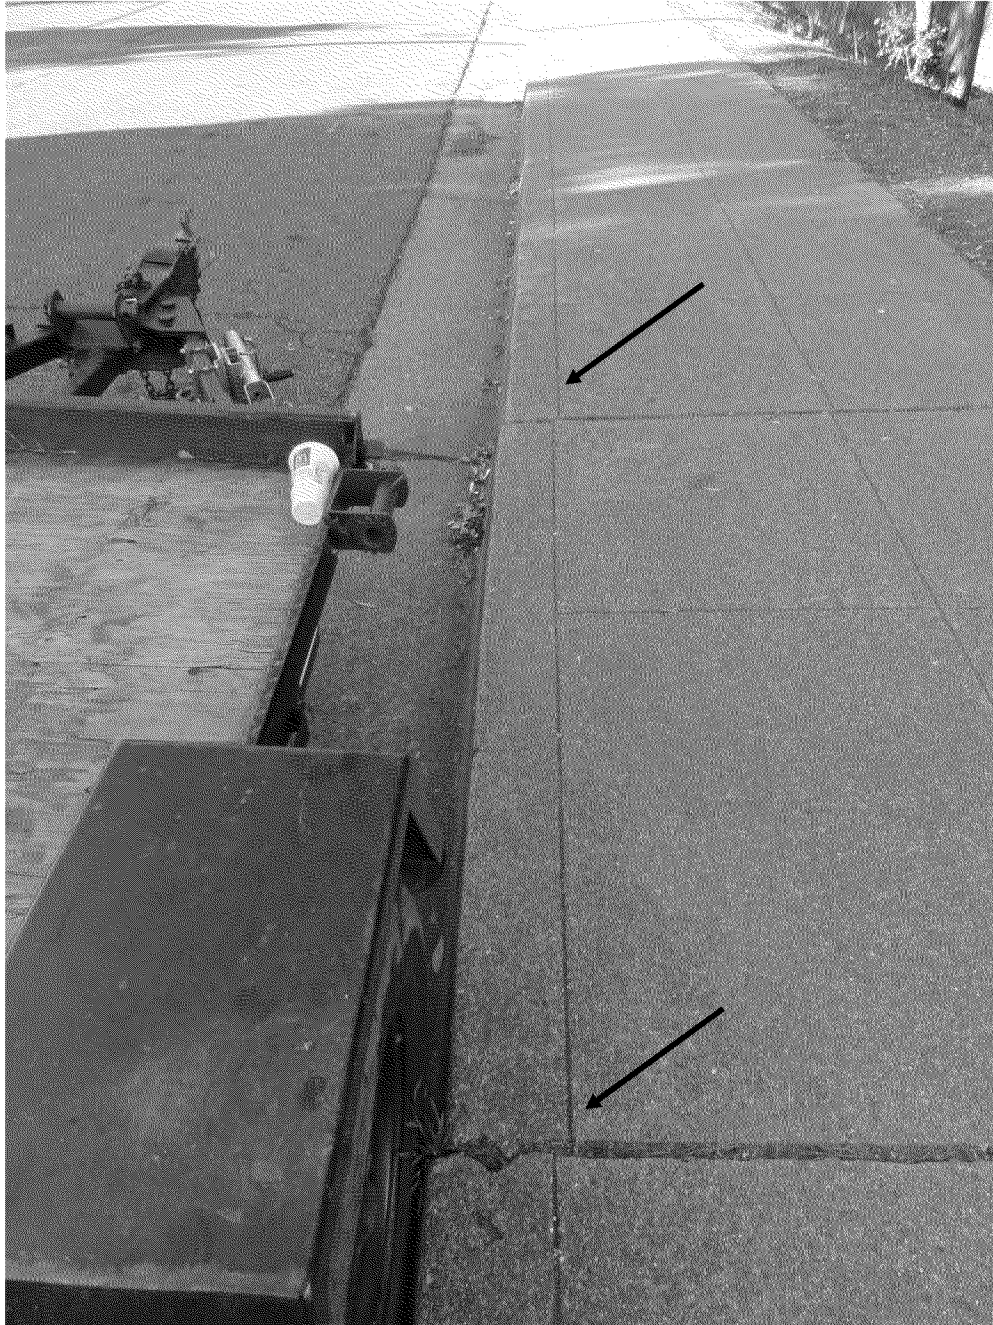
freeway, as shown in Figure 28. The displacements shown in the photograph in Figure 33 are two of three right-lateral displacements of the sidewalk, curb, and gutter observed along the northwestern side of the street. The distance between the first and last (third) displaced joints was approximately 15 feet. The curb on the opposite side of the street was also displaced right laterally.

Figure 33. View southwestward along northwestern curb of Redacted. Arrows indicate two of three joints that exhibited right-lateral displacement. Photograph by Exponent, December 26, 2013.

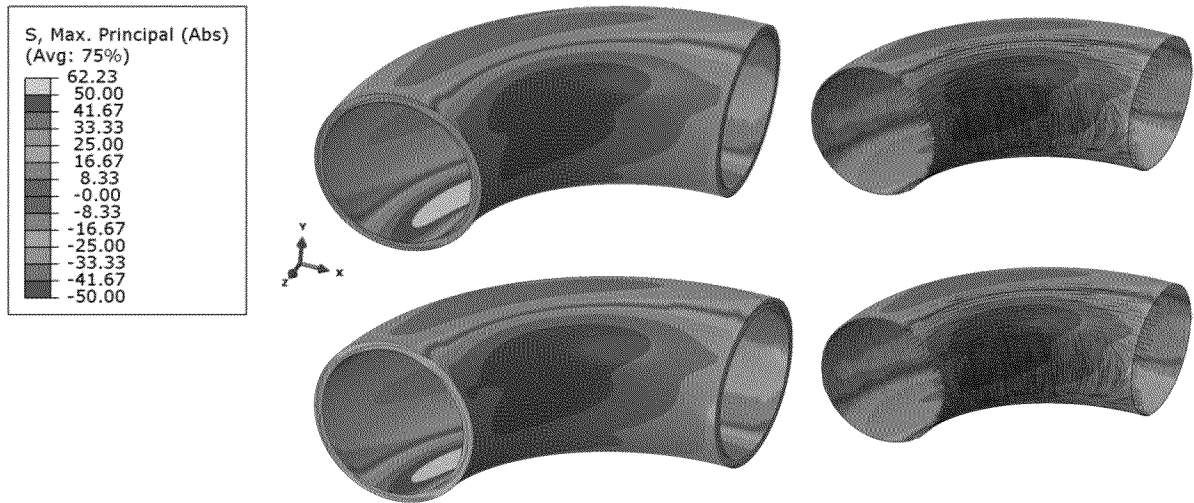
Figure 47. Tensile stress contours of the incident elbows subjected to shearing in the fault-creep direction (top) and the landslide direction (bottom). Images on the right show tensile stress directions for the outside wall of the elbow. The location and direction of the peak tensile stresses on the elbow exterior are consistent with the crack opening direction observed in the failed elbow. Units are ksi.

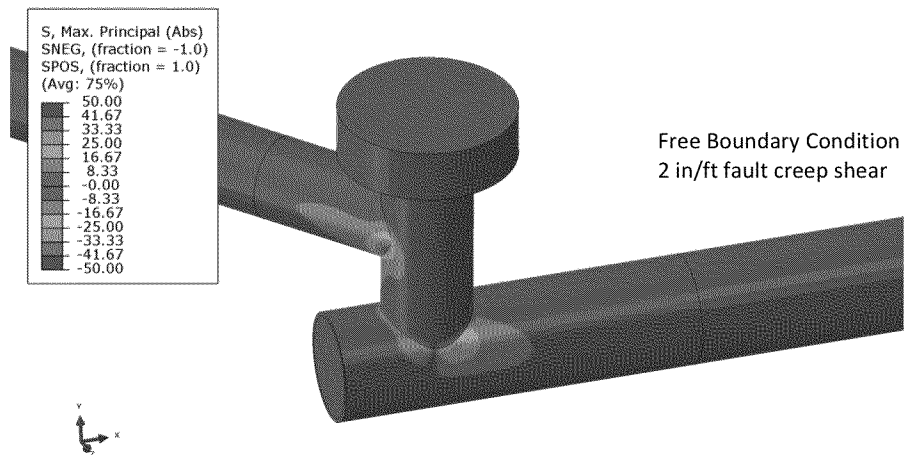
Figure 52. Tensile stresses after the post-failure repair in the flange tee neighboring the incident elbow for different boundary conditions on the Fontaine Street pipe. Note that the models have decreasing amount of shear despite increasing stresses. Units are ksi.

After the failure, the connection between the [Redacted] and the [Redacted] pipe remains intact. Exponent's stress analysis indicates that local stresses likely remain in the existing configuration. As more fault creep occurs in the future, these stresses are expected to increase. Exponent recommends the current connection be replaced to relieve the current stresses.
