**Golf Links Road (Oakland)
Incident Analysis**

Sumeet Singh
Pacific Gas and Electric Company
6111 Bollinger Canyon Road
San Ramon, CA 94583

January 2014
Revised January 20, 2014

Doc. no. 1308766.000 - 3956

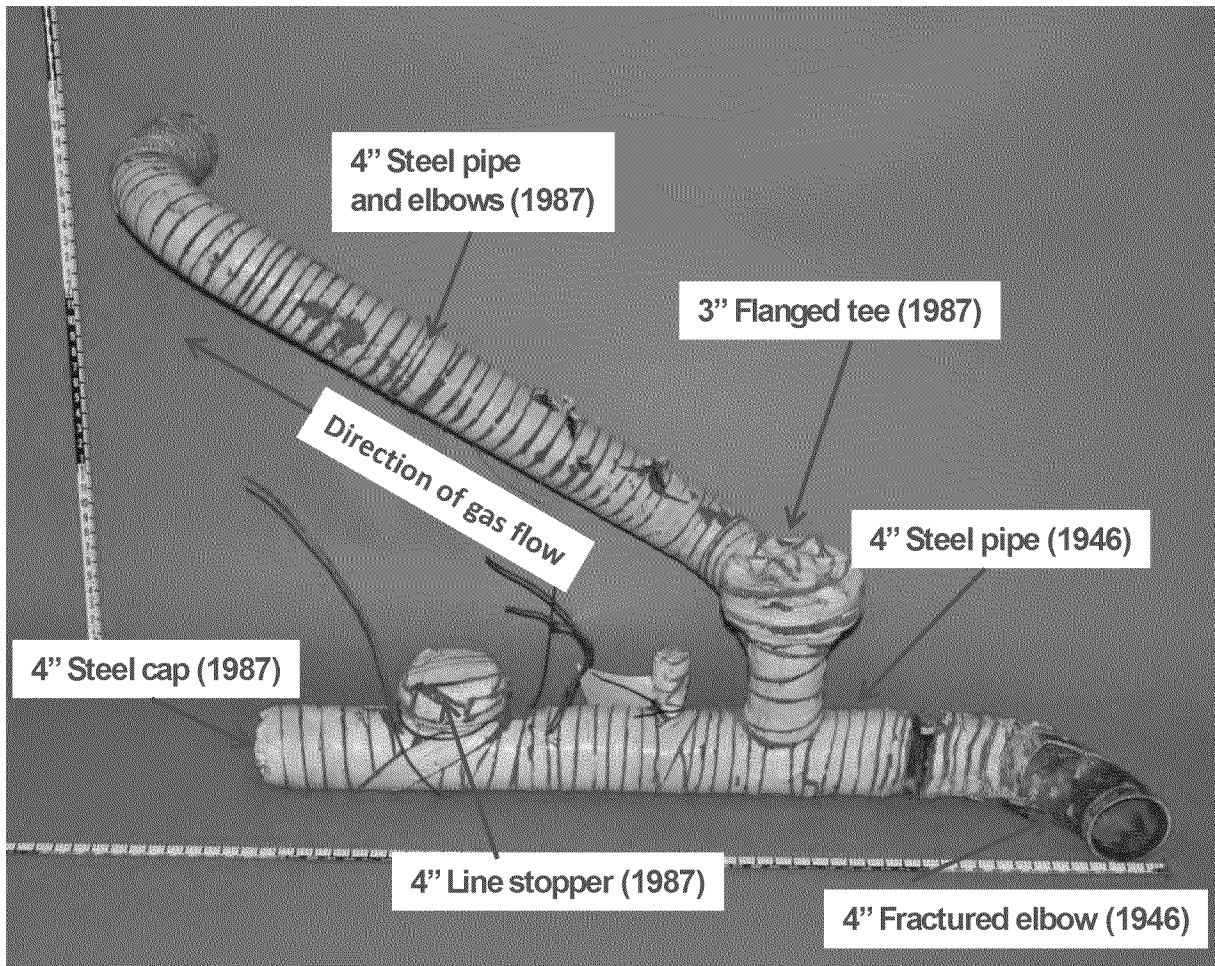
Figure 5. Fractured elbow and adjacent features after removal, with piping photographed as if viewer is looking downstream.

The ruptured elbow and piping downstream from the break was removed from the leak site as shown in Figure 5, and was brought to Exponent's Menlo Park, California laboratories for analysis. The break occurred at the elbow intrados, as shown in Figure 15. The fracture plane was primarily perpendicular to the gas flow direction and located near the center of the elbow. This fracture orientation is consistent with bending of the elbow, rather than a pressure-induced break. Comparison of the ruptured elbow before and after excavation (Figure 4 and Figure 15) showed that the fracture opened during the excavation process. This is consistent with reports of witnesses on site during the excavation process.

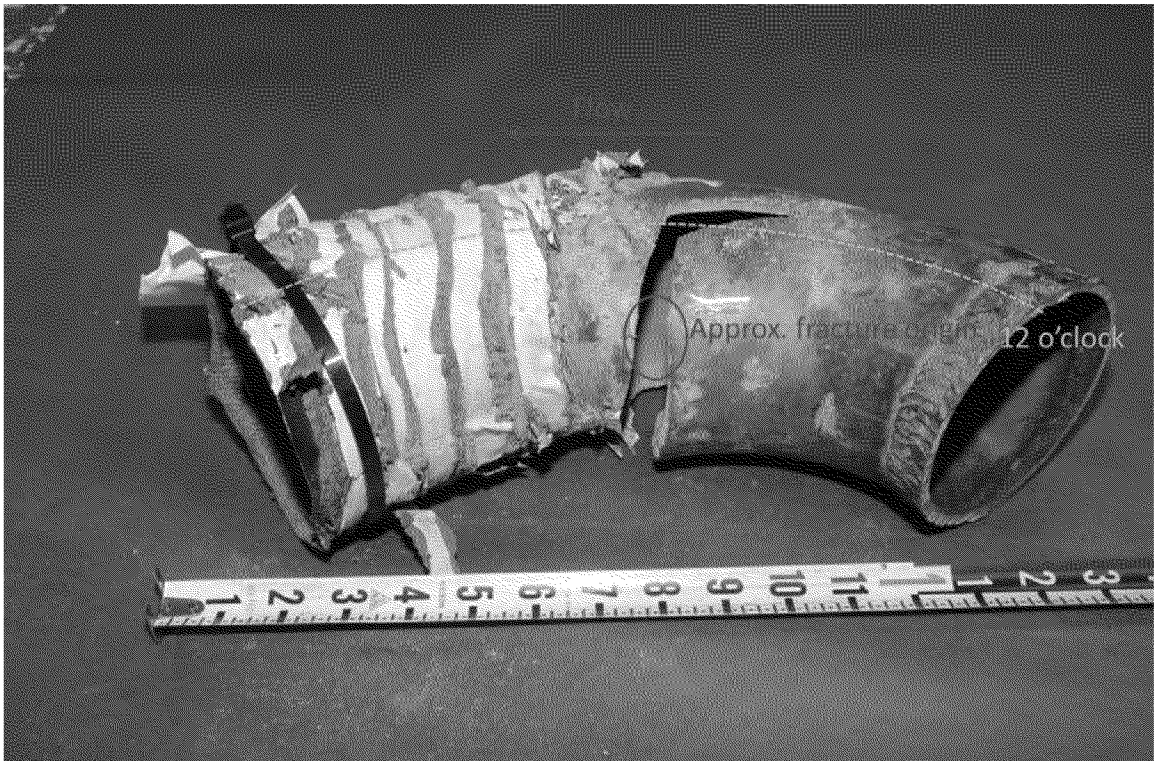
Figure 15. Image of fractured elbow.

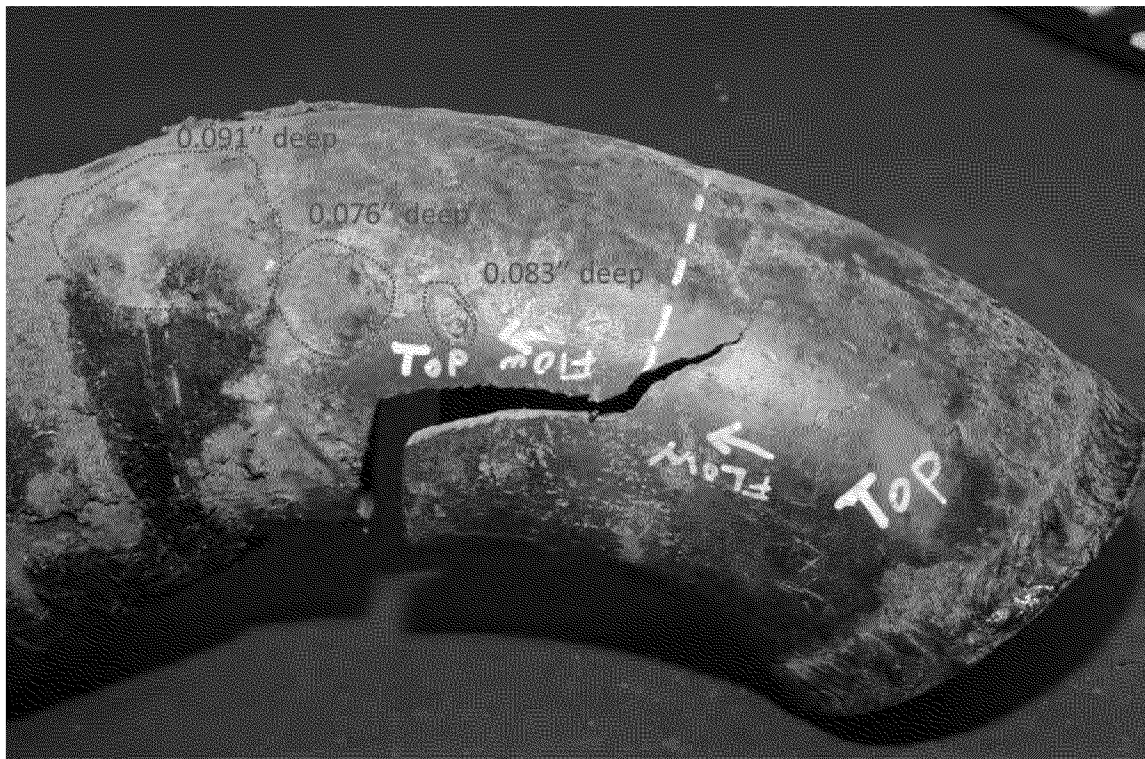
The pipe coating was manually removed from the subject to allow better visual inspection and measurements of the pipe thickness. Areas of pitting corrosion were observed near the top of the elbow, as shown in Figure 16. However, these pitted areas occurred well away from the fracture. No evidence of mechanical damage was observed. No other defects, cracks, seams, weld issues, or anomalies were observed.

Figure 16. Photograph of the fractured elbow with pipe coating removed showing several corrosion pits, with their depths indicated.

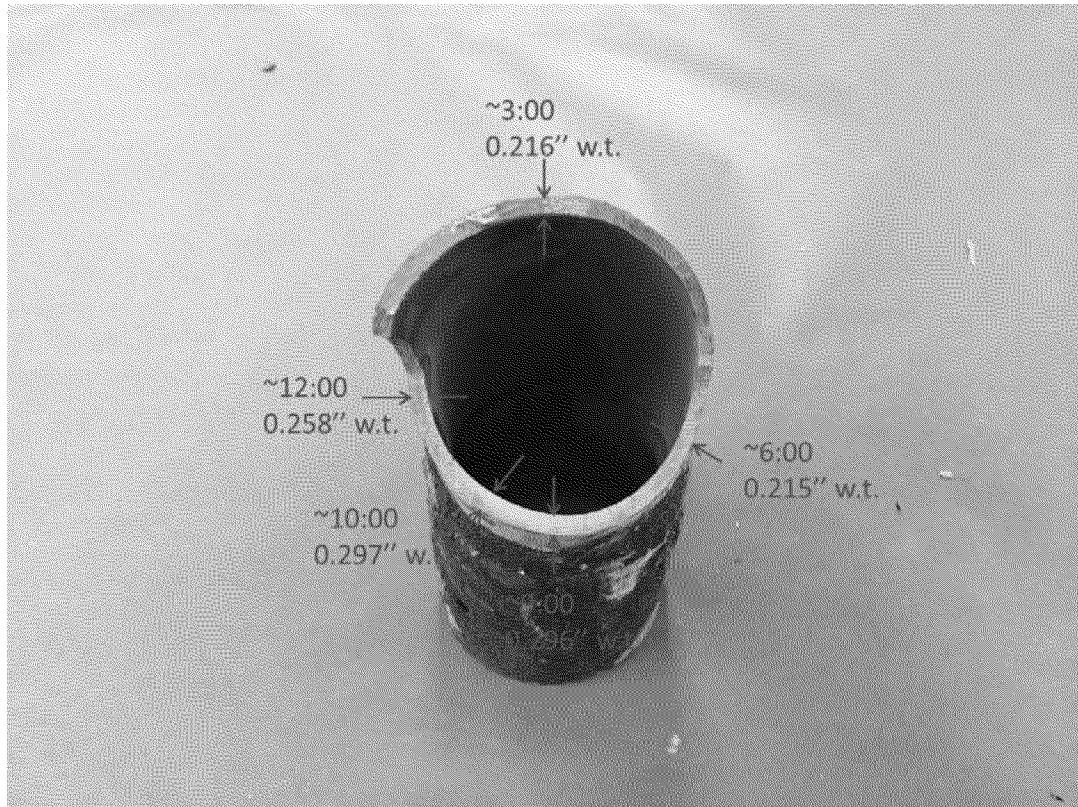
The subject elbow was sectioned to allow fractographic and metallographic examination, as well as elbow wall thickness measurements. The minimum wall thickness was 0.215-inch at the 6 o'clock position, and the maximum thickness was 0.297-inch, located at the 10 o'clock position, as shown in Figure 17. All clock positions reported are looking downstream. PG&E construction documents from 1946 and fitting specifications indicated that the subject elbow was specified to have a wall thickness of 0.237-inch, and to be fabricated from ASTM A 106 Grade A or B material. Note that the elbow fractured at the location of greatest wall thickness.

Figure 17. Cross-sectional measurements of pipe thickness around the circumference of the subject elbow at the fracture location.

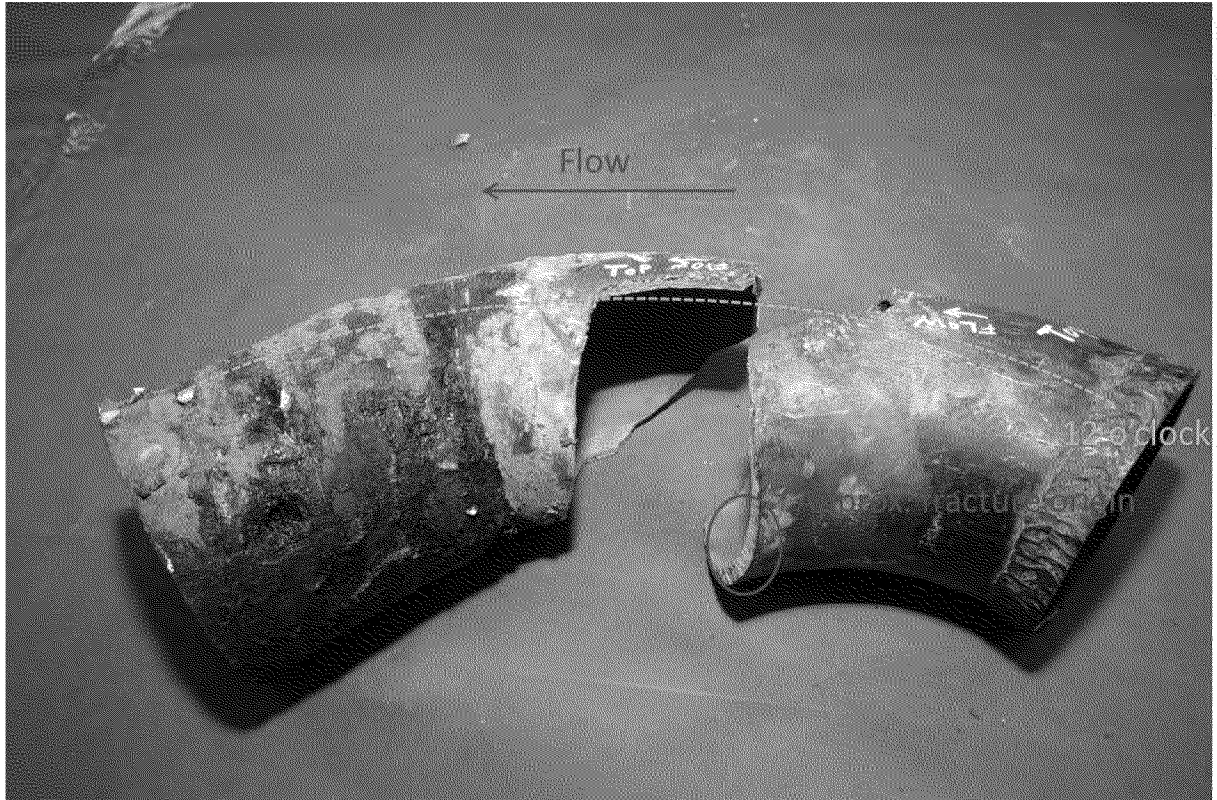
Fractographic analysis was conducted to help determine the cause of the rupture. The elbow was sectioned across the remaining intact area near the break to better expose the fracture surfaces for examination, as shown in Figure 18. To help remove the soil that obscured the surface, the fracture faces were cleaned in a warm Alconox (detergent and water) solution and scrubbed with a nylon brush. Following cleaning, the fracture surface was examined visually as well as using optical and scanning electron microscopy (SEM) techniques. A photograph of the cleaned fracture surface is shown in Figure 19. No dark areas, associated with long-term corrosion, or evidence of progressive fracture (such as beach marks) were observed. The fracture origin area was relatively flat with little ductility. Examination of tear ridges and chevron marks (which point back to the initiation point), shown in Figure 19 and Figure 20, indicated that the fracture origin was located at roughly the 10 o'clock position.

Figure 18. Image that shows the elbow after sectioning. The piece on the right (upstream) was subjected to fractographic and metallographic examination.

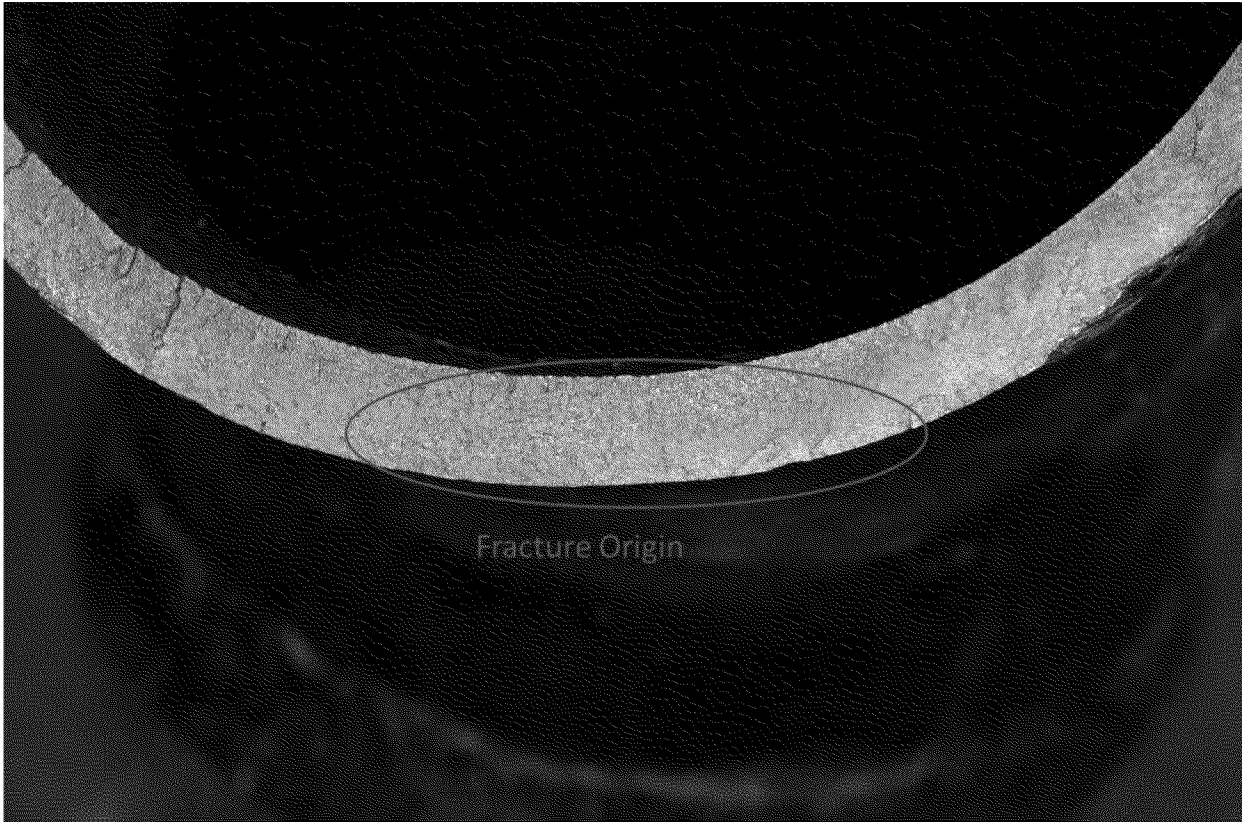
Figure 19. Image that shows the cleaned fracture surface with the fracture origin indicated.

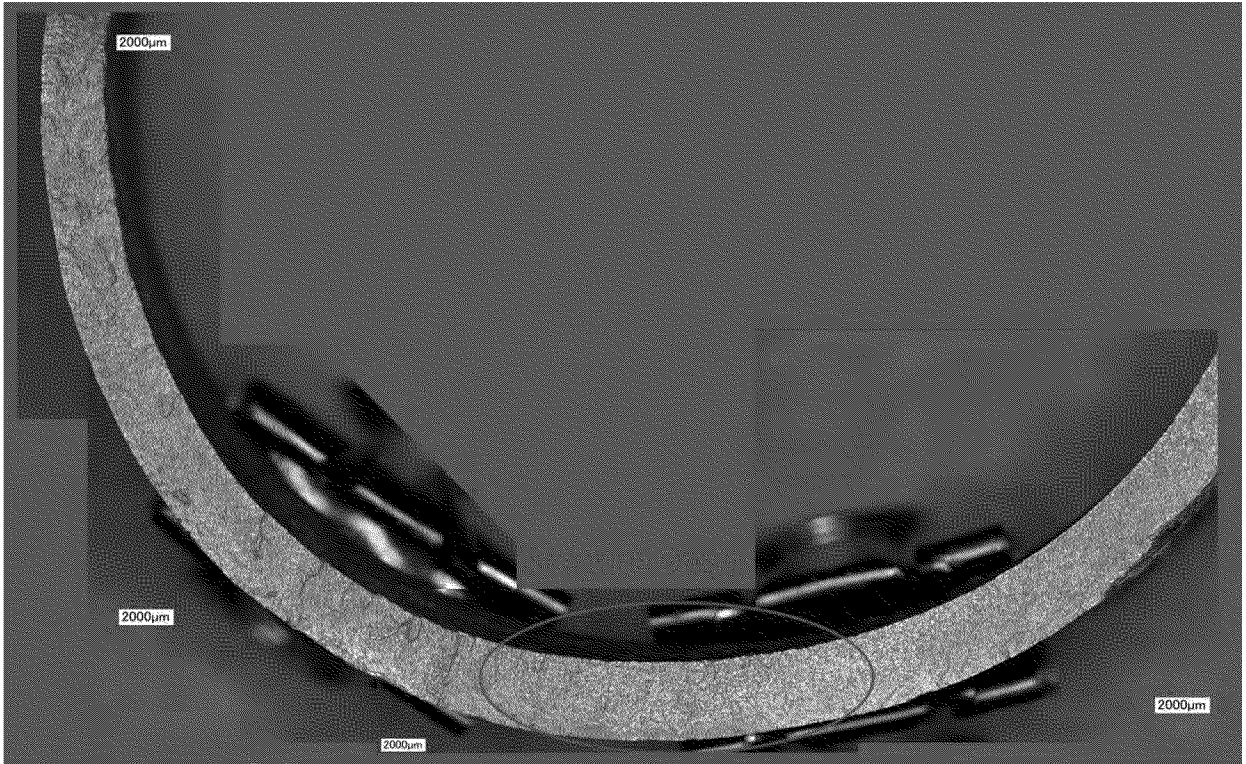
Figure 20. Optical microscope photo montage that shows the fracture surface with the origin indicated.

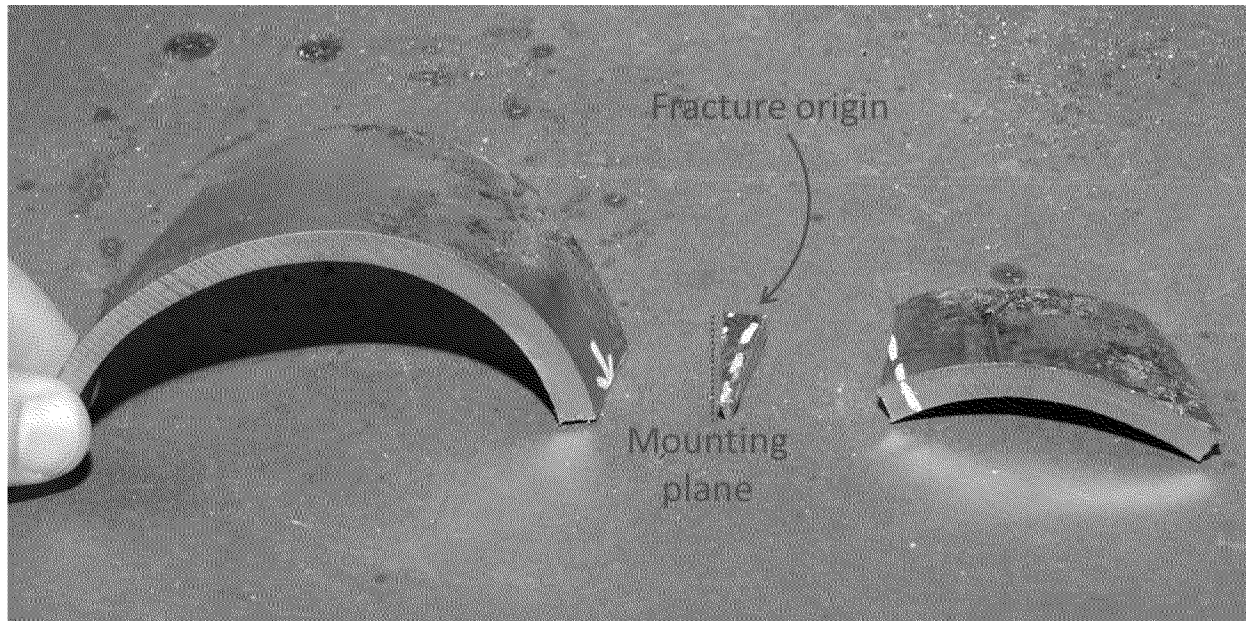
A portion of the fracture origin was sectioned to allow metallographic examination, shown in Figure 23. The sample was mounted perpendicular to the fracture plane (i.e., along the longitudinal direction along the elbow), and was ground, polished, and etched using typical metallographic procedures. The elbow exhibited a typical ferrite and pearlite microstructure, including at the fracture origin, as shown in Figure 24. Microhardness testing was conducted on the metallographic sample: the average hardness was measured to be 193 HV.

Figure 23. A photograph that shows the metallographic specimen from the origin area.

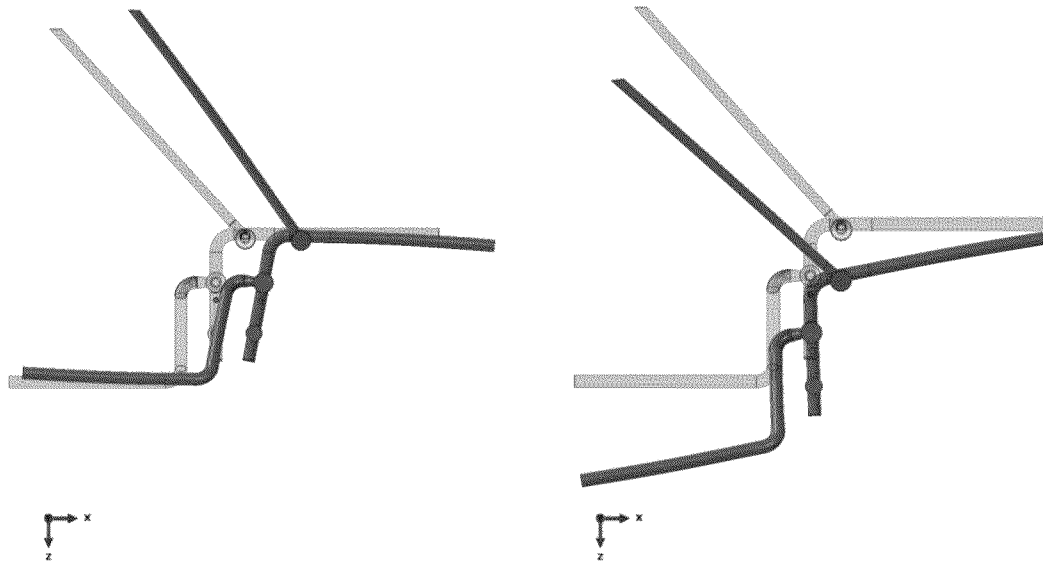
Figure 45. Deformed shapes of the gas pipe network when subjected to fault-creep shear (left) and landslide shear (right). The total shearing applied is 0.2 in/ft, but the deformations are scaled by a factor of 10.

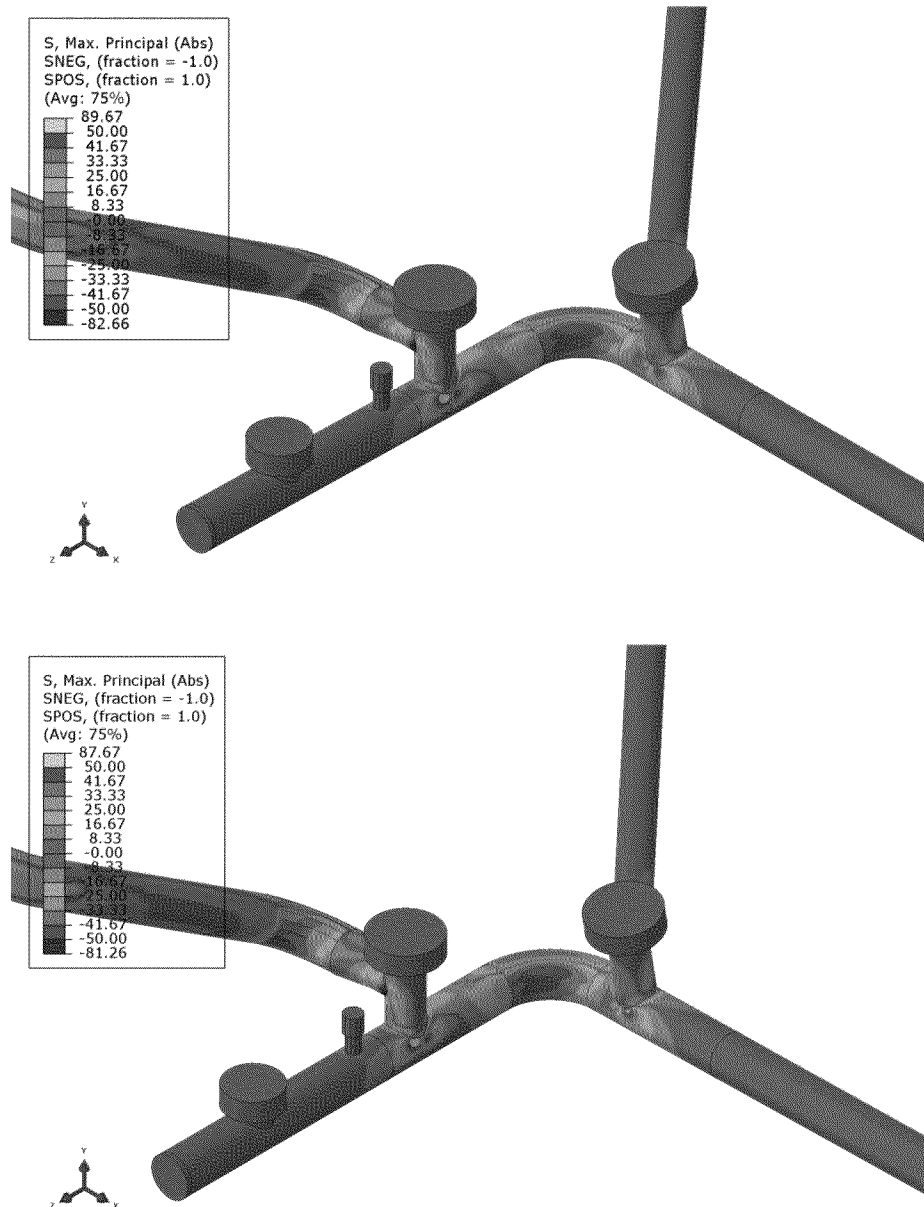
Figure 46. Tensile stresses in the gas pipes when subjected to 0.2 in/ft of shear in the fault creep direction (top) and the landslide shear direction (bottom). Units are ksi.

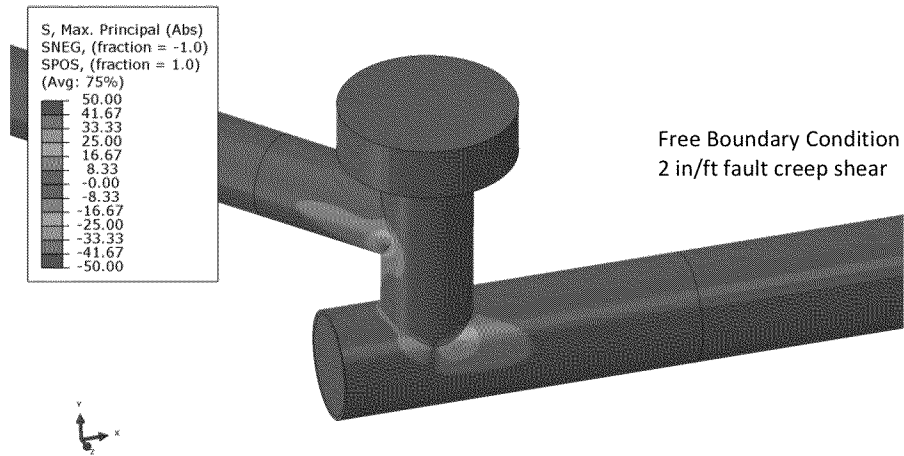
After the failure, the connection between the Fontaine Street pipe and the Golf Links Road pipe remains intact. Exponent's stress analysis indicates that local stresses at this connection may be approximately 30 ksi. As more fault creep occurs in the future, these stresses are expected to increase.

Figure 52. Tensile stresses after the post-failure repair in the flange tee neighboring the incident elbow for different boundary conditions on the Fontaine Street pipe. Note that the models have decreasing amount of shear despite increasing stresses. Units are ksi.
