Jane Yura  
Vice President  
Asset & Risk Management  
Gas Operations

Re: Update - Oakland Incident of December 10, 2013

*Failure Analysis Associates*

Pacific Gas and Electric (PG&E) has retained Exponent Failure Analysis Associates (Exponent) to conduct a failure analysis investigation of an elbow that fractured as part of a four-inch natural gas distribution line on December 10, 2013 near the intersection of [Redacted] and [Redacted] in Oakland, California. Our investigation to-date has included inspection of the leak site, review of PG&E's historical construction documents, a fire cause and origin study, metallurgical analysis, geotechnical analysis, analysis of other leak locations within the immediate area, and finite element-based stress analyses of ground movement and stresses on the subject elbow and associated piping.

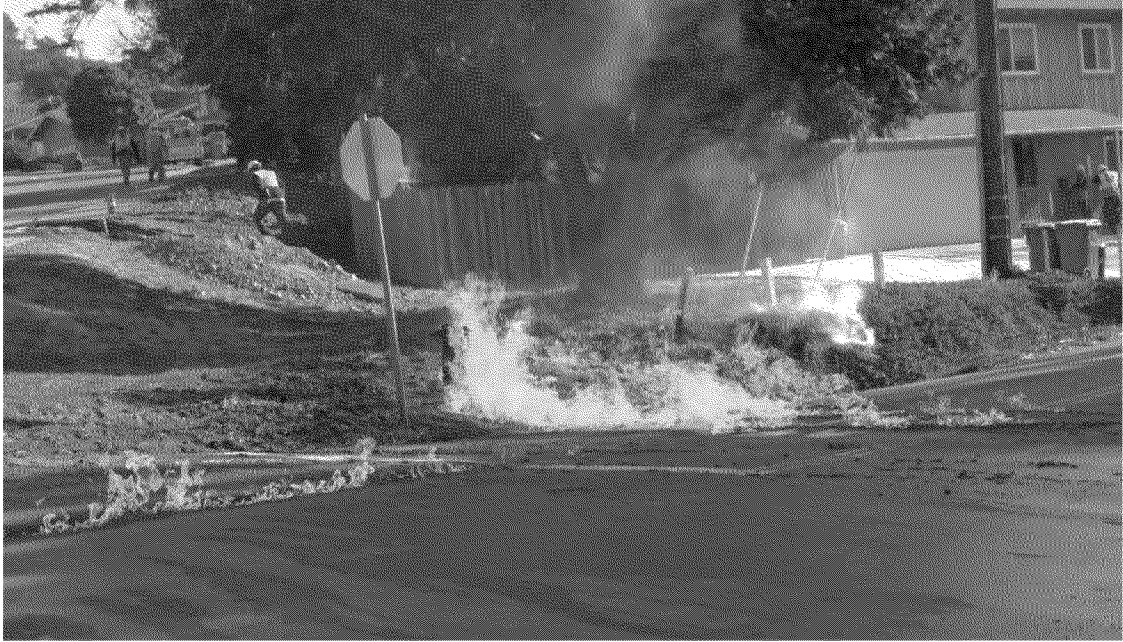
The released gas was ignited and resulted in a gas-fueled fire, which is shown in Figure 2. The fire was first reported to PG&E at approximately 8:39 a.m. and at 8:44 a.m. PG&E personnel arrived on site. The responding fire crews allowed the fire to burn in order to prevent an explosive accumulation of gas from forming. The fire continued to burn until after the upstream flow of gas was shut off at approximately 11:35 a.m. by cutting, capping, and welding the 4-inch main in three locations. No injuries or fatalities occurred and the total damages were reported to be less than \$50,000.

Figure 2. Image of the fire resulting from gas release. Source: PG&E

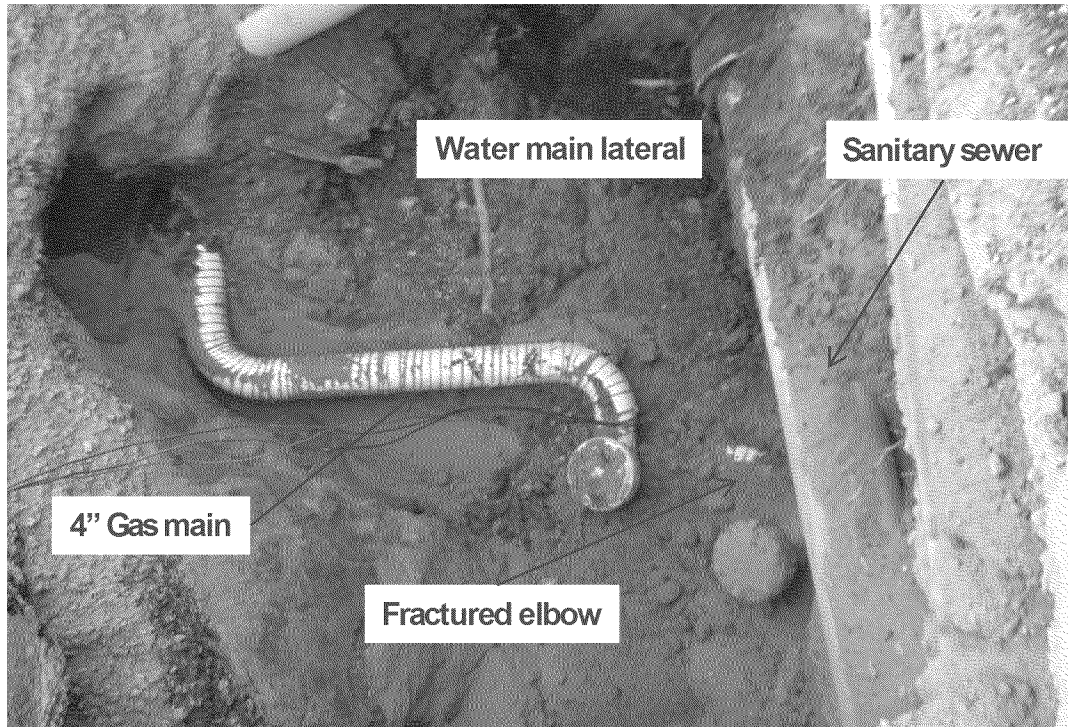
An excavation of the area of the gas release site, shown in Figure 3, revealed steel natural gas distribution mains, a water main lateral, and a sanitary sewer line in the immediate vicinity. Upon visual inspection, it was determined that the source of the gas release was a fractured elbow. A portion of the fractured elbow, while still covered with pipe wrap, is shown partially protruding from the soil in Figure 3. The continuation of the 4-inch gas main, the adjacent water pipe, and the sanitary sewer main are also shown. The fractured elbow is shown prior to removal in Figure 4. The flanged tee and 3-inch pipe shown in Figure 4 were not removed from the ground. Following Exponent's site inspection, the fractured elbow and several adjacent pipeline features were removed and retained by Exponent for laboratory inspection. The gas main features that were removed and their respective installation dates are shown in Figure 5. The features in Figure 5 are shown as they would have been seen if the viewer were facing approximately northwest.

Figure 3. Excavated area of the gas release.

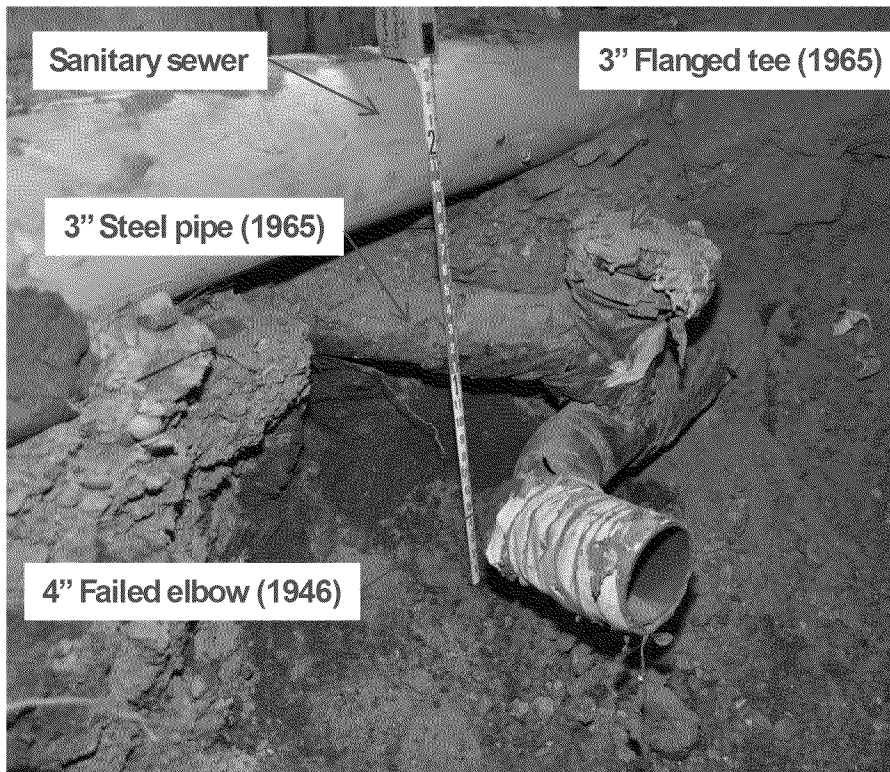
Figure 4. Fractured elbow prior to removal.

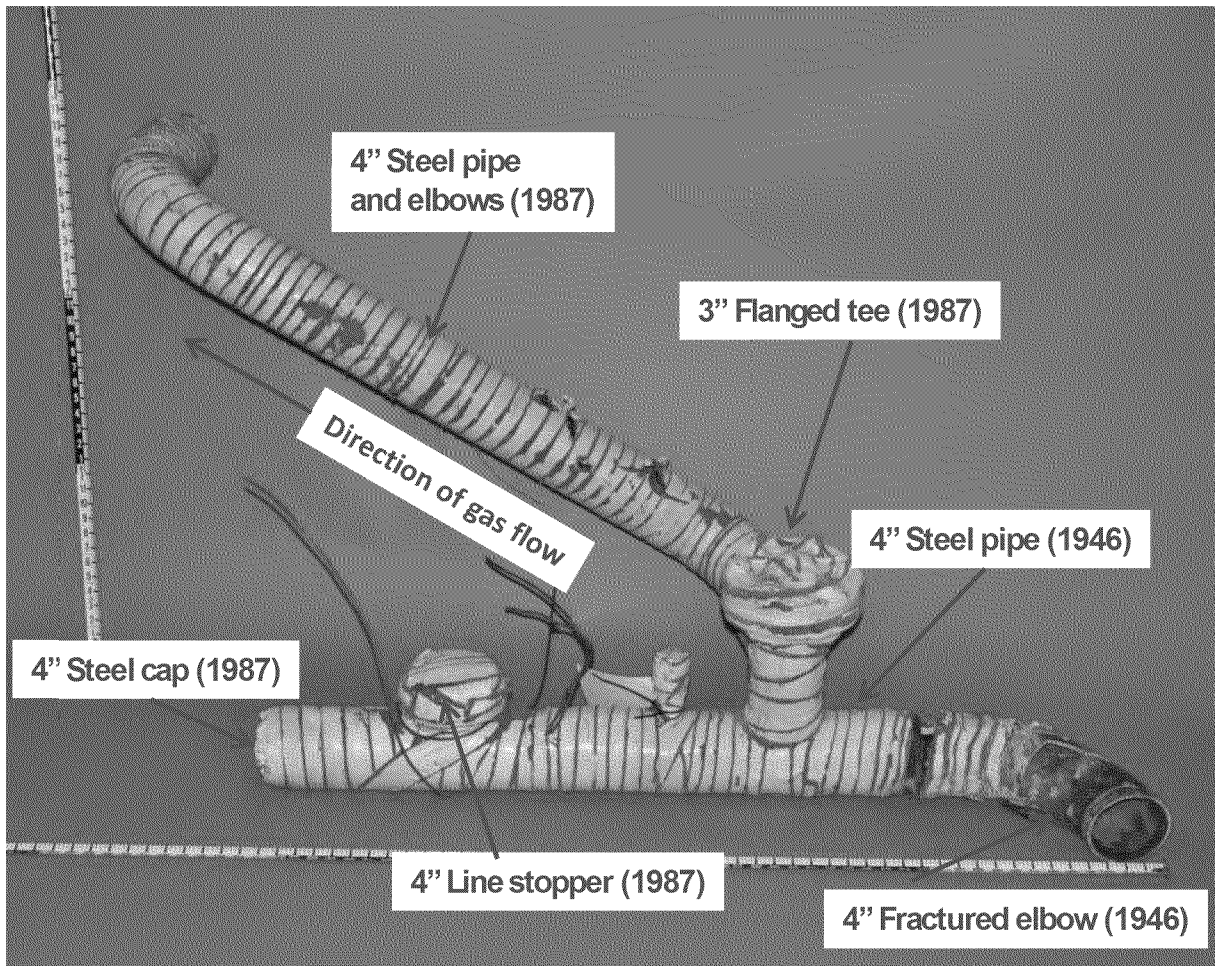
Figure 5. Fractured elbow and adjacent features after removal, with piping photographed as if viewer is looking downstream.

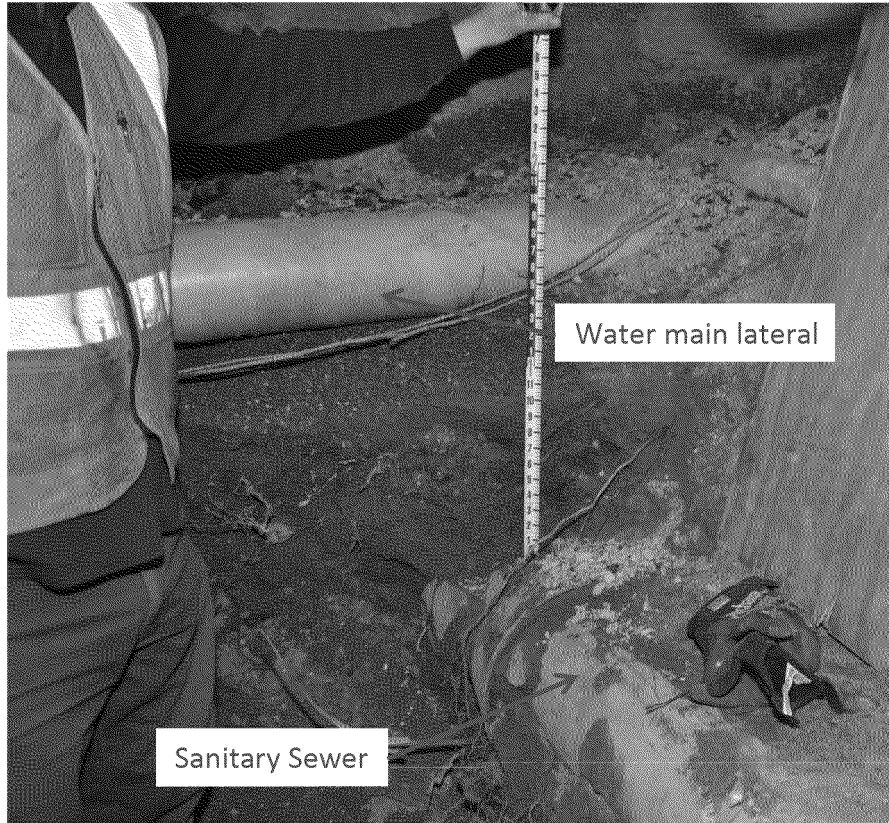
The nearby water main lateral, shown in Figure 3 and Figure 13, was located near the 4-inch steel gas main that was installed in 1987. This water line likely feeds a fire hydrant adjacent to the gas release site. The water lines in the area are owned by the East Bay Municipal Utility District (EBMUD). Per information provided to PG&E by EBMUD, there are three water mains under [Redacted]; an 8-inch main installed in 1961, a 36-inch diameter main installed in 1957, and a 48-inch diameter main installed in 1962. EBMUD has reportedly experienced water main failures in the immediate vicinity about once every ten years. EBMUD believes that landslides and the Hayward Fault are the primary external loading factors that contributed to the failures.

Figure 13. Water main lateral and sanitary sewer.

The nearby sanitary sewer line, shown in Figure 4 and Figure 13, was located near the 3-inch steel gas main that was installed in 1965. The existing sewer line appears to have been installed by slip lining or pipe bursting an older clay sewer pipe. Pieces of broken red clay pipe were observed to surround the plastic sewer main as shown in Figure 4 and Figure 13. Sewer maps from the City of Oakland, last revised on 8-25-2004, indicate that the sanitary sewer at [Redacted] [Redacted] and [Redacted] was rehabilitated and the City of Oakland has records indicating the as-built date as 2003.

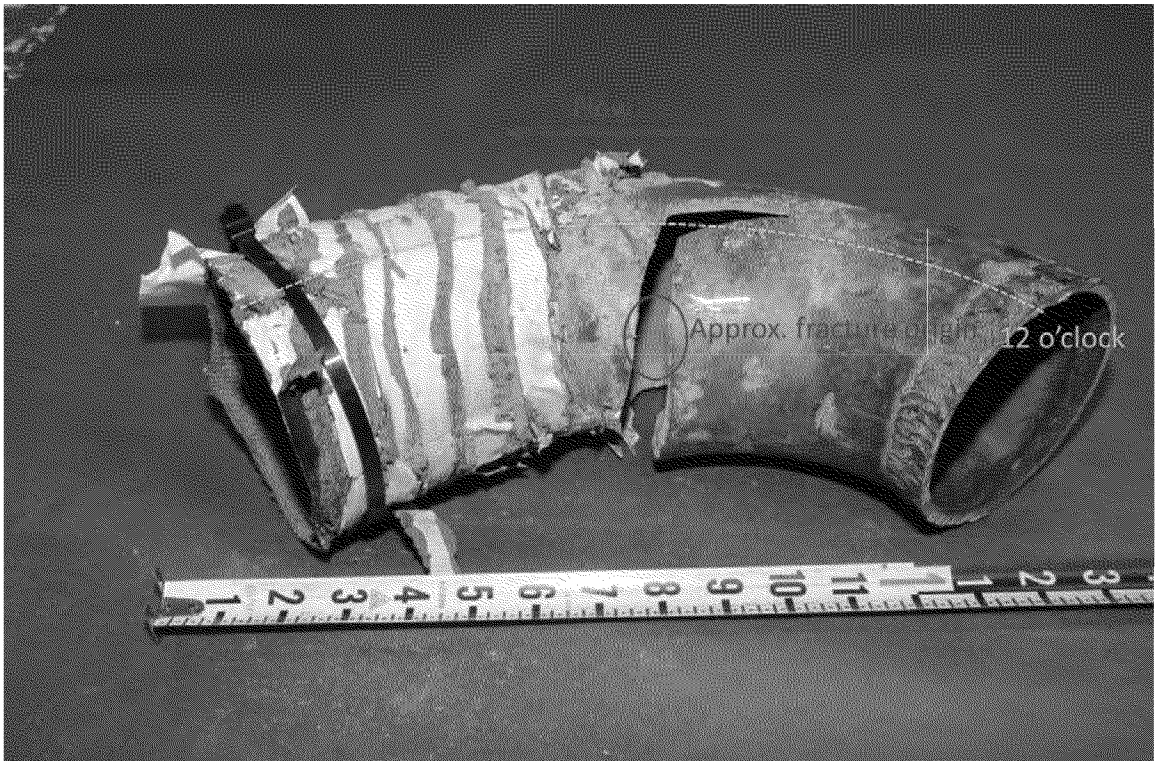
The subject elbow was sectioned to allow fractographic and metallographic examination, as well as elbow wall thickness measurements. The minimum wall thickness was 0.215-inch at the 6 o'clock position, and the maximum thickness was 0.297-inch, located at the 10 o'clock position, as shown in Figure 17. All clock positions reported are looking downstream. PG&E construction documents from 1946 and fitting specifications indicated that the subject elbow was specified to have a wall thickness of 0.237-inch, and to be fabricated from ASTM A 106 Grade A or B material. Note that the elbow fractured at the location of greatest wall thickness.

Figure 15. Image of fractured elbow.

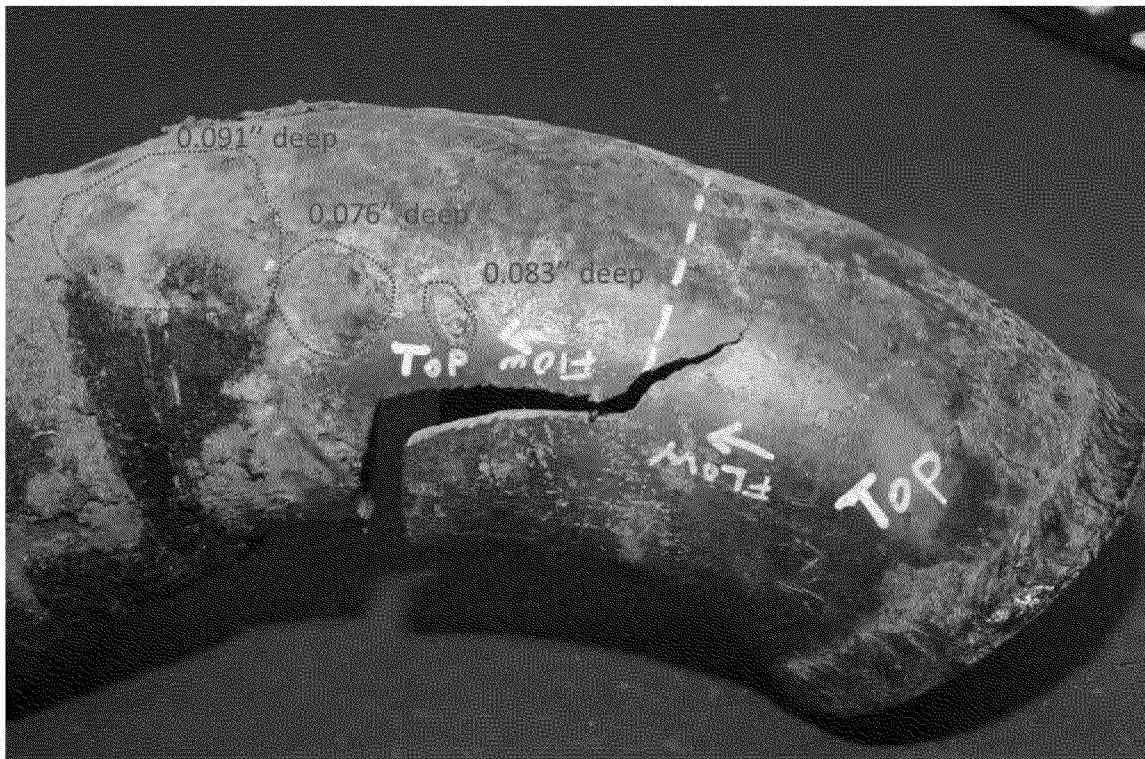
Figure 16. Photograph of the fractured elbow with pipe coating removed showing several corrosion pits, with their depths indicated.

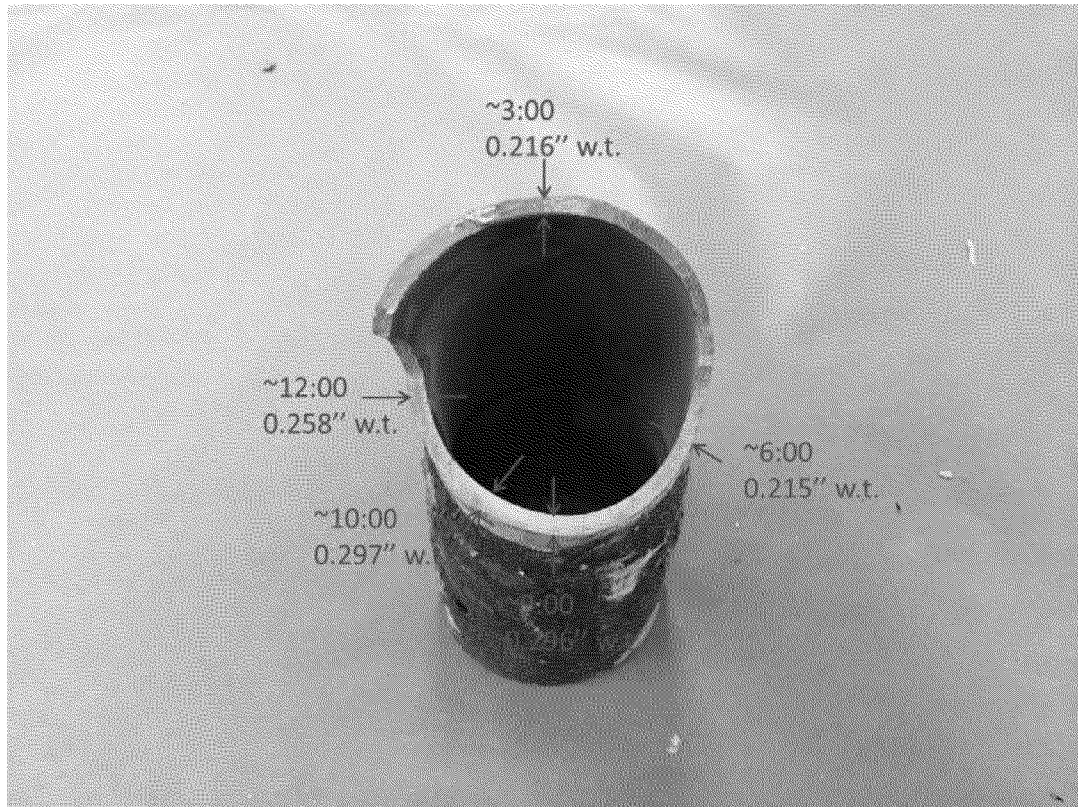
Figure 17. Cross-sectional measurements of pipe thickness around the circumference of the subject elbow at the fracture location.

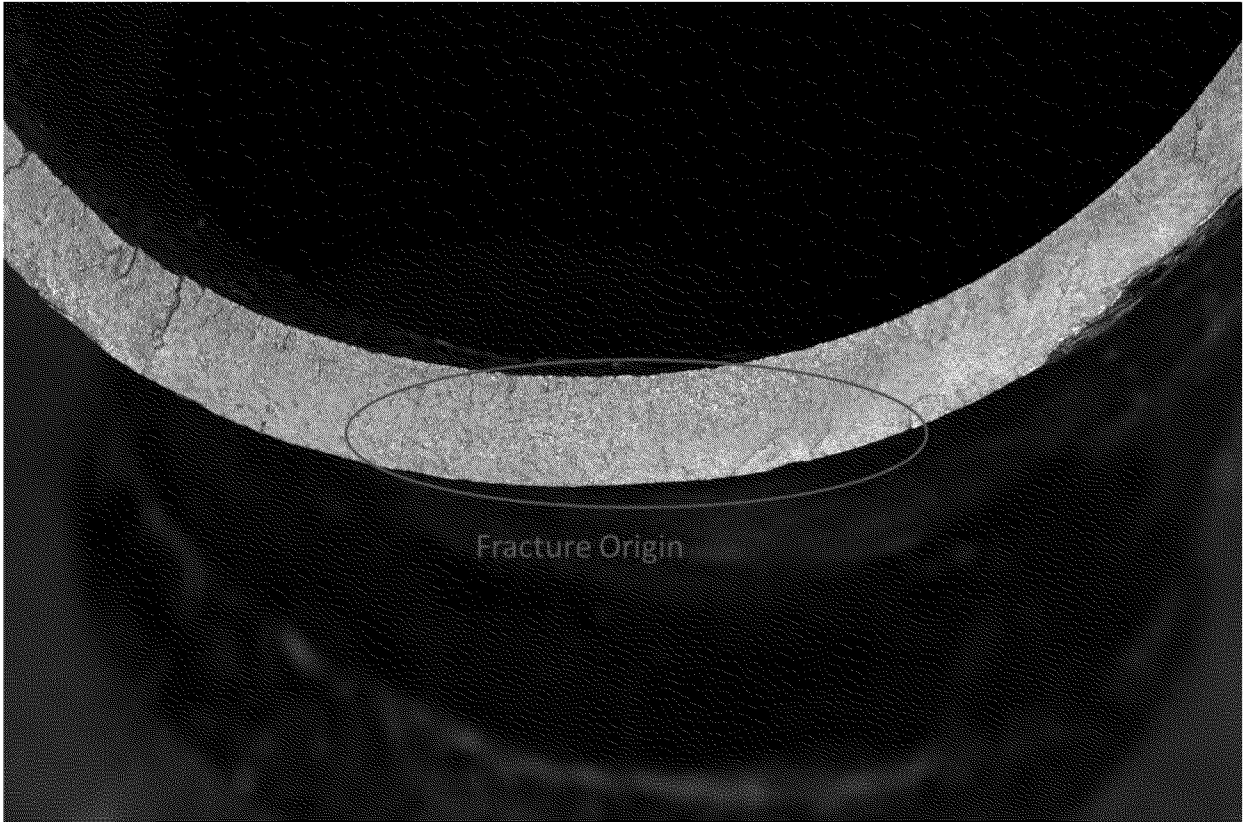
Figure 19. Image that shows the cleaned fracture surface with the fracture origin indicated.

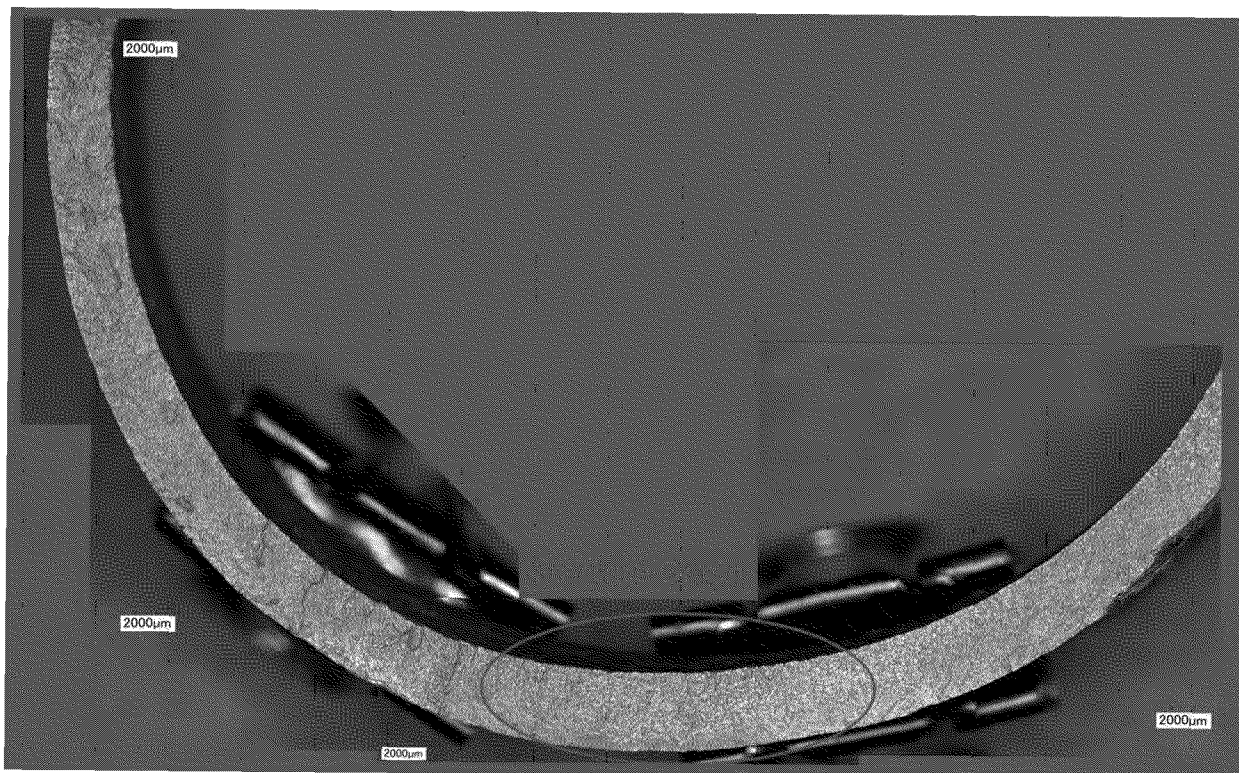
Figure 20. Optical microscope photo montage that shows the fracture surface with the origin indicated.

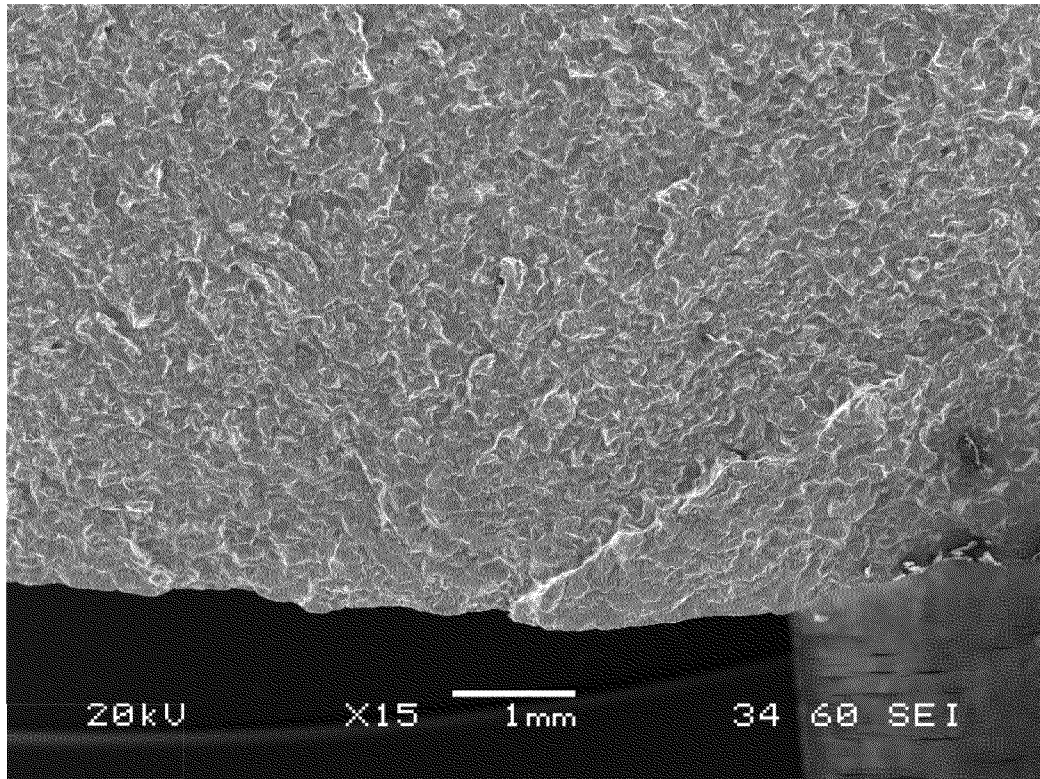
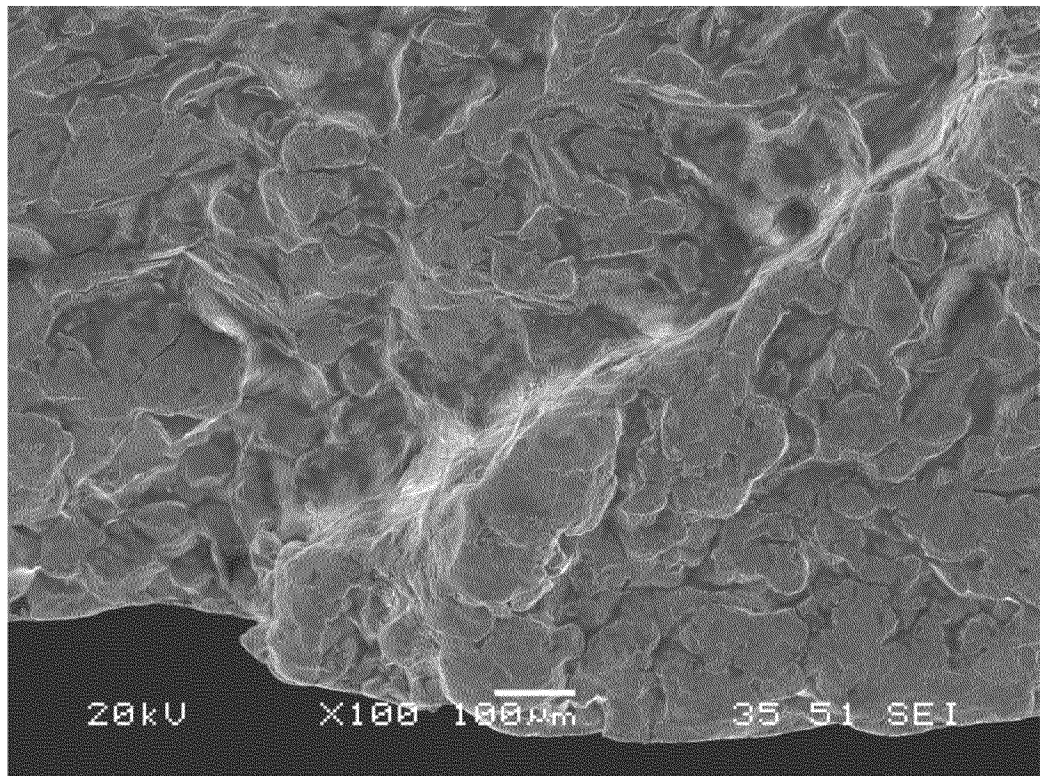
Consistent with our visual and optical microscope fractographic analysis, no evidence of progressive fracture, such as fatigue or stress corrosion cracking (SCC) was observed. Energy dispersive spectroscopy (EDS) showed no evidence of anomalous elemental species (not shown).

Figure 21. SEM images of the fracture origin showing brittle fracture and erosion from gas release.

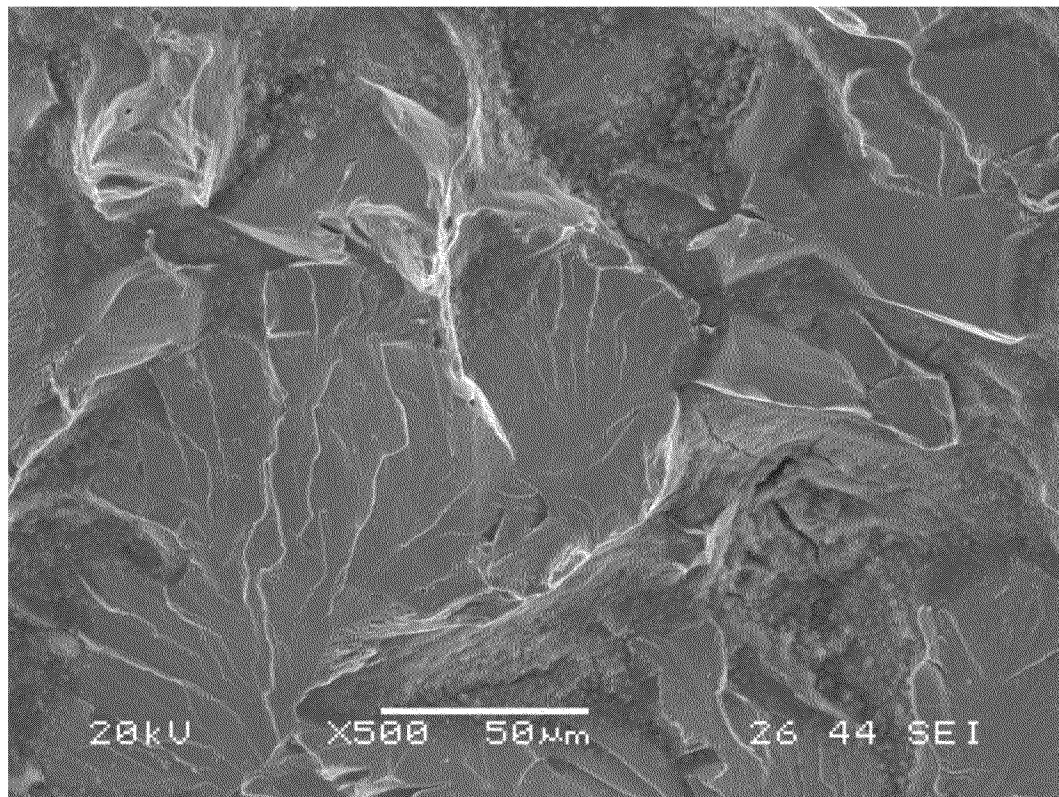
Figure 22. SEM images of varying magnifications of the mid-wall location in the fracture origin region. The fracture morphology shows cleavage, indicative of brittle fracture.

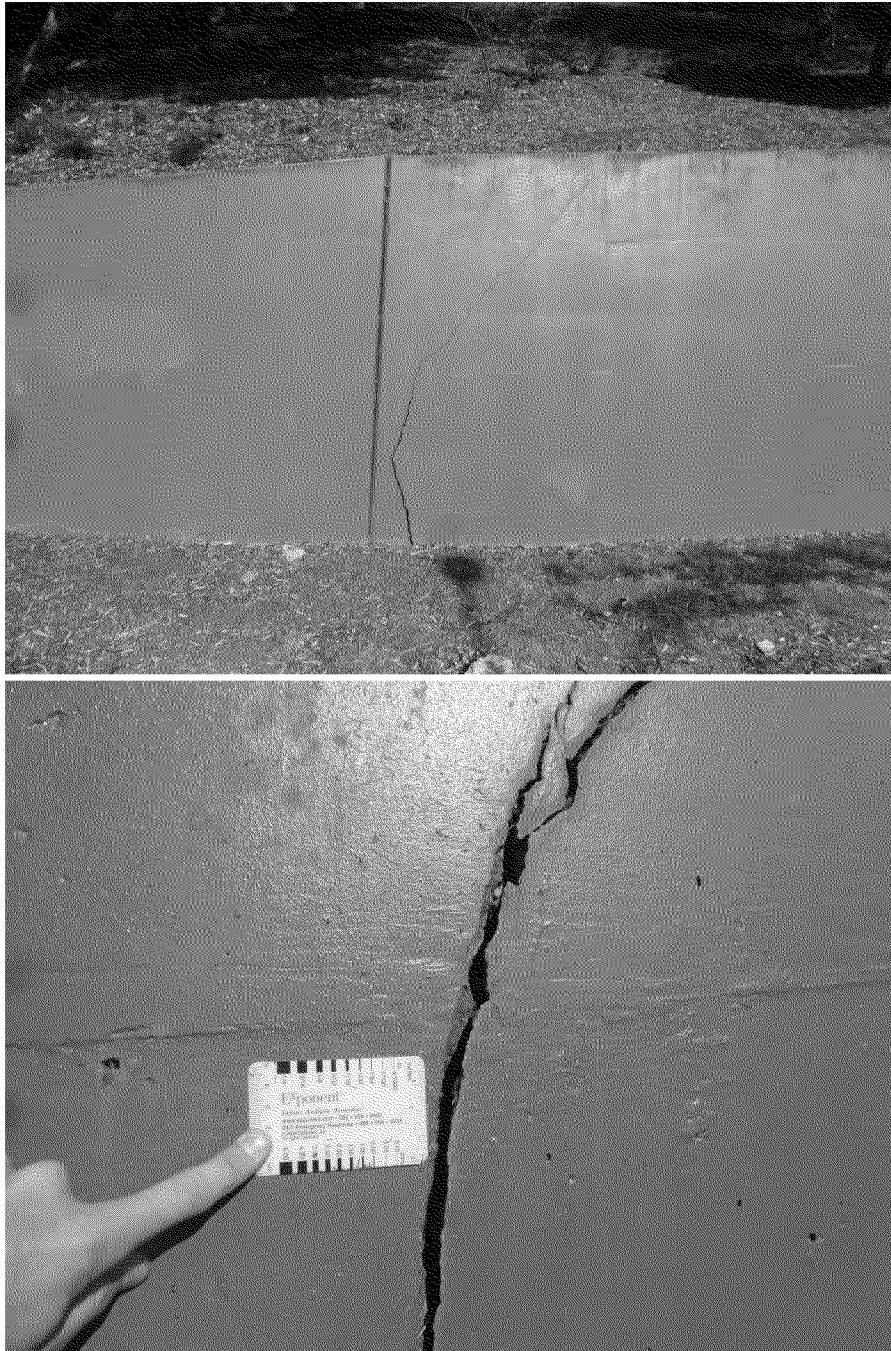
Figure 31. Retaining wall crack, looking north. Photographs by Exponent, December 13, 2013.

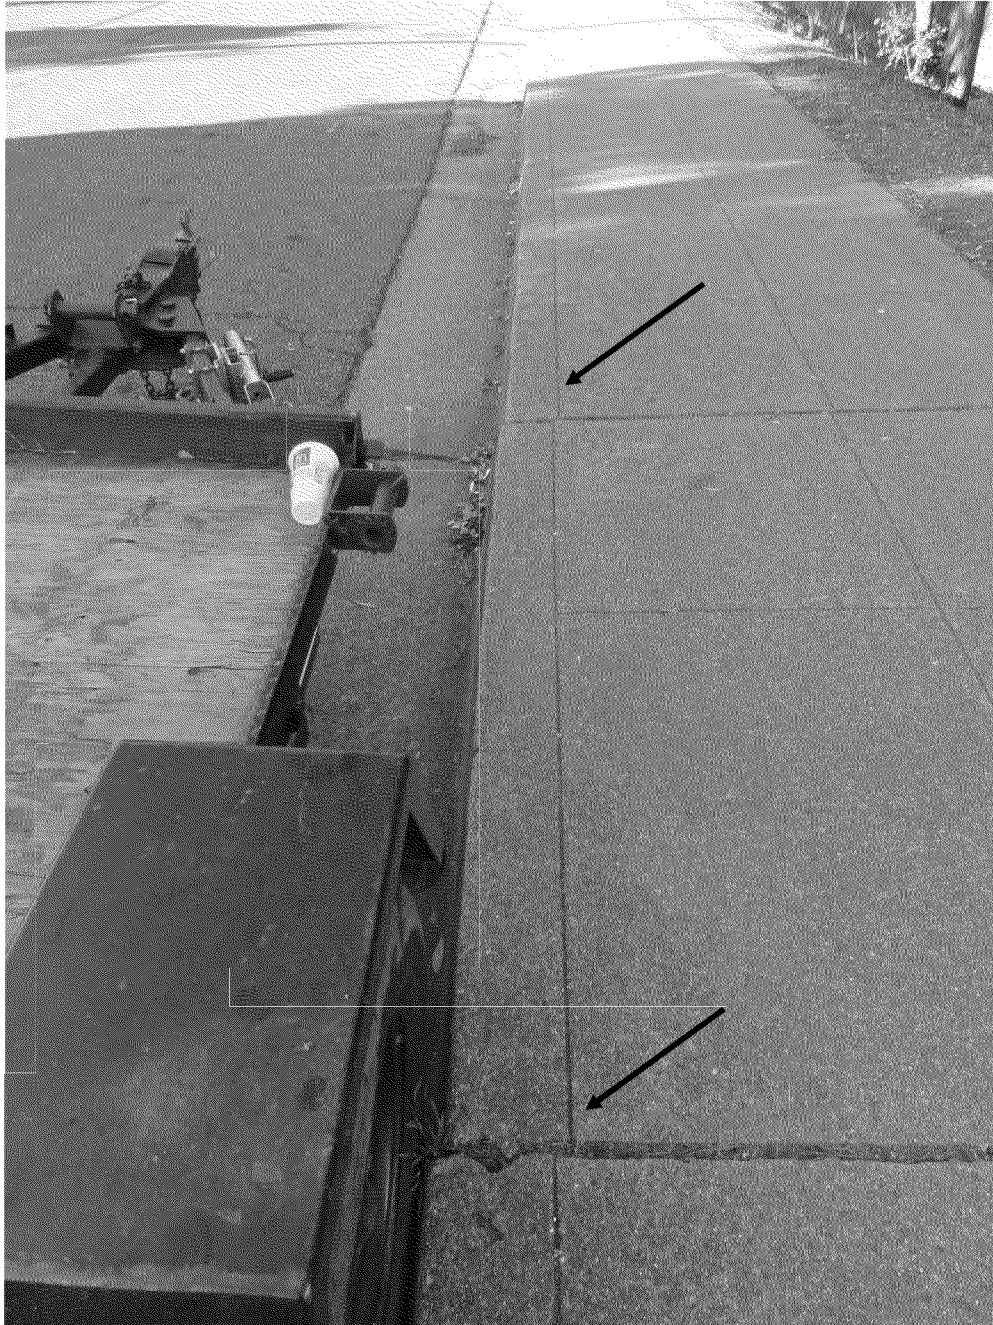
Figure 33. View southwestward along northwestern curb of Redacted. Arrows indicate two of three joints that exhibited right-lateral displacement. Photograph by Exponent, December 26, 2013.

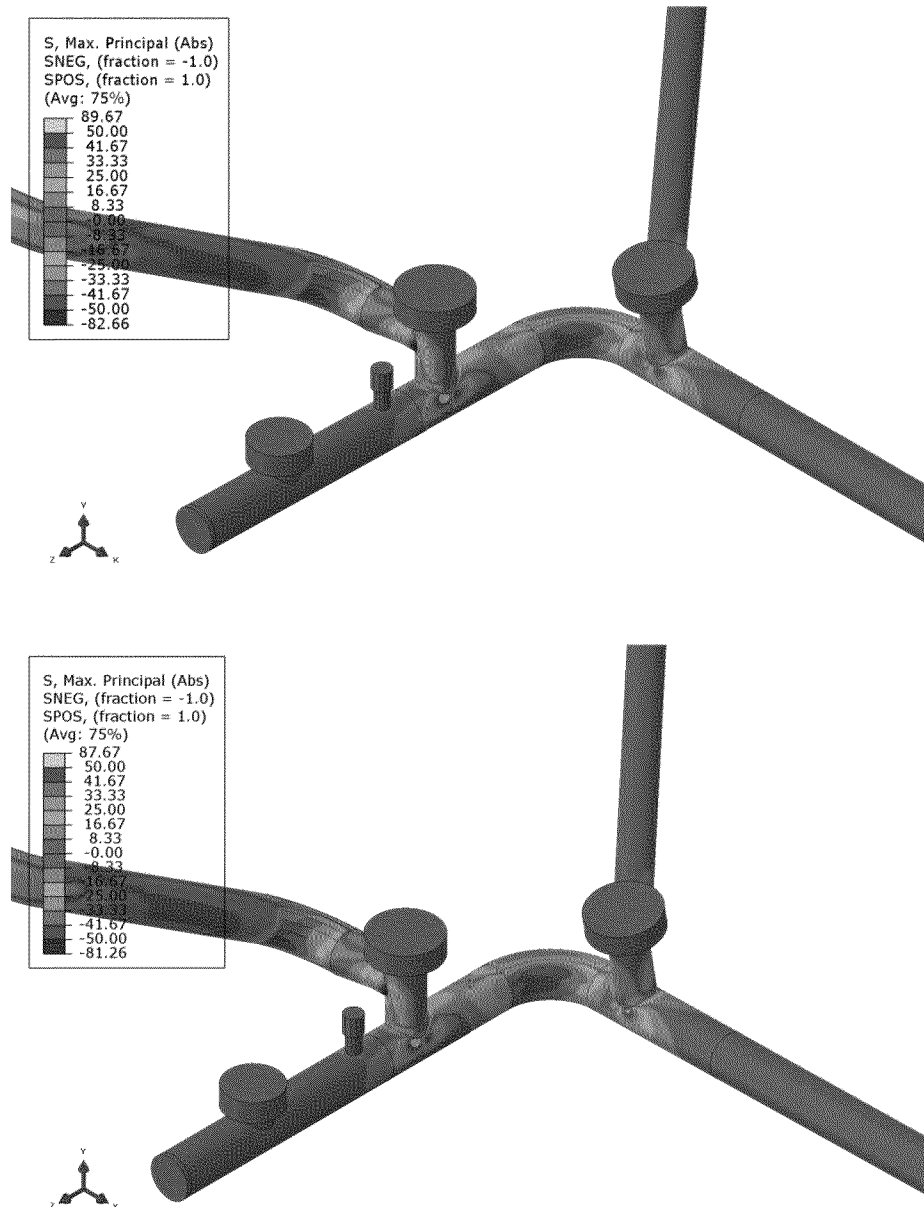
Figure 46. Tensile stresses in the gas pipes when subjected to 0.2 in/ft of shear in the fault creep direction (top) and the landslide shear direction (bottom). Units are ksi.

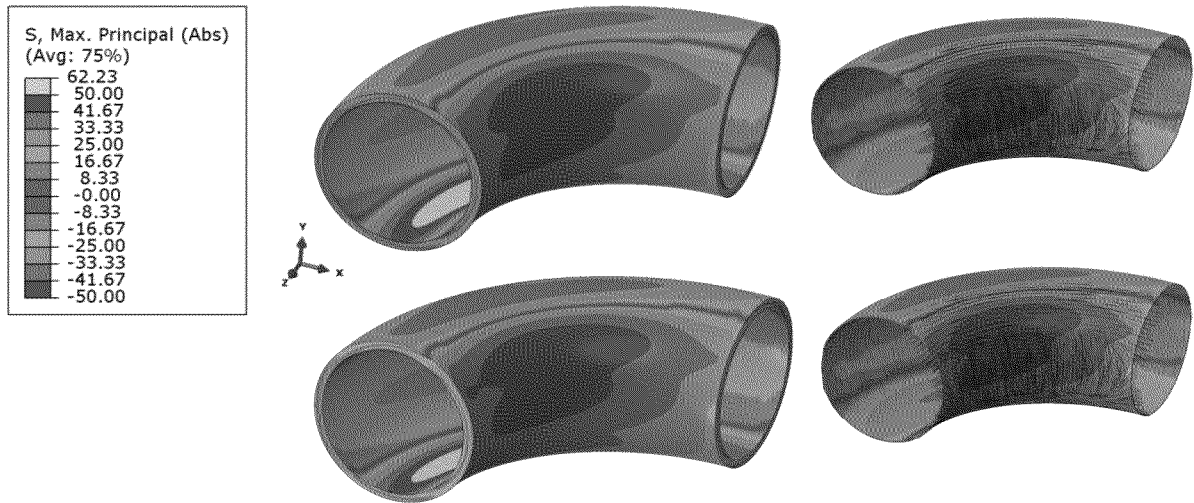
Finite element analysis indicated that the subject elbow likely fractured from stresses accumulated from creep along the [Redacted]. Finite element analysis also indicated that

Figure 47. Tensile stress contours of the incident elbows subjected to shearing in the fault-creep direction (top) and the landslide direction (bottom). Images on the right show tensile stress directions for the outside wall of the elbow. The location and direction of the peak tensile stresses on the elbow exterior are consistent with the crack opening direction observed in the failed elbow. Units are ksi.

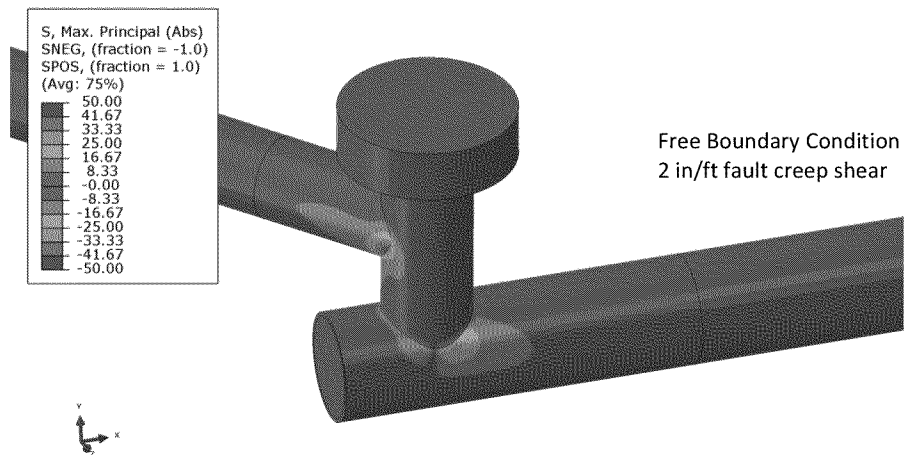
After the failure, the connection between the [Redacted] pipe and the [Redacted] pipe remains intact. Exponent's stress analysis indicates that local stresses likely remain in the existing configuration. As more fault creep occurs in the future, these stresses are expected to increase. Exponent recommends the current connection be replaced to relieve the current stresses.

Figure 52. Tensile stresses after the post-failure repair in the flange tee neighboring the incident elbow for different boundary conditions on the Fontaine Street pipe. Note that the models have decreasing amount of shear despite increasing stresses. Units are ksi.
