**Golf Links Road (Oakland)  
Incident Analysis**

January 2014  
Revised January 20, 2014

Doc. no. 1308766.000 - 3956

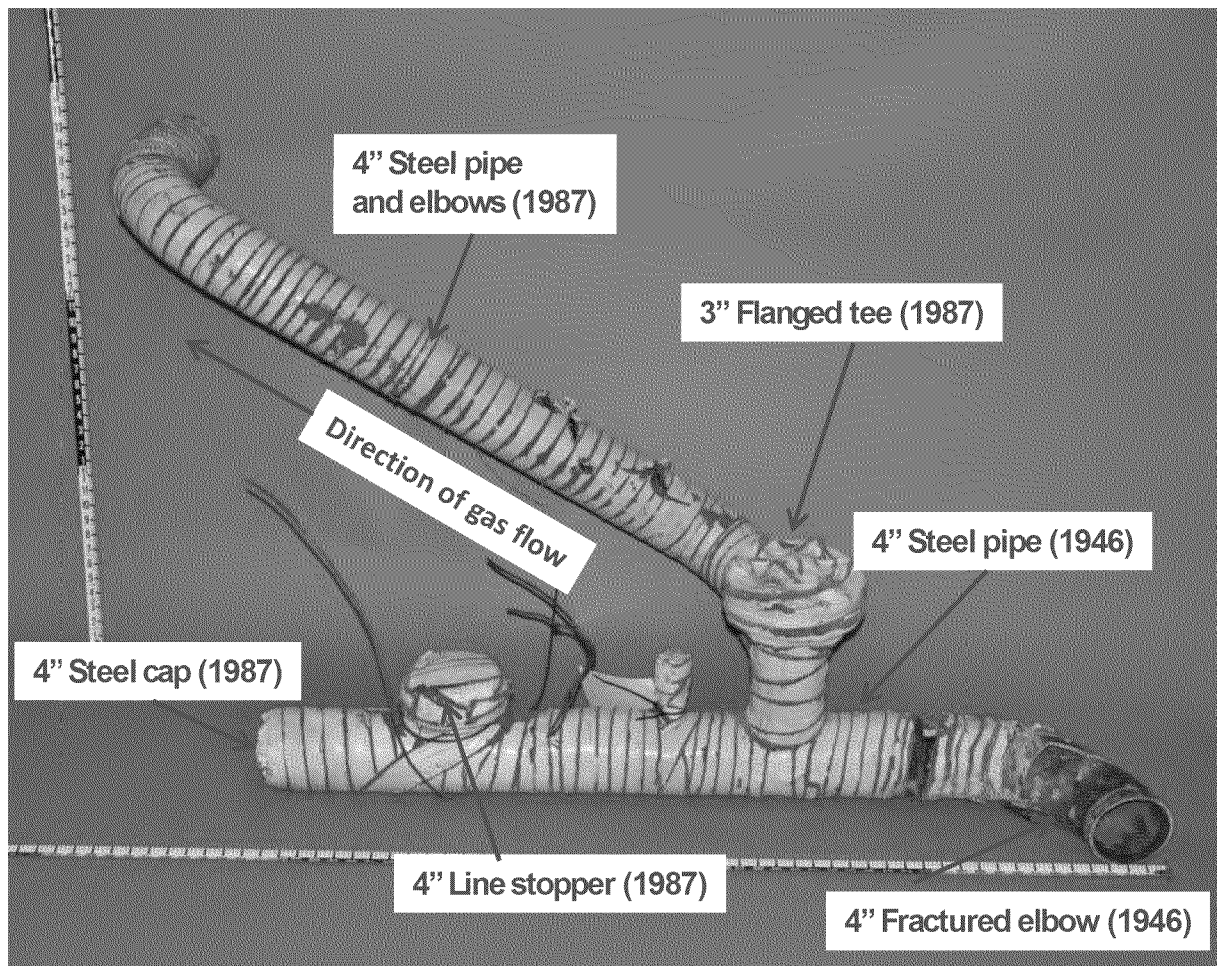
Figure 5. Fractured elbow and adjacent features after removal, with piping photographed as if viewer is looking downstream.

The ruptured elbow and piping downstream from the break was removed from the leak site as shown in Figure 5, and was brought to Exponent's Menlo Park, California laboratories for analysis. The break occurred at the elbow intrados, as shown in Figure 15. The fracture plane was primarily perpendicular to the gas flow direction and located near the center of the elbow. This fracture orientation is consistent with bending of the elbow, rather than a pressure-induced break. Comparison of the ruptured elbow before and after excavation (Figure 4 and Figure 15) showed that the fracture opened during the excavation process. This is consistent with reports of witnesses on site during the excavation process.

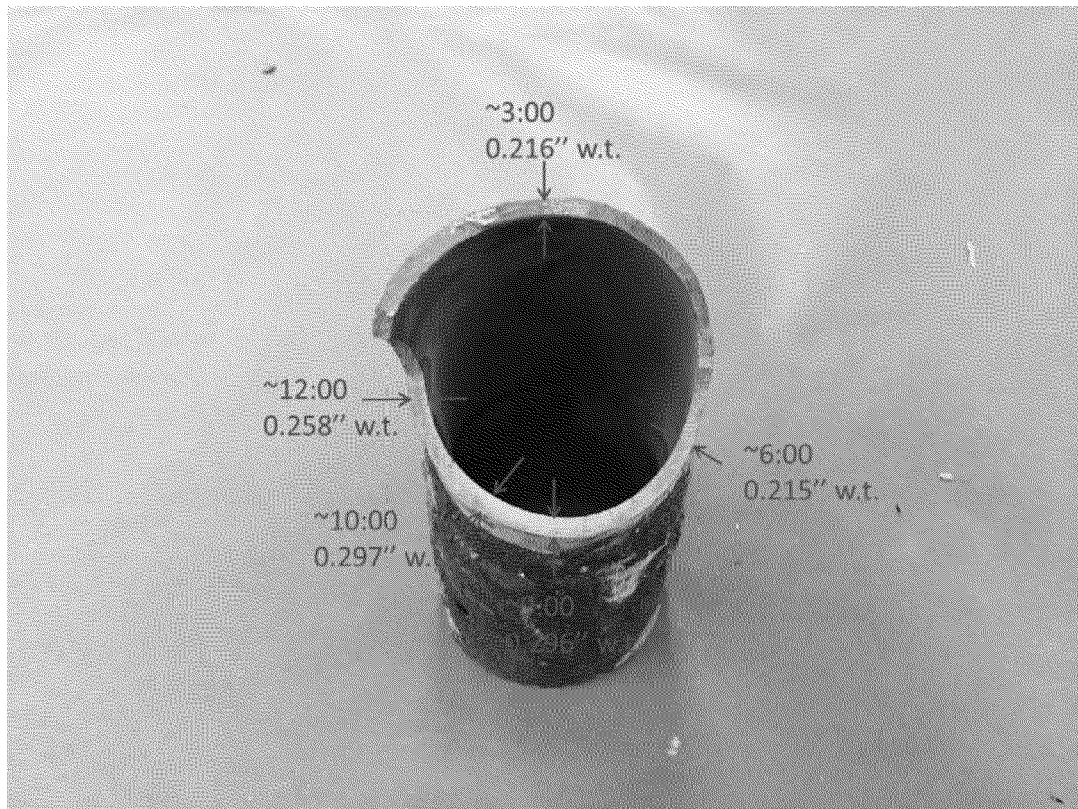
The subject elbow was sectioned to allow fractographic and metallographic examination, as well as elbow wall thickness measurements. The minimum wall thickness was 0.215-inch at the 6 o'clock position, and the maximum thickness was 0.297-inch, located at the 10 o'clock position, as shown in Figure 17. All clock positions reported are looking downstream. PG&E construction documents from 1946 and fitting specifications indicated that the subject elbow was specified to have a wall thickness of 0.237-inch, and to be fabricated from ASTM A 106 Grade A or B material. Note that the elbow fractured at the location of greatest wall thickness.

Figure 17. Cross-sectional measurements of pipe thickness around the circumference of the subject elbow at the fracture location.

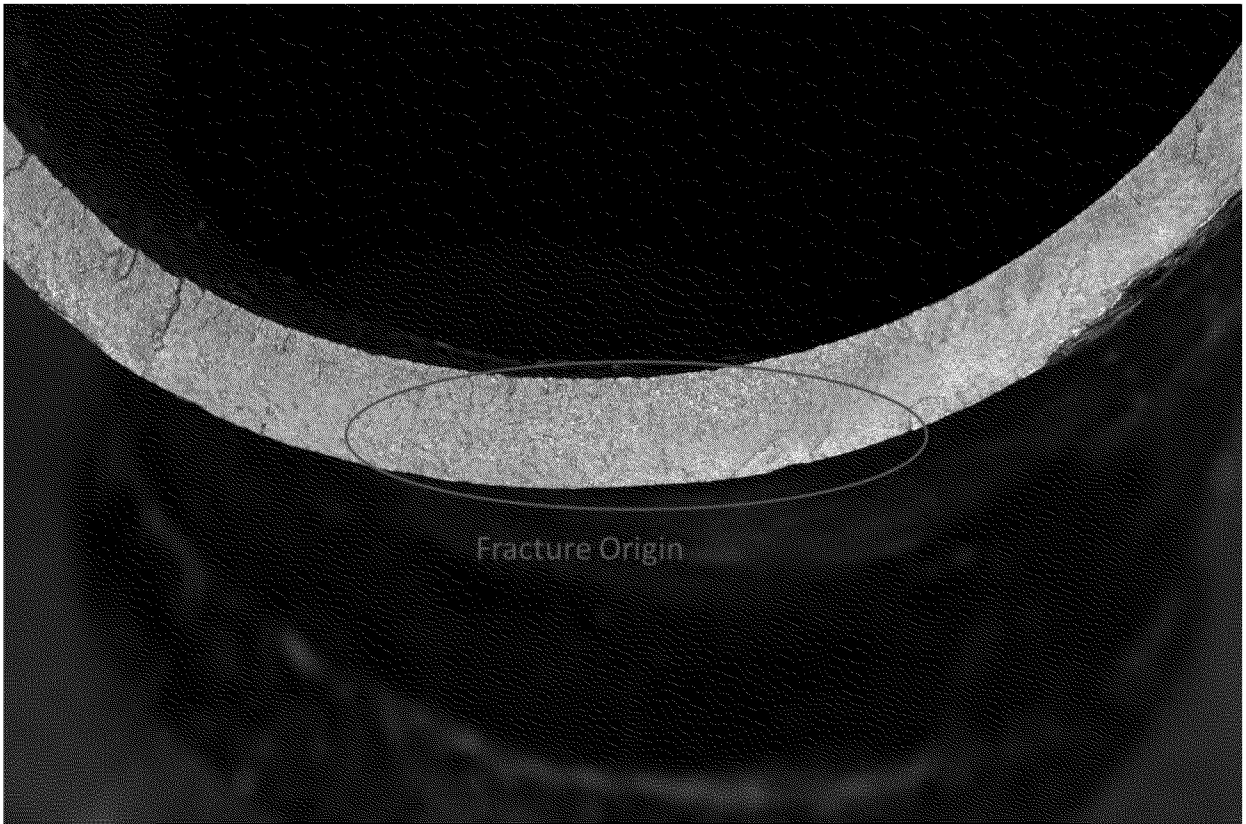
Fractographic analysis was conducted to help determine the cause of the rupture. The elbow was sectioned across the remaining intact area near the break to better expose the fracture surfaces for examination, as shown in Figure 18. To help remove the soil that obscured the surface, the fracture faces were cleaned in a warm Alconox (detergent and water) solution and scrubbed with a nylon brush. Following cleaning, the fracture surface was examined visually as well as using optical and scanning electron microscopy (SEM) techniques. A photograph of the cleaned fracture surface is shown in Figure 19. No dark areas, associated with long-term corrosion, or evidence of progressive fracture (such as beach marks) were observed. The fracture origin area was relatively flat with little ductility. Examination of tear ridges and chevron marks (which point back to the initiation point), shown in Figure 19 and Figure 20, indicated that the fracture origin was located at roughly the 10 o'clock position.

Figure 19. Image that shows the cleaned fracture surface with the fracture origin indicated.

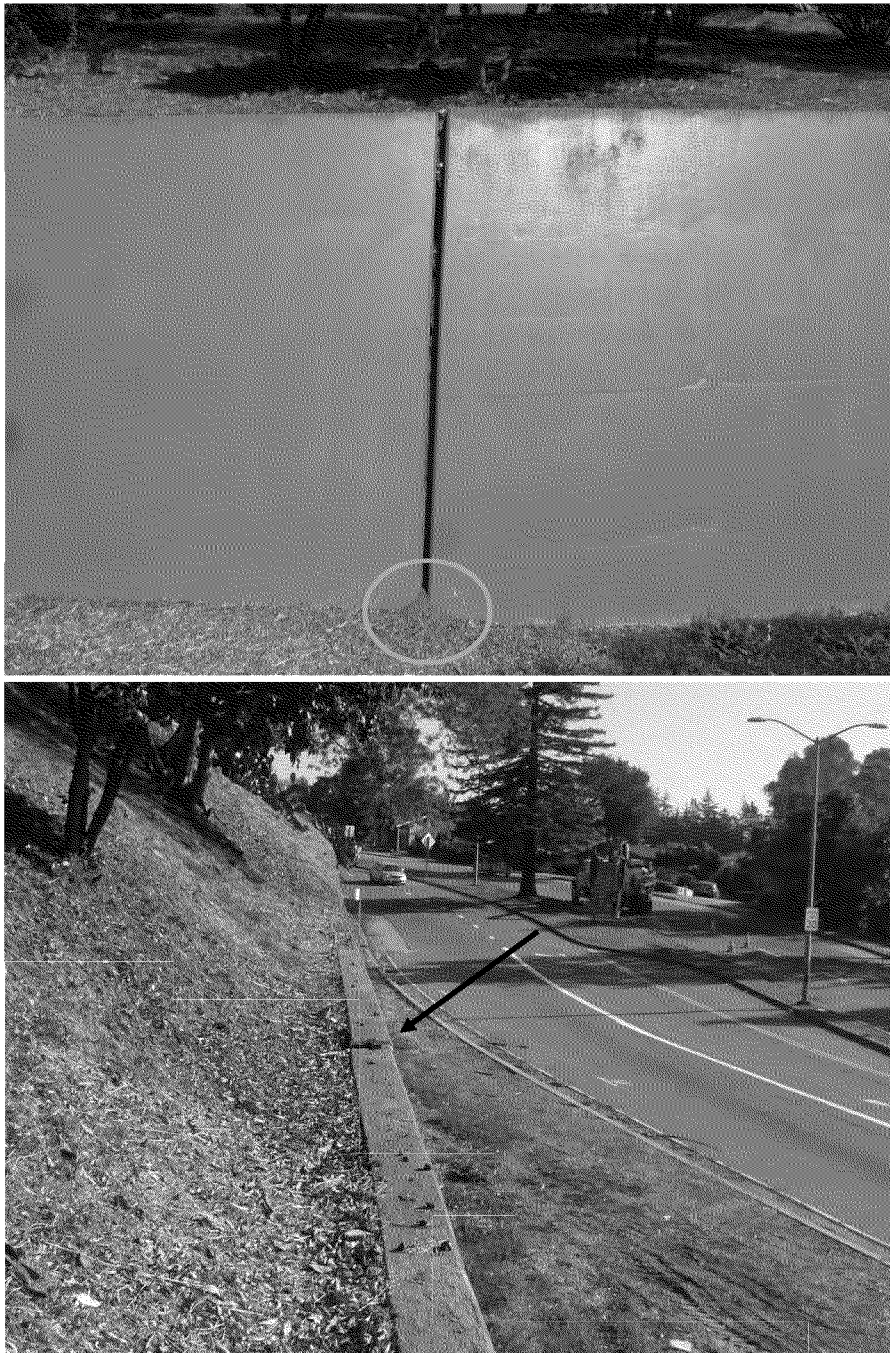
Figure 32. Displaced retaining wall joint. Oval encloses observed recent soil deposits near the base of the wall. Arrow indicates right-lateral displacement at top of wall. Photographs by Exponent, December 13, 2013.

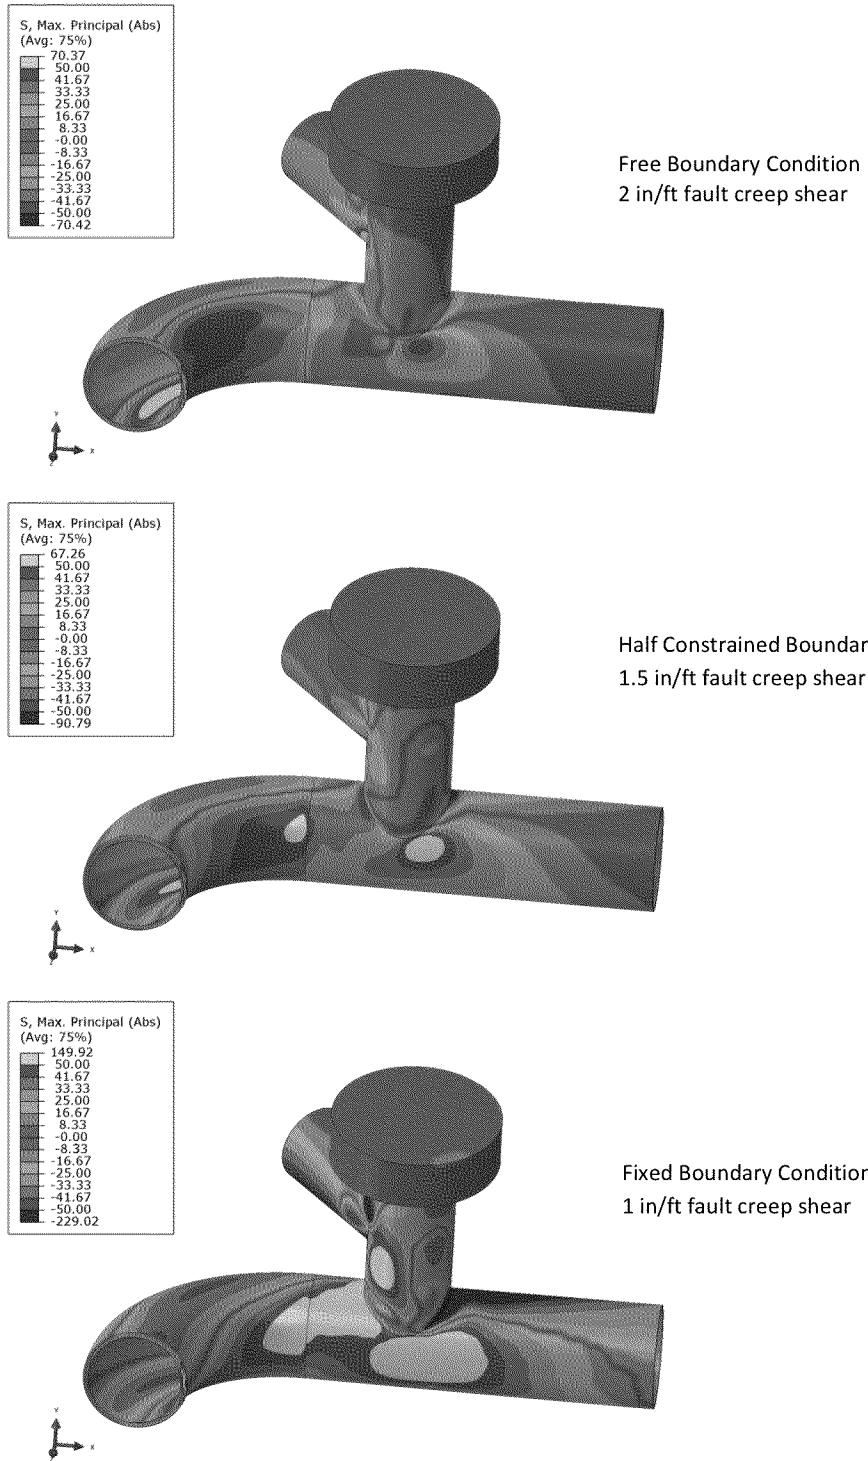
After the failure, the connection between the Fontaine Street pipe and the Golf Links Road pipe remains intact. Exponent's stress analysis indicates that local stresses at this connection may be approximately 30 ksi. As more fault creep occurs in the future, these stresses are expected to increase.

Figure 50. Tensile stresses in the incident elbow and neighboring tee for different boundary conditions on the Fontaine Street pipe. Note that the models have decreasing amount of shear despite increasing stresses. Units are ksi.

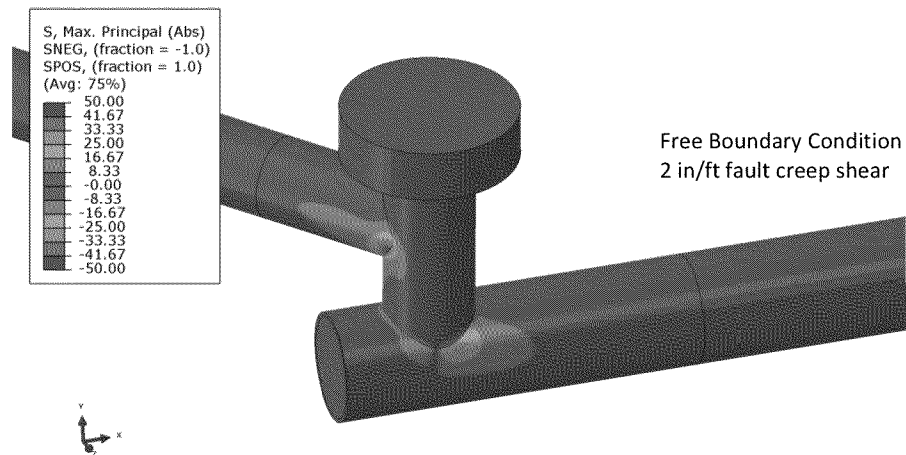
Figure 52. Tensile stresses after the post-failure repair in the flange tee neighboring the incident elbow for different boundary conditions on the Fontaine Street pipe. Note that the models have decreasing amount of shear despite increasing stresses. Units are ksi.
