Re: Update - Oakland Incident of December 10, 2013

Failure Analysis Associates

Pacific Gas and Electric (PG&E) has retained Exponent Failure Analysis Associates (Exponent) to conduct a failure analysis investigation of an elbow that fractured as part of a four-inch natural gas distribution line on December 10, 2013 near the intersection of [Redacted] [Redacted] in Oakland, California. Our investigation to-date has included inspection of the leak site, review of PG&E's historical construction documents, a fire cause and origin study, metallurgical analysis, geotechnical analysis, analysis of other leak locations within the immediate area, and finite element-based stress analyses of ground movement and stresses on the subject elbow and associated piping.

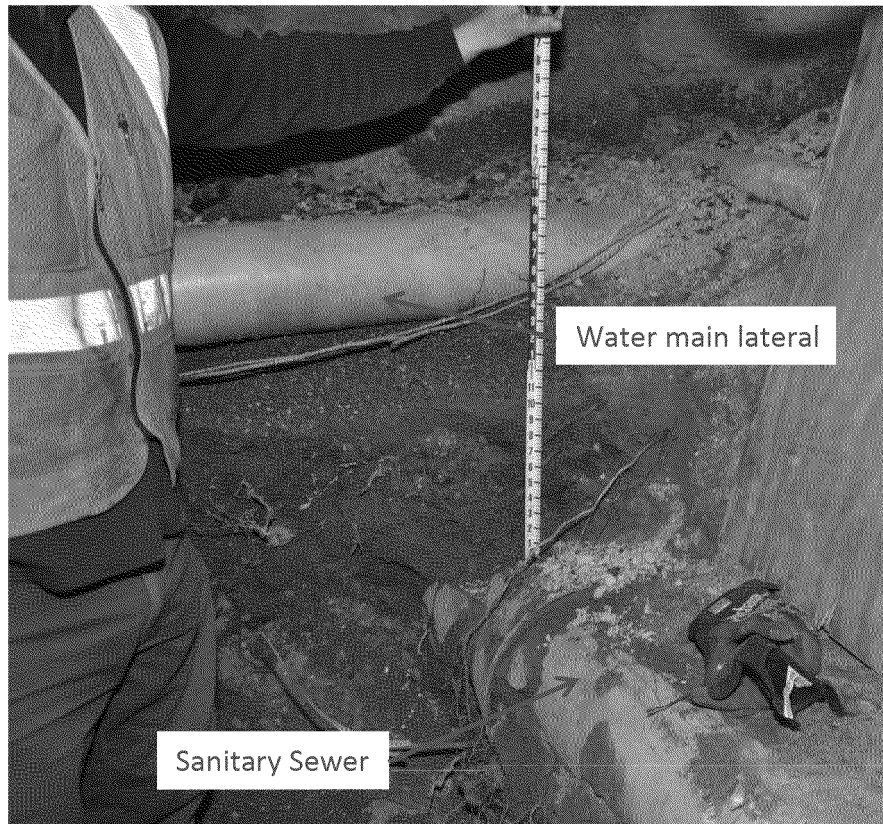
Figure 13. Water main lateral and sanitary sewer.

The nearby water main lateral, shown in Figure 3 and Figure 13, was located near the 4-inch steel gas main that was installed in 1987. This water line likely feeds a fire hydrant adjacent to the gas release site. The water lines in the area are owned by the East Bay Municipal Utility District (EBMUD). Per information provided to PG&E by EBMUD, there are three water mains under [Redacted] an 8-inch main installed in 1961, a 36-inch diameter main installed in 1957, and a 48-inch diameter main installed in 1962. EBMUD has reportedly experienced water main failures in the immediate vicinity about once every ten years. EBMUD believes that landslides and the Hayward Fault are the primary external loading factors that contributed to the failures.

The nearby sanitary sewer line, shown in Figure 4 and Figure 13, was located near the 3-inch steel gas main that was installed in 1965. The existing sewer line appears to have been installed by slip lining or pipe bursting an older clay sewer pipe. Pieces of broken red clay pipe were observed to surround the plastic sewer main as shown in Figure 4 and Figure 13. Sewer maps from the City of Oakland, last revised on 8-25-2004, indicate that the sanitary sewer at [Redacted] [Redacted] was rehabilitated and the City of Oakland has records indicating the as-built date as 2003.

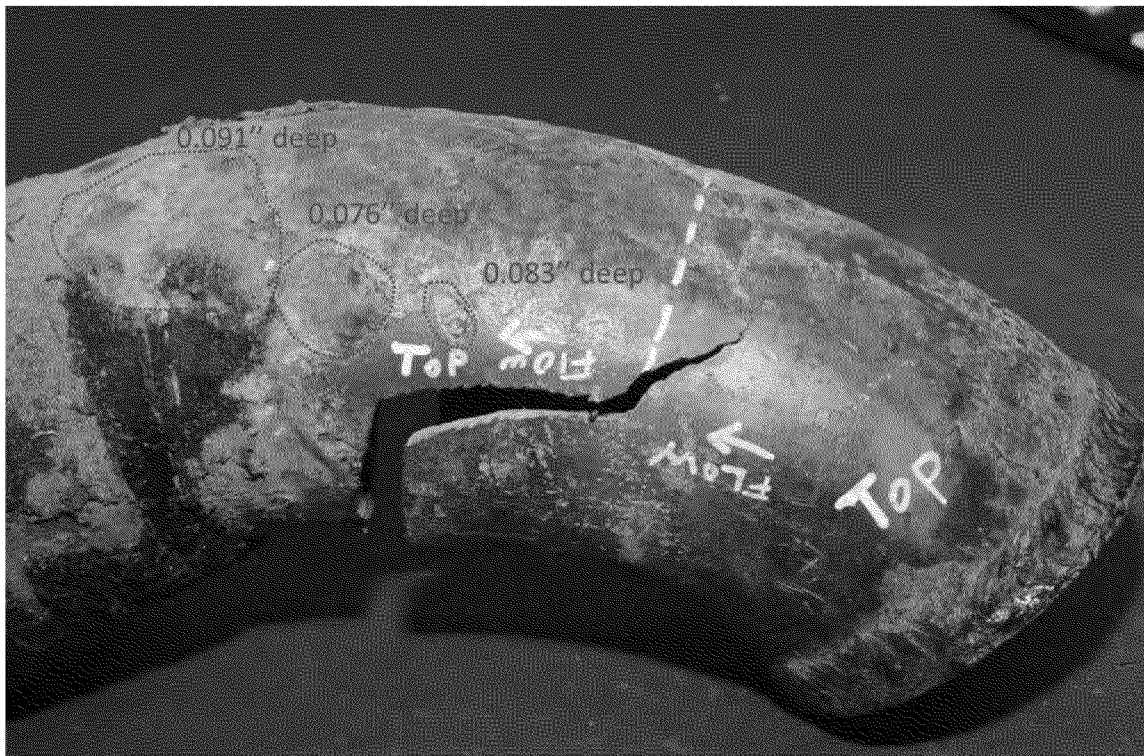
Figure 16. Photograph of the fractured elbow with pipe coating removed showing several corrosion pits, with their depths indicated.

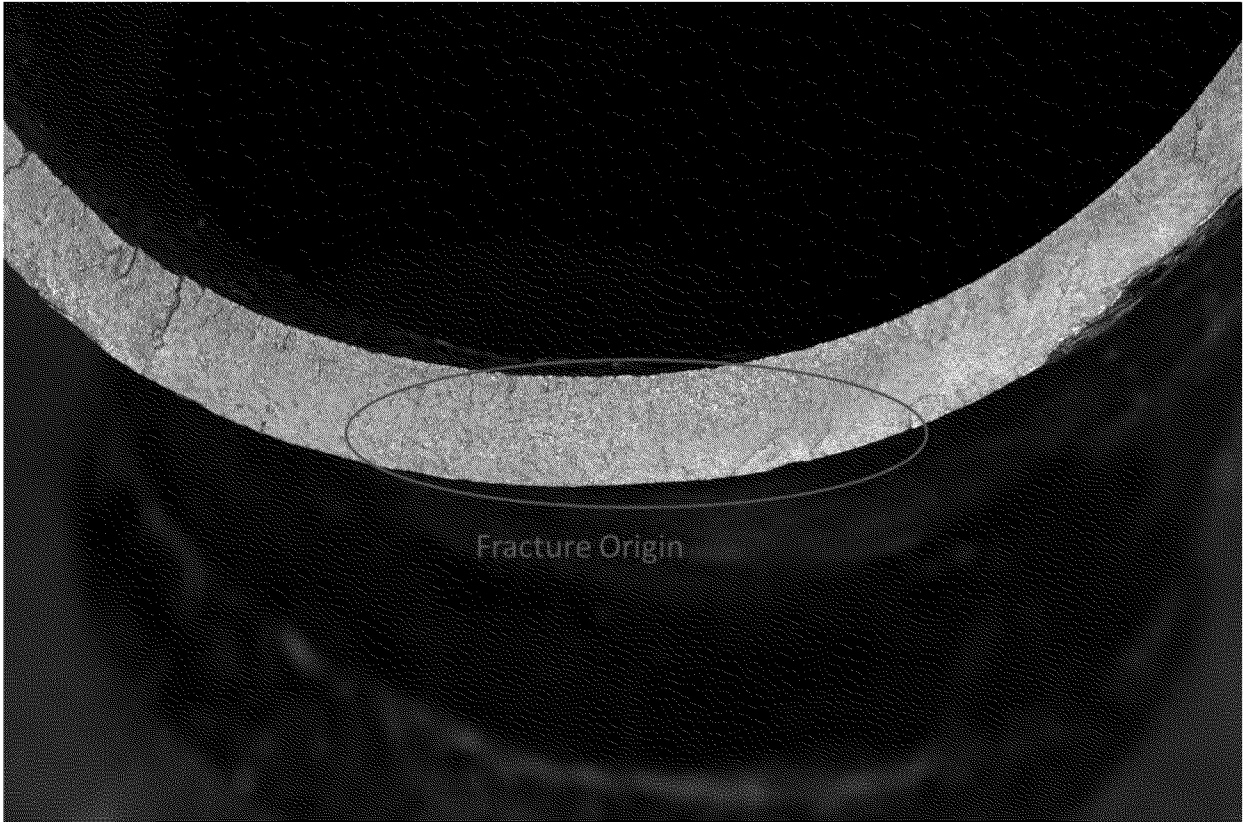
Consistent with our visual and optical microscope fractographic analysis, no evidence of progressive fracture, such as fatigue or stress corrosion cracking (SCC) was observed. Energy dispersive spectroscopy (EDS) showed no evidence of anomalous elemental species (not shown).

Figure 19. Image that shows the cleaned fracture surface with the fracture origin indicated.
