Photo of tram prior to modifications made post-accident

Photo of tram with modifications made post-accident

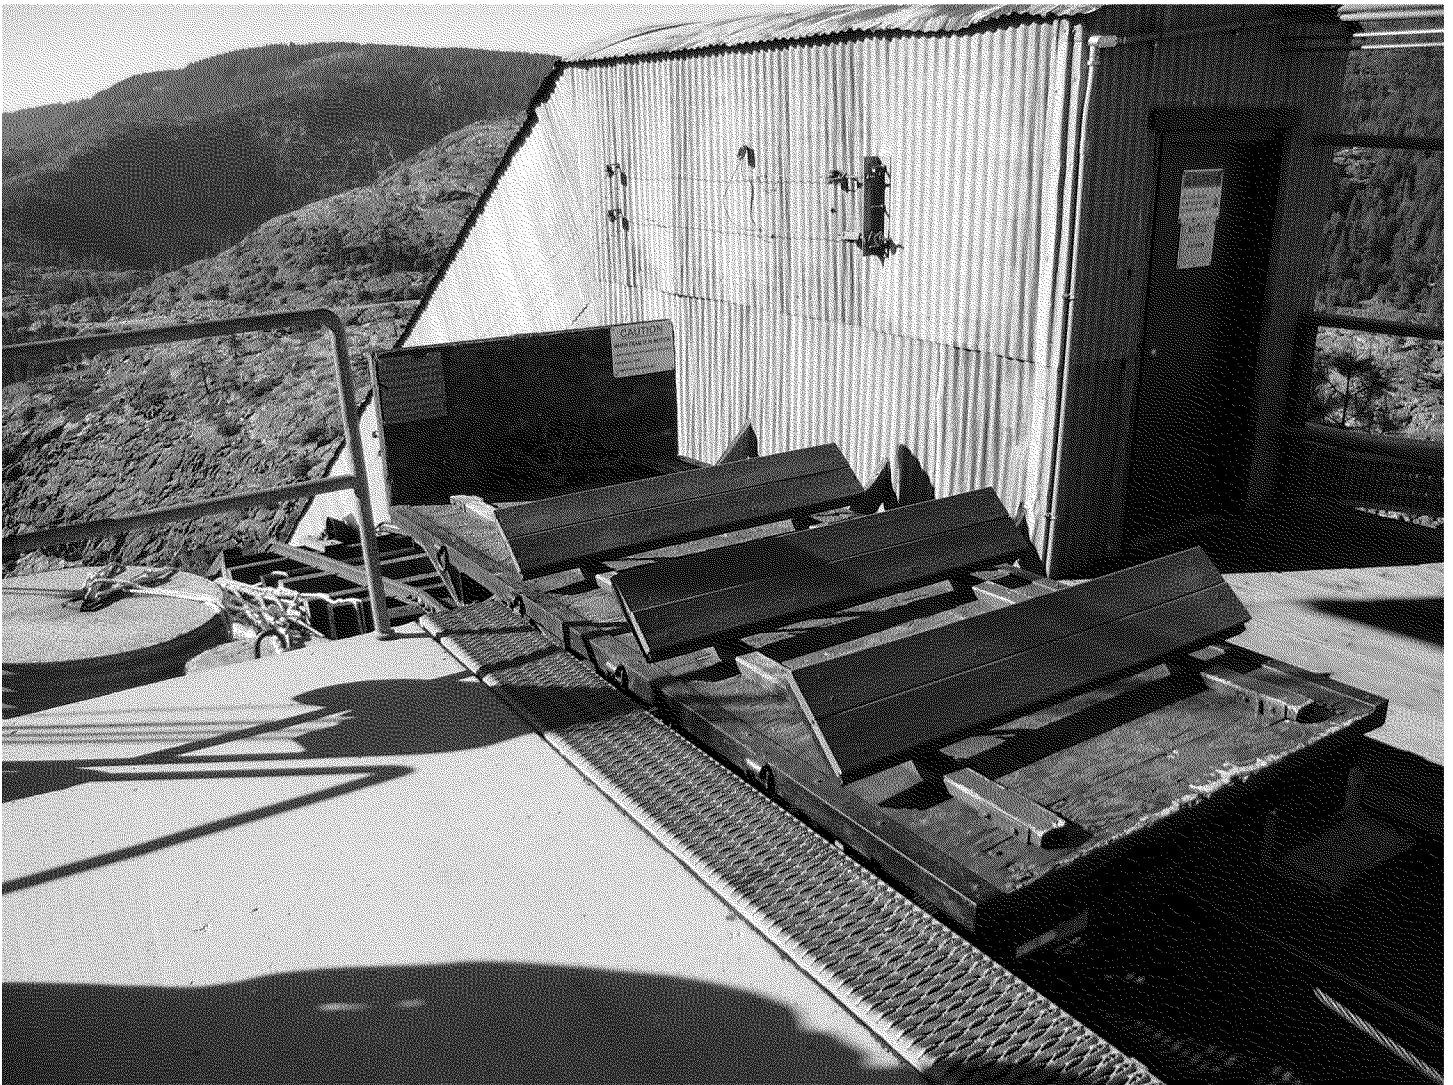
Note: The Caution sign in the upper right corner was installed post-accident
