Incident Communication

Incident Date: 11/15/2013

Incident Summary:

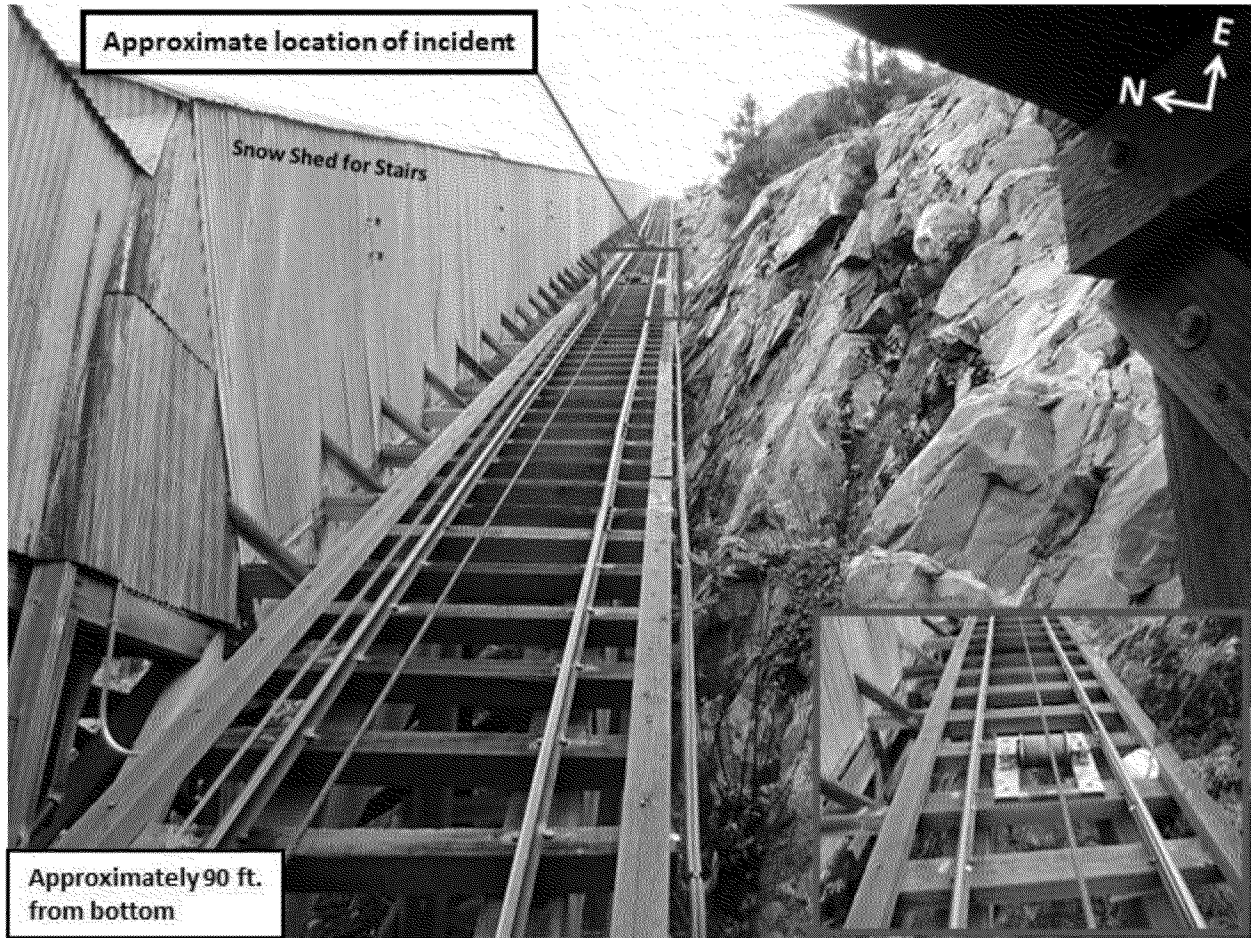
Approximate location of incident

Snow Shed for Stairs

Approximately 90 ft.
from bottom
