FINAL REPORT
VOLUME I
R-PG&E-20140117

Pacific Gas and Electric Company

Tree Root Interference Assessment

January 17, 2014

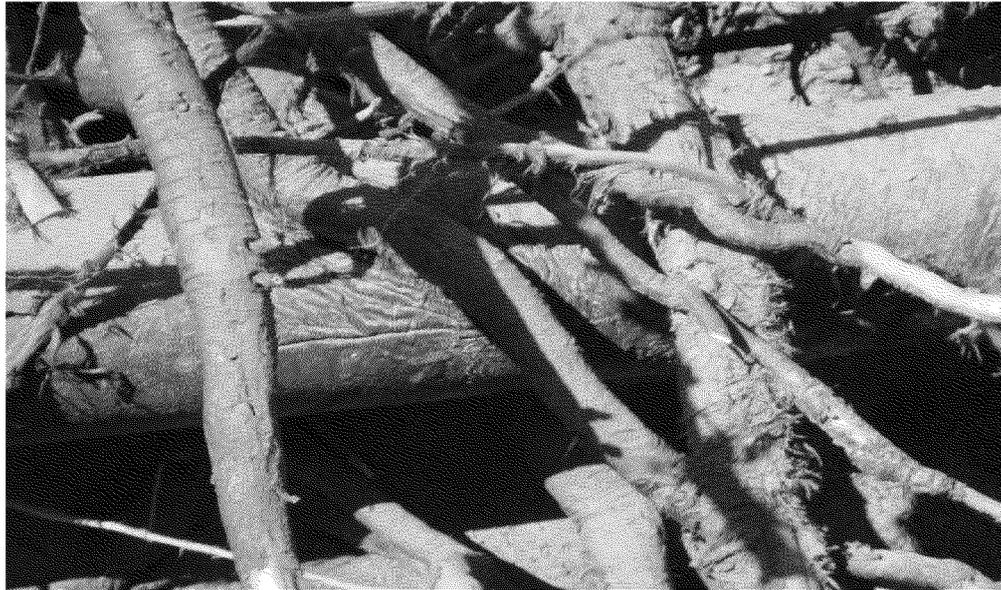
Figure 3. RWVIM-107-13 (Weber Lane)
(CTE coating damage)

The distribution of damage as a function of external coating type is summarized in Table 2. These results show that for the excavations performed, over 80% of the sites with CTE or HAA coating types^m had coating damage attributed to the tree root system. While there are limited results for the sites with tape coating (8 sites), the propensity for coating damage appeared to be much lower. Examples of CTE and Tape coating damage caused by tree roots are presented in Figure 3 (RWVIM-107-13, Weber Lane) and Figure 4 (RWVIM-74-13, Atascadero), respectively. Since none of the excavations sites within this study contained pipe with fusion bonded epoxy (FBE) and there are limited results for pipe with polyethylene tape coating, there is insufficient information within the results to understand whether or not these coatings are less susceptible to damage from tree roots.

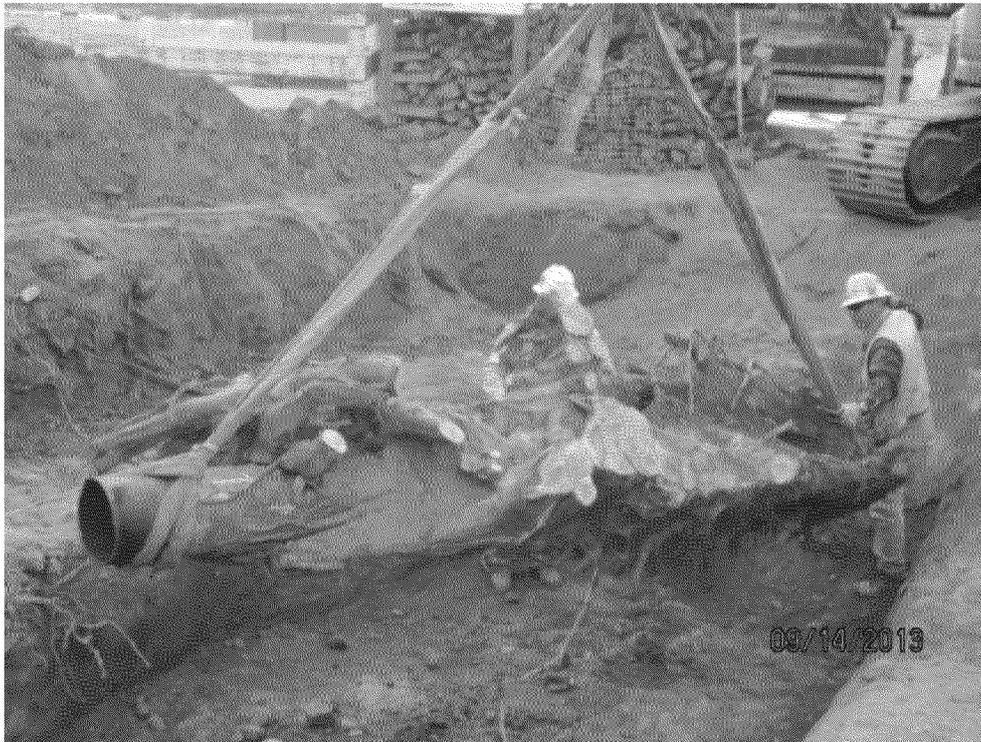
Figure 6. RWVIM-90-13 (Hall Road)

8. There is the potential for tree roots to structurally damage the pipeline, including inducing increased bending strains, if tree roots are uprooted by external forces. While this was not observed at any of the 53 sites, one site in particular (Hall Road) clearly demonstrated the significance of this potential threat. The root ball was located directly above the pipe and the pipeline was fully encapsulated by the Valley Oak tree roots. In a similar situation, if external forces and events (such as seismic, high winds) caused movement of the tree and tree roots, the forces created by such movement could damage the buried pipeline.

Tree root and pipeline interactive conditions were reviewed relative to the potential for pipeline structural damage. An example of one location where the tree root ball was situated directly on top of the pipe and the tree roots encapsulated the buried pipe is presented in Figure 6 (RWVIM-90-13, Hall Road).

The Hall Road site provides evidence of what can occur when a tree root ball and root system is located in close proximity to a buried pipeline. A primary concern under these conditions is that weather (e. g., high force winds, flooding, seismic events) may cause tree and root movement, resulting in pipe damage. In addition, since the buried pipeline and tree root systems are interconnected, a lightning strike to the tree would most likely also impact the pipeline and provide an electrical path for the strike and may also provide a path for the electrical discharge.
