FINAL REPORT
VOLUME I
R-PG&E-20140117

Pacific Gas and Electric Company

Tree Root Interference Assessment

January 17, 2014

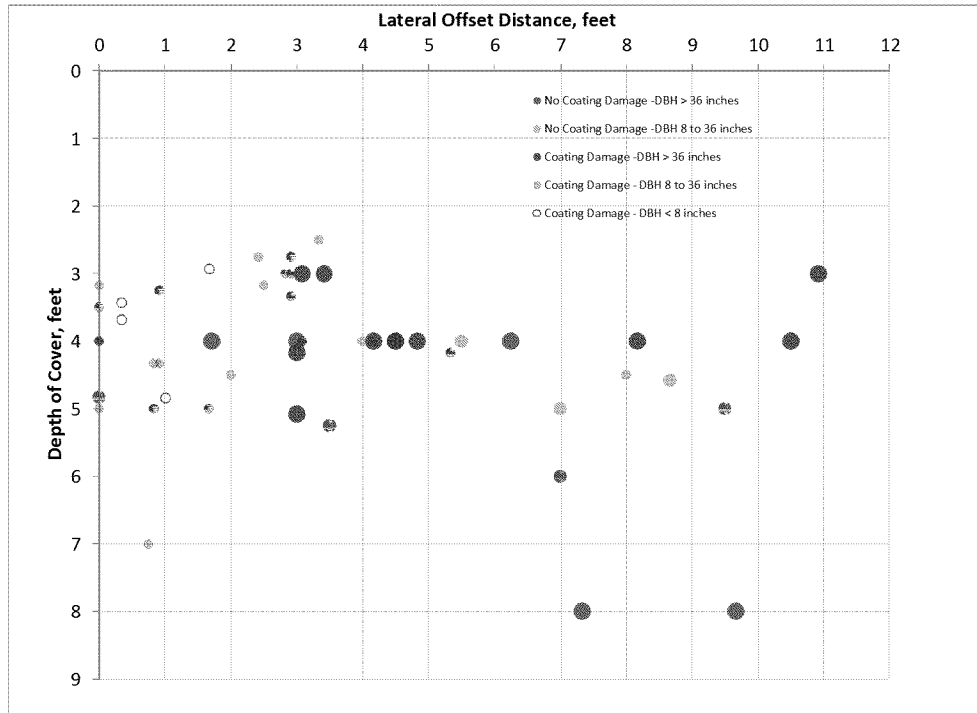
Figure 5. Depth of Cover versus Lateral Offset Distance⁵.

In evaluating the results from the 53 sites, a comparison between the lateral offset distance and depth of cover was produced and is presented in Figure 5. The legend provided in this figure discriminates the data based upon the tree diameter (DBH) and whether or not coating damage was evident.

As is evident from Figure 5, there is no obvious trend from these results. This is likely due to the number of attributes that influence the results. However, it is evident that tree size (DBH), offset distance, and depth of cover may be indicators as to whether or not coating damage has occurred.

⁵ It is worth noting that the two data points (green filled circle) with a depth of cover equal to 8-feet were also tape coated sections of pipe.
