FINAL REPORT
VOLUME I
R-PG&E-20140117

Pacific Gas and Electric Company

Tree Root Interference Assessment

January 17, 2014

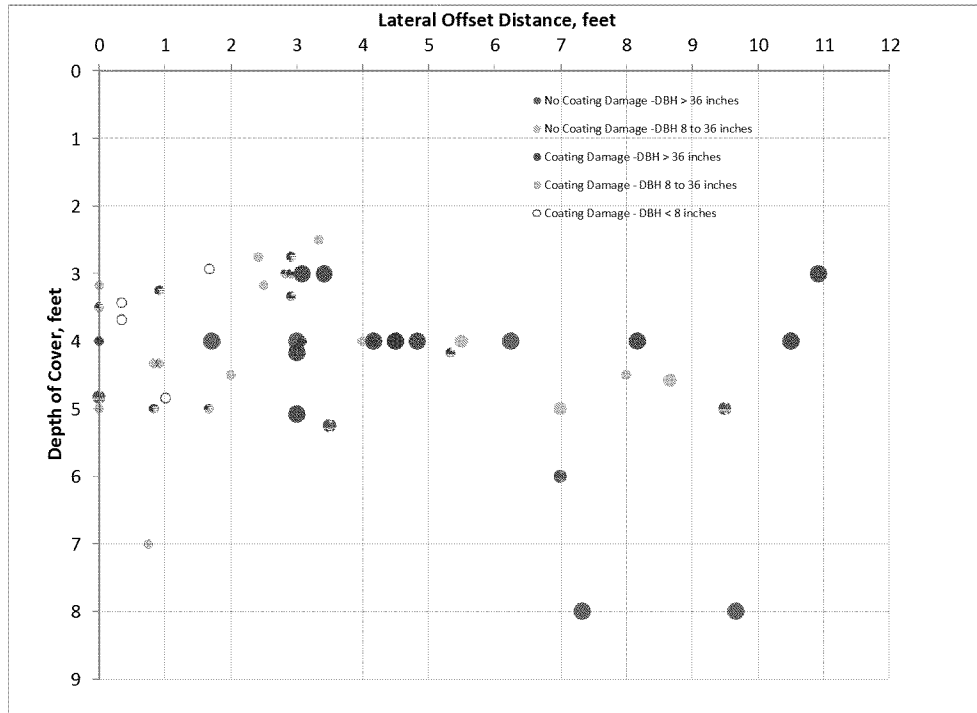
Figure 5. Depth of Cover versus Lateral Offset Distance⁵.

In evaluating the results from the 53 sites, a comparison between the lateral offset distance and depth of cover was produced and is presented in Figure 5. The legend provided in this figure discriminates the data based upon the tree diameter (DBH) and whether or not coating damage was evident.

- Lateral Offset Distance less than 5-feet
 - 35 of 39 sites (90%) exhibited coating damage
- Lateral Offset Distance between 5-feet and 10-feet, and DBH greater than 8-inches
 - 3 of 12 sites (25%) exhibited coating damage
 - Note: None of these sites had a DBH less than 8-inches
- Lateral Offset Distance great than 10-feet, and a DBH greater than 36-inches
 - 2 of 2 sites (100%) exhibited coating damage.

As is evident from Figure 5, there is no obvious trend from these results. This is likely due to the number of attributes that influence the results. However, it is evident that tree size (DBH), offset distance, and depth of cover may be indicators as to whether or not coating damage has occurred.

⁵ It is worth noting that the two data points (green filled circle) with a depth of cover equal to 8-feet were also tape coated sections of pipe.

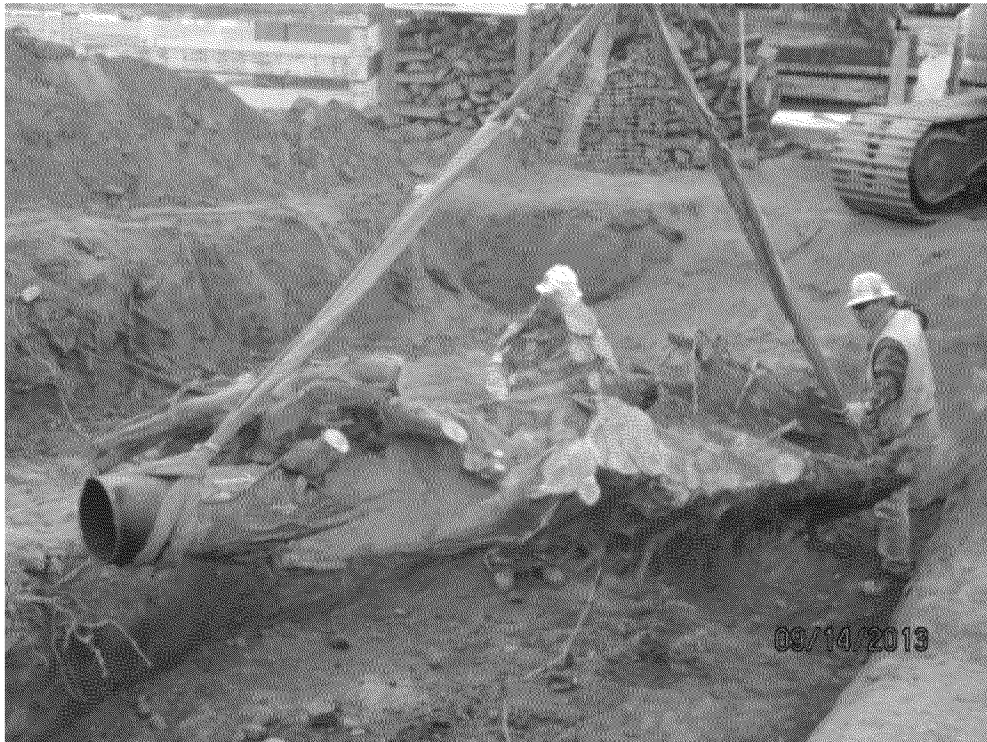
Figure 6. RWVIM-90-13 (Hall Road)

Tree root and pipeline interactive conditions were reviewed relative to the potential for pipeline structural damage. An example of one location where the tree root ball was situated directly on top of the pipe and the tree roots encapsulated the buried pipe is presented in Figure 6 (RWVIM-90-13, Hall Road).

The Hall Road site provides evidence of what can occur when a tree root ball and root system is located in close proximity to a buried pipeline. A primary concern under these conditions is that weather (e. g., high force winds, flooding, seismic events) may cause tree and root movement, resulting in pipe damage. In addition, since the buried pipeline and tree root systems are interconnected, a lightning strike to the tree would most likely also impact the pipeline and provide an electrical path for the strike and may also provide a path for the electrical discharge.
