FINAL REPORT
VOLUME I
R-PG&E-20140117

Pacific Gas and Electric Company

Tree Root Interference Assessment

January 17, 2014

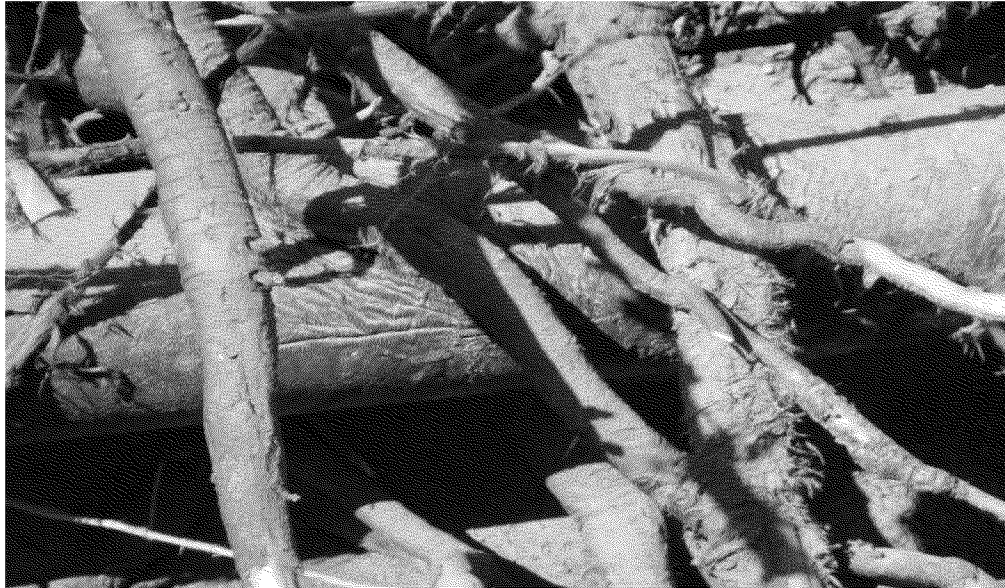
**Figure 3. RWVIM-107-13 (Weber Lane)
(CTE coating damage)**

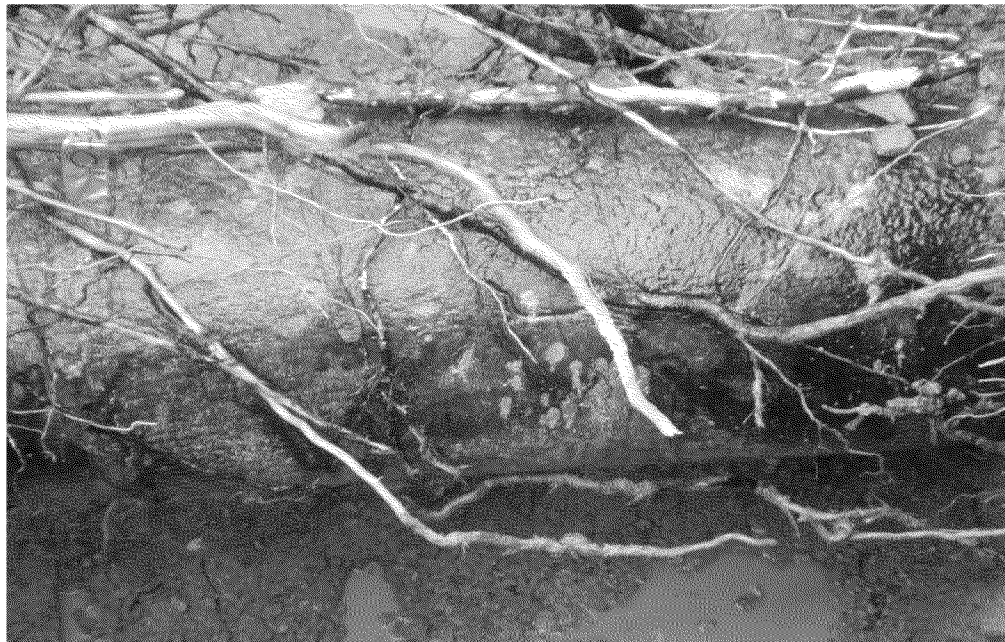
**Figure 4. RWVIM-74-13 (Atascadero)
(Tape coating damage)**
