**FINAL REPORT**  
**VOLUME I**  
R-PG&E-20140117

**Pacific Gas and Electric Company**

**Tree Root Interference Assessment**

**January 17, 2014**

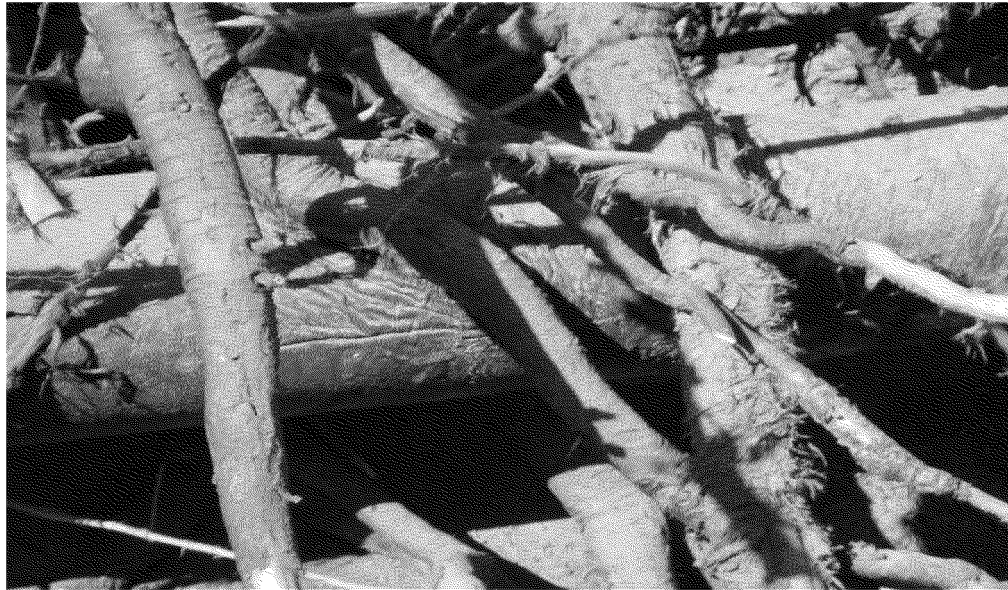
**Figure 3. RWVIM-107-13 (Weber Lane)  
(CTE coating damage)**

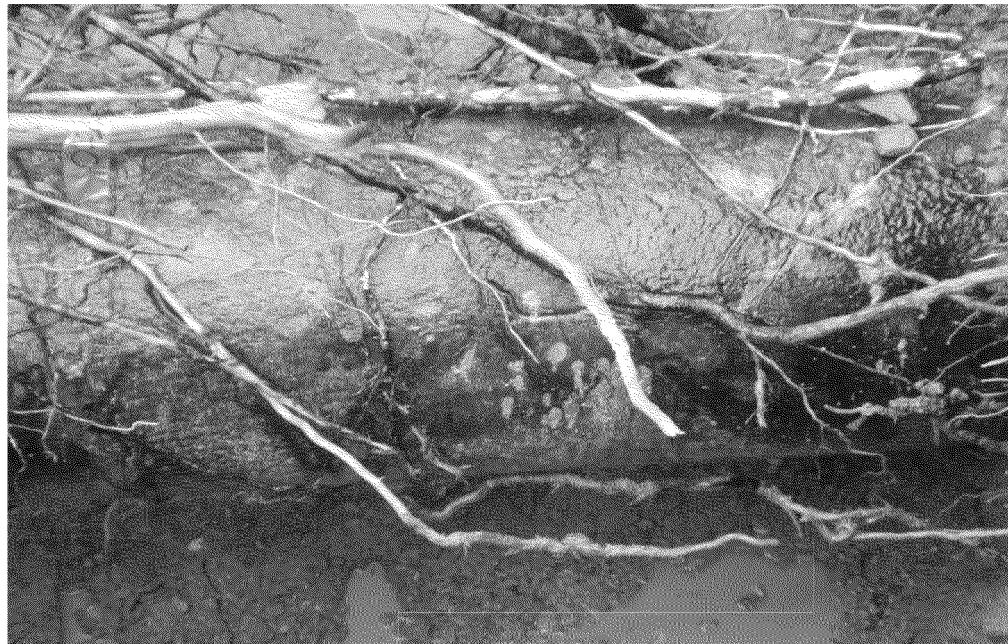
**Figure 4. RWVIM-74-13 (Atascadero)  
(Tape coating damage)**
