# Surge Arrester Grounding

## Briefing for SED

April 22, 2014

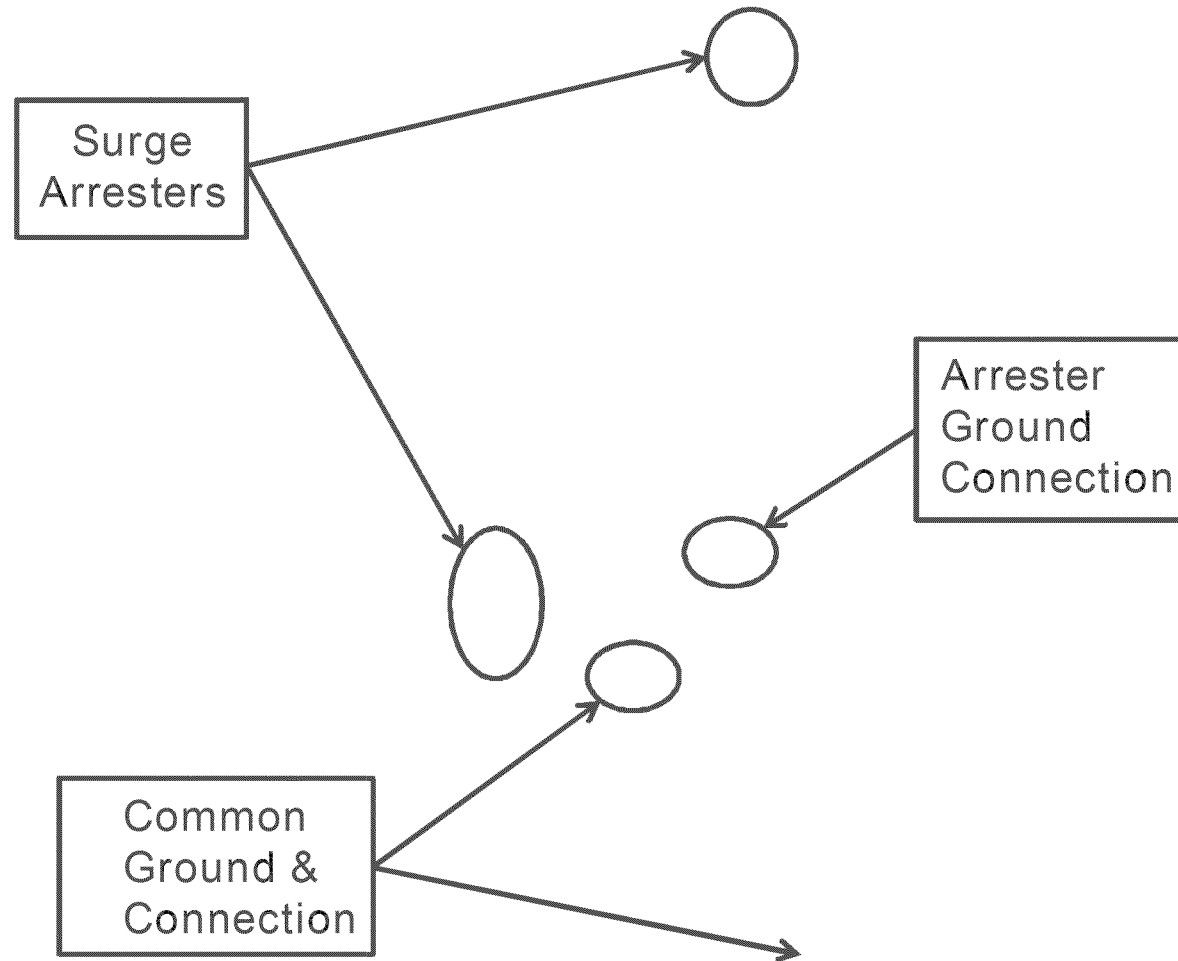
# Common Transformer Neutral Conductor and Surge Arresters Ground

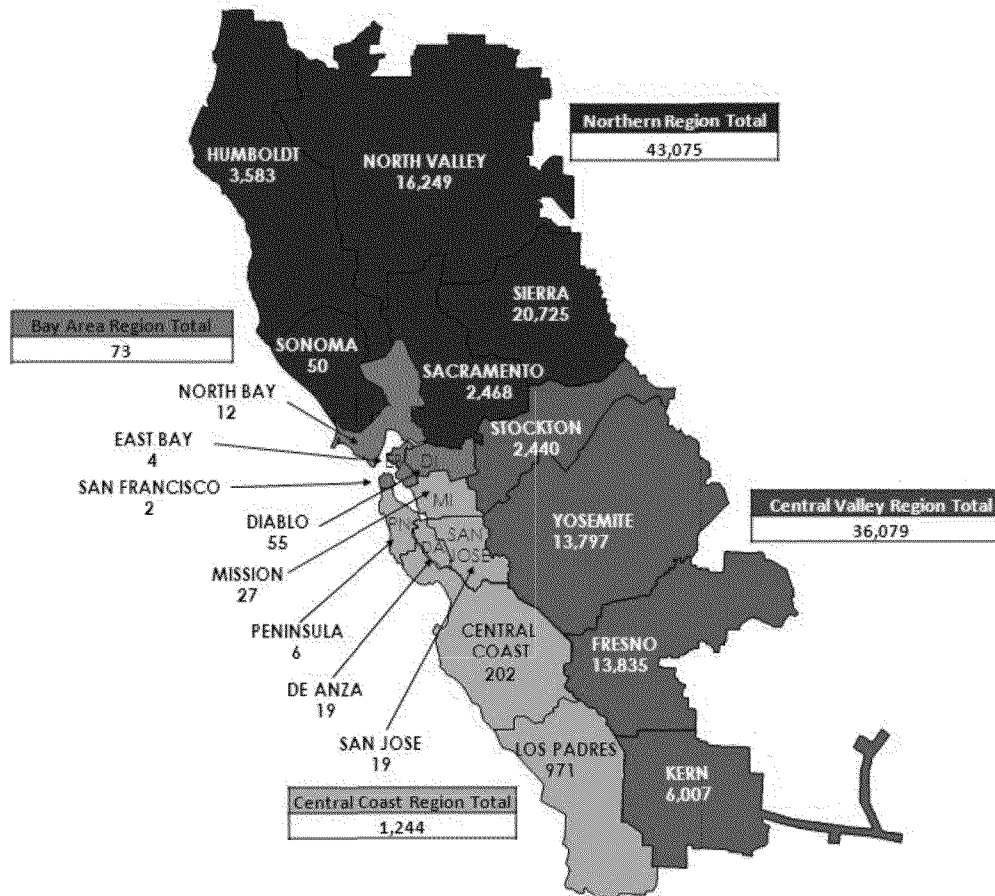
# Transformers with Surge Arresters Installed 1975 - 2008

80,471 transformer locations with surge arrester installed in 1975 – 2008 were identified in the Centralized Electric Distribution System Assets (CEDSA) data base.
