# Threats Posed by Trees on ROW

For CPUC  
By Transmission Asset Integrity Management

April 23, 2014

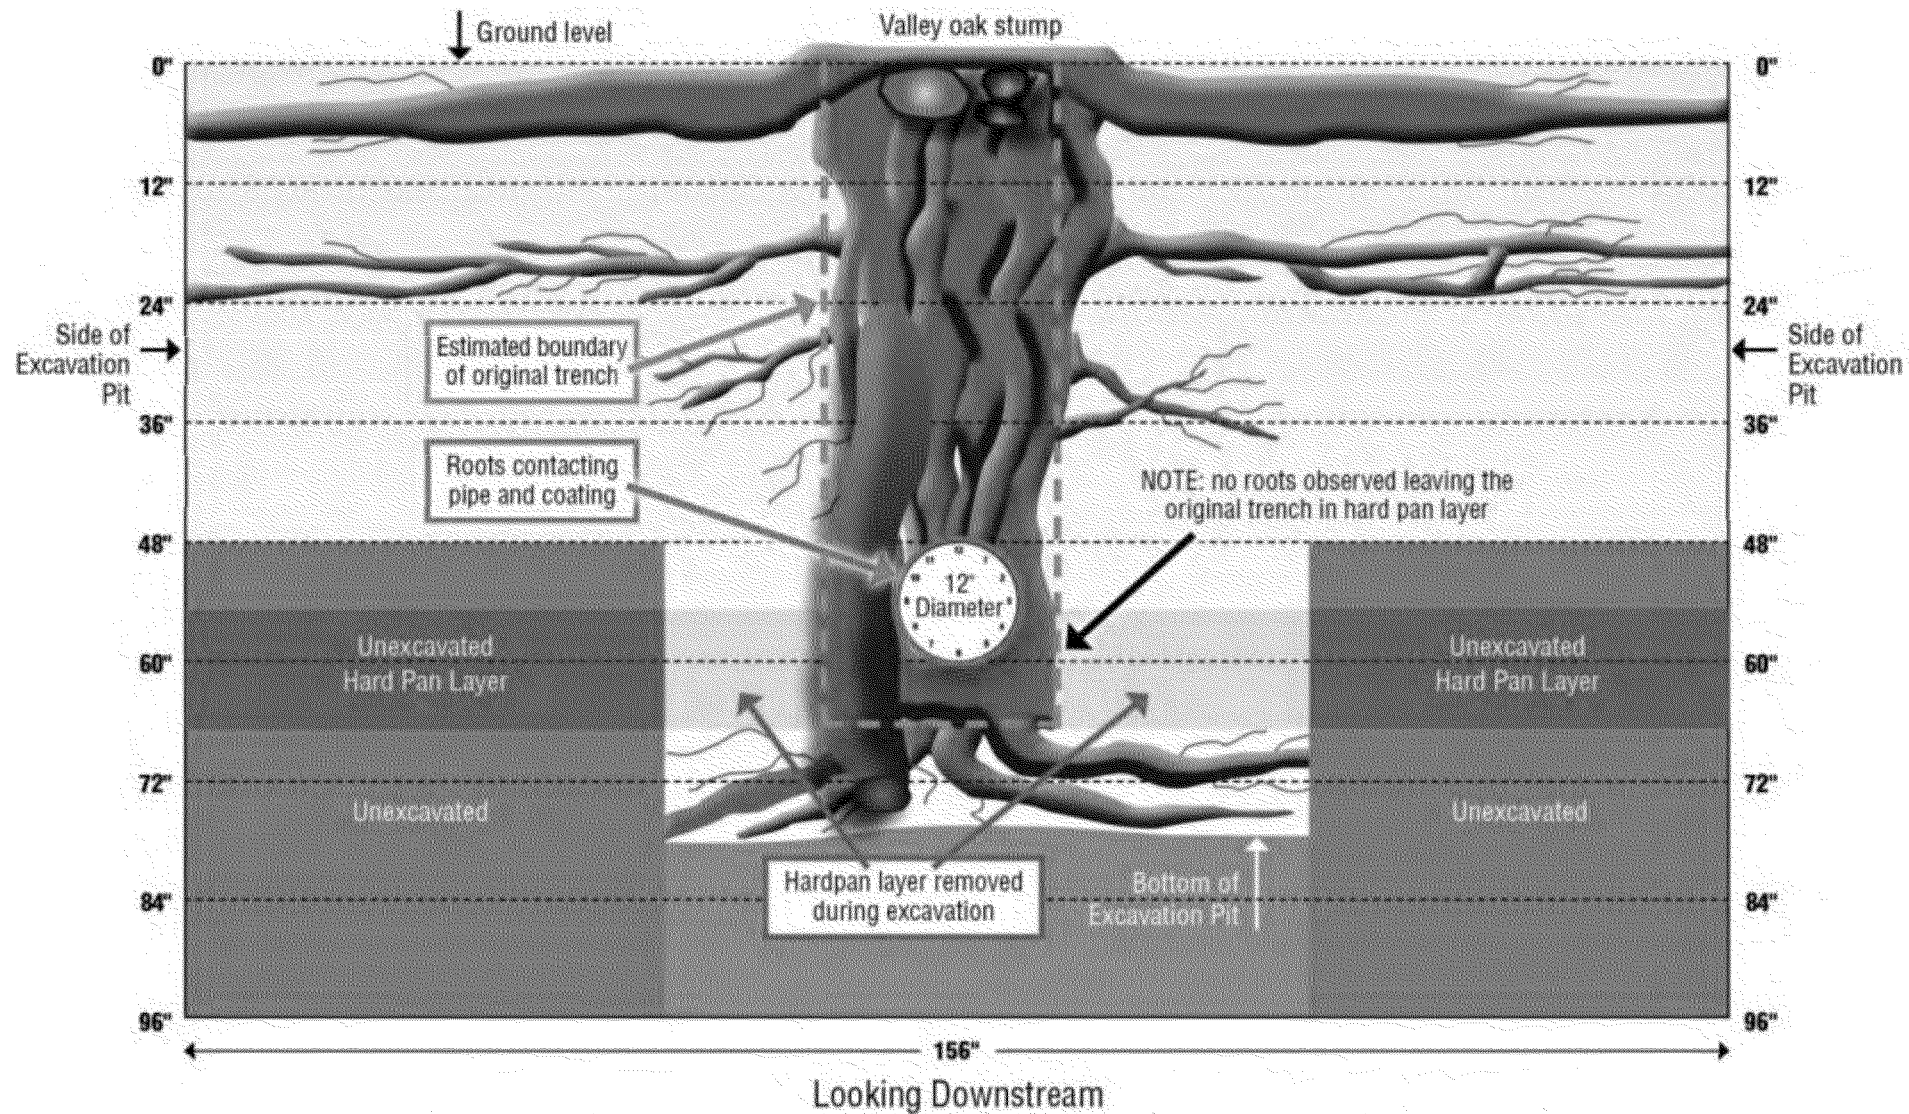
Excavation was accomplished by destructive methods using a trackhoe excavator. The integrity of the root system could not be maintained as the excavation proceeded, therefore, this graphic is strictly the root inspector and graphic artist's best estimate of the actual root architecture that existed underground.

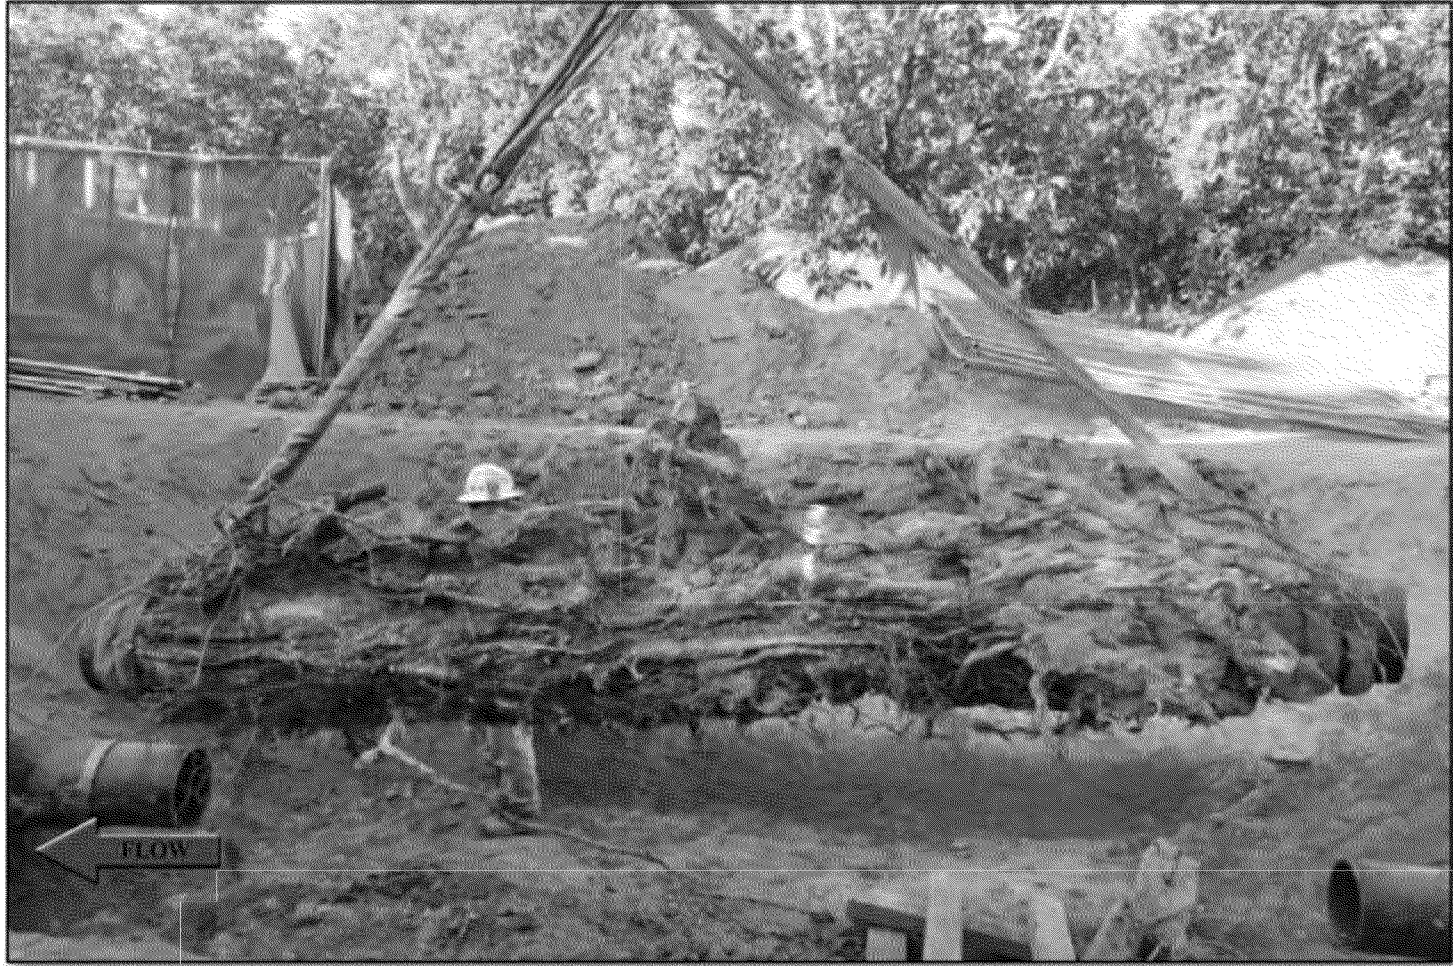
A 15-foot section of pipe with roots intact was extracted from the construction site.

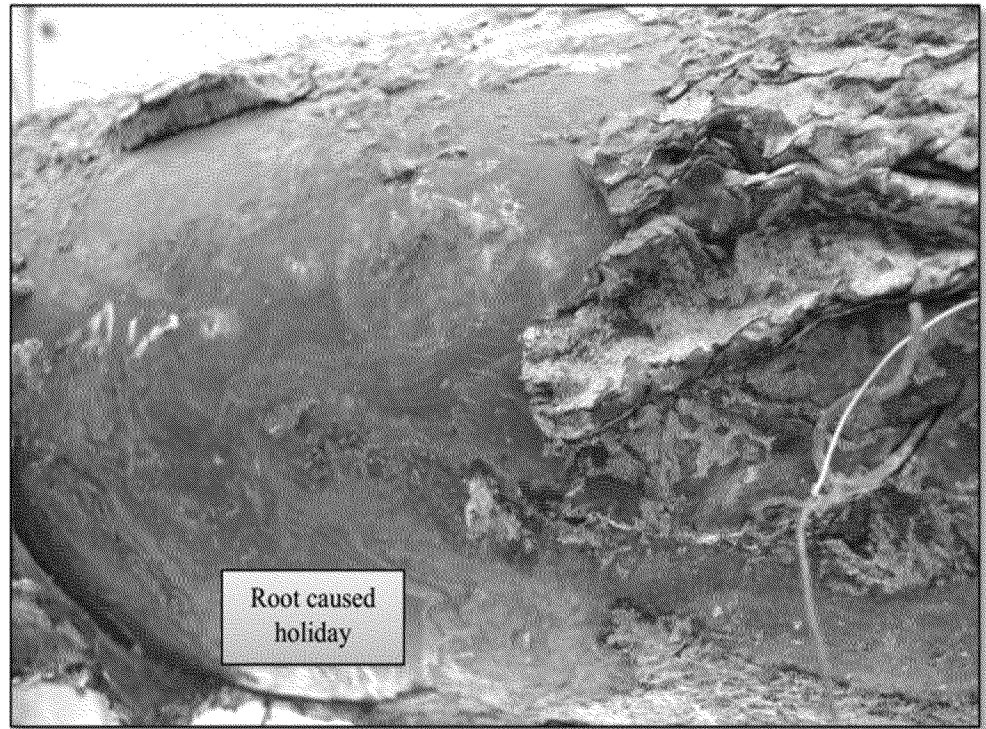
## ➤ Coating damage present due to root interference

- 25% of the surface area of the coating was damaged by root impact
- “Coating impressions” from a single root caused an identifiable groove or impression in the coating
- Approximately one half of the pipe section was affected by root contact

One of many large root-caused holidays.

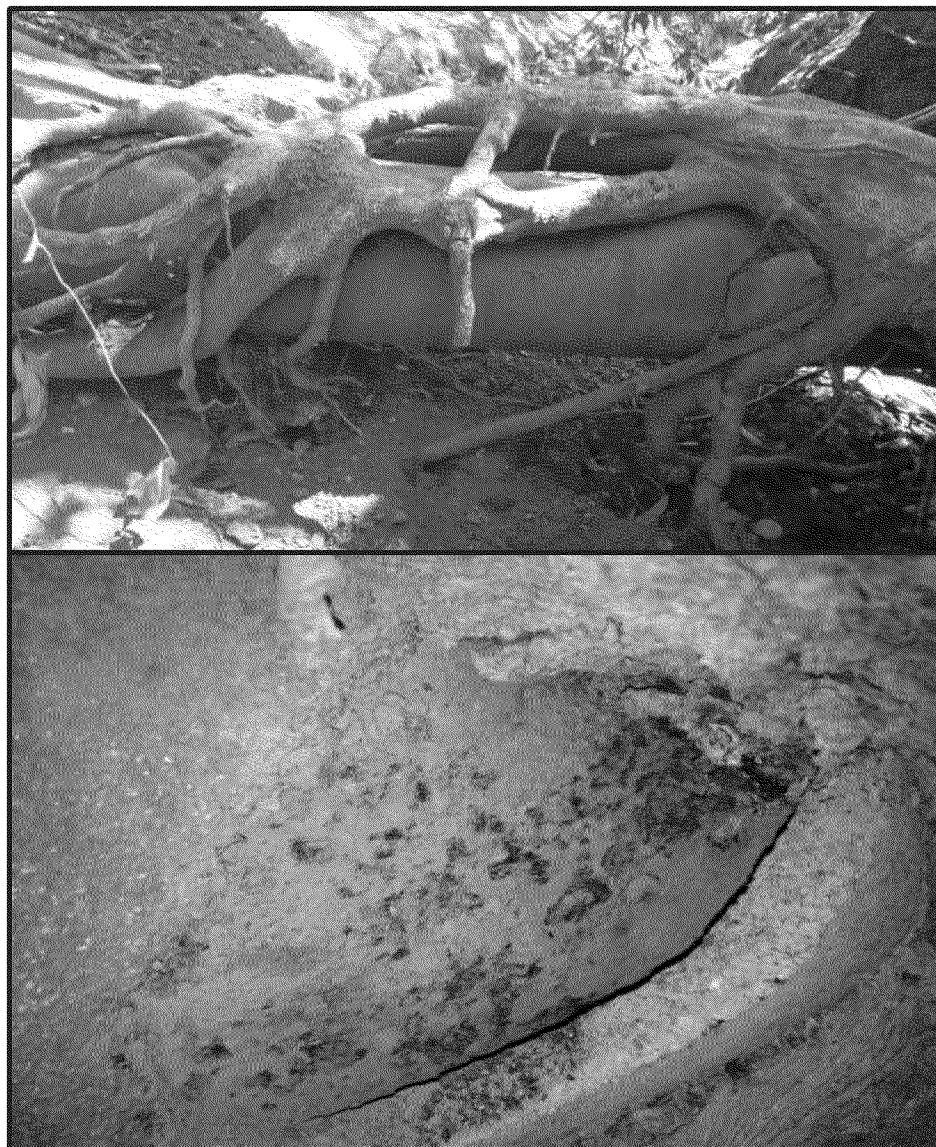
- **Coating damage was observed in 75% of excavated sites**
- **Corrosion observed in 38% of the excavated sites**
- **Extent of damage varies by coating type and other local conditions; unclear whether any difference by tree type.**

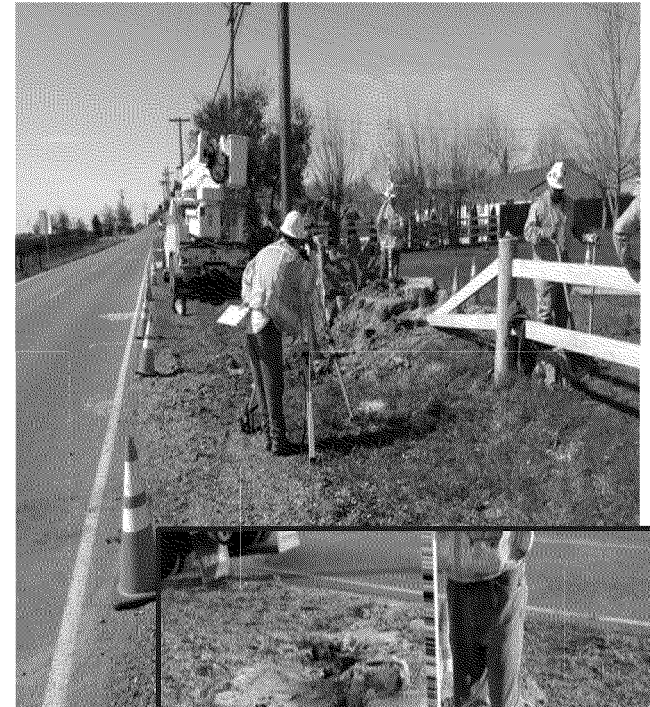
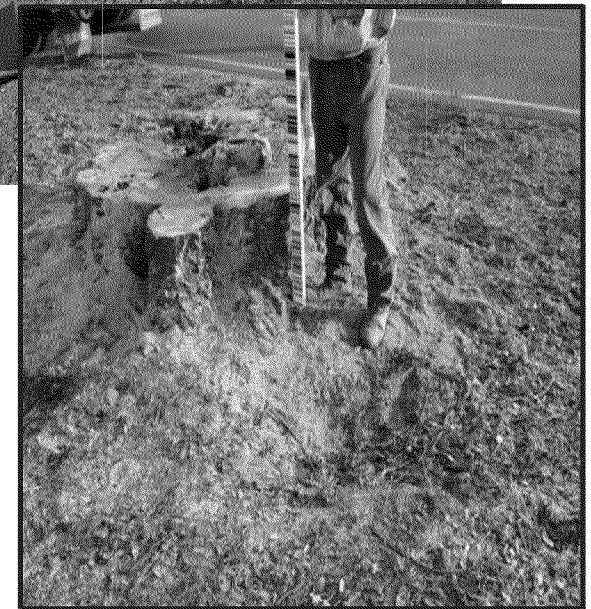
- **Minimal vertical displacement measured**
