Carmel Gas Incident

Sumeet Singh
Pacific Gas and Electric Company
6111 Bollinger Canyon Road
San Ramon, CA 94583

Doc. no. 1401752.000 - 6877

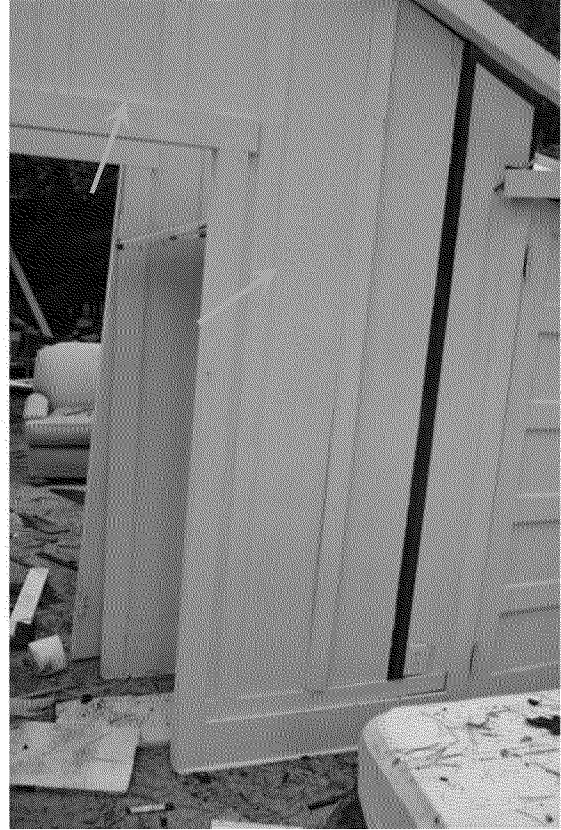
Figure 11. Interior walls and furniture. An unburned couch in the living room is visible in the background and the corner of an unburned mattress is visible in the foreground. Yellow arrows indicate some areas of wall blistering. Photograph by Exponent on March 6, 2014.

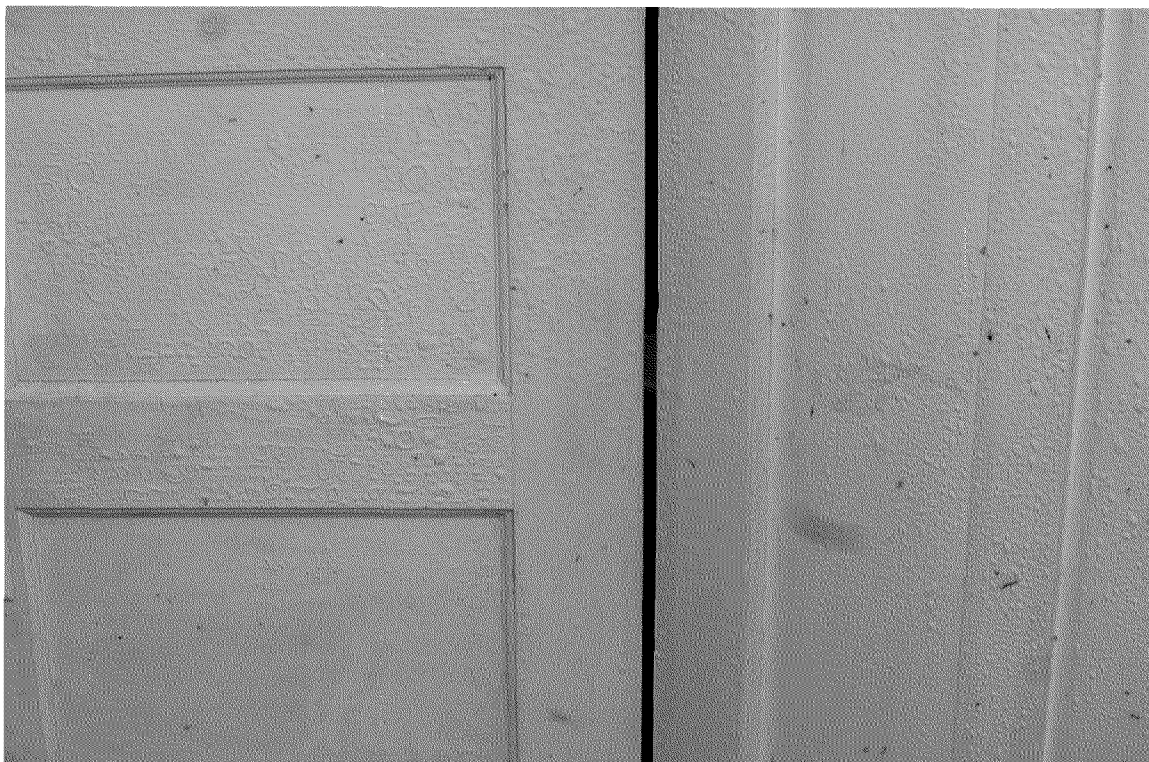
Figure 12. Close-up of the paint blistering on bedroom wall and door. Photograph by Exponent on March 7, 2014.

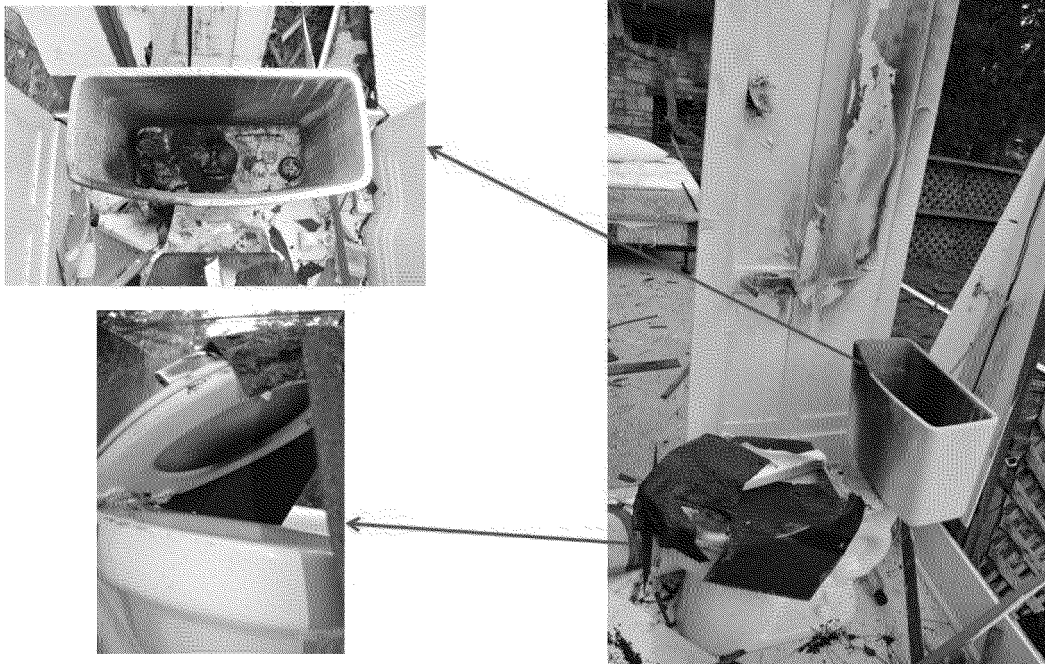
Figure 15. Damage to bathroom toilet. Burn marks below toilet seat and melted components inside toilet tank. Photographs by Exponent on March 6, 2014.

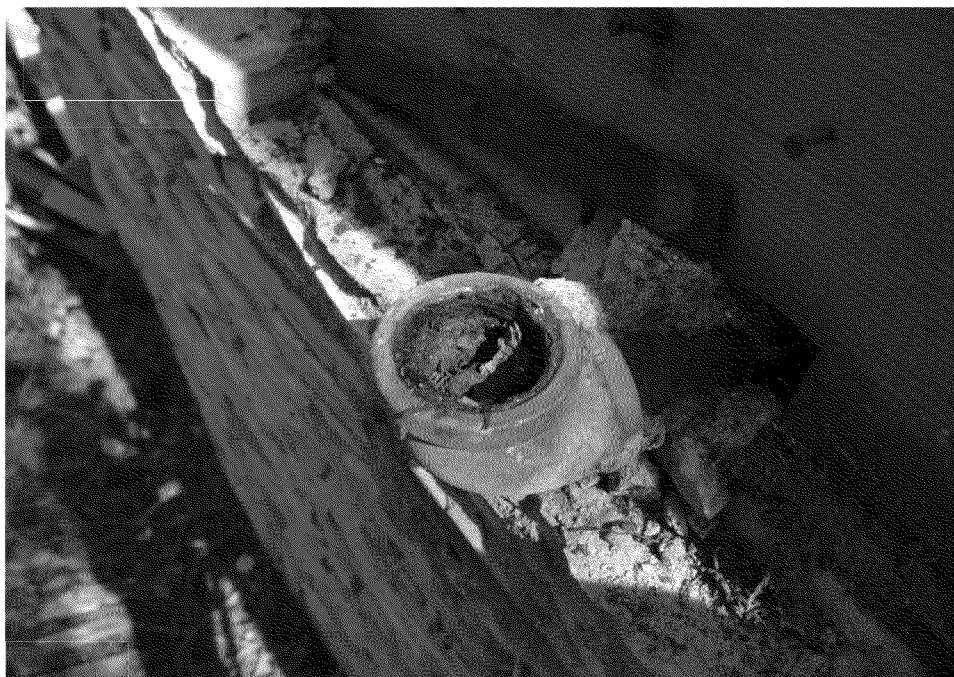
Figure 19. Vent pipe (broken off) in the bathroom. Vent pipe likely broken off during the explosion. Photograph by Exponent on March 7, 2014.

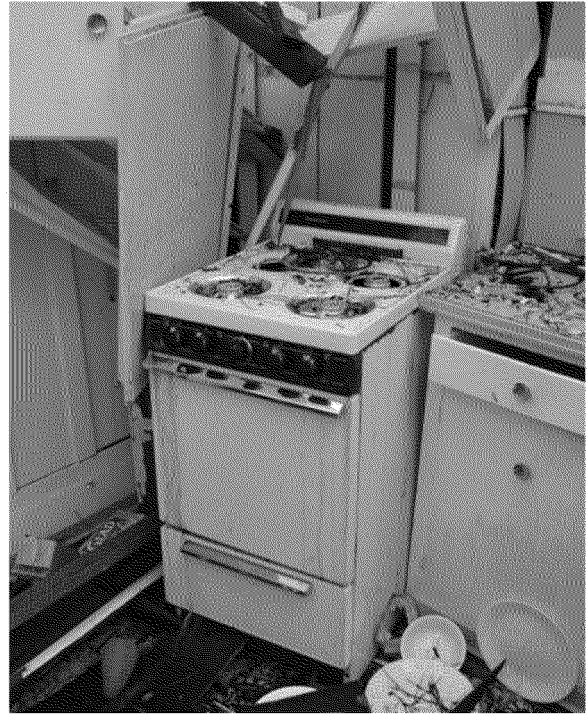
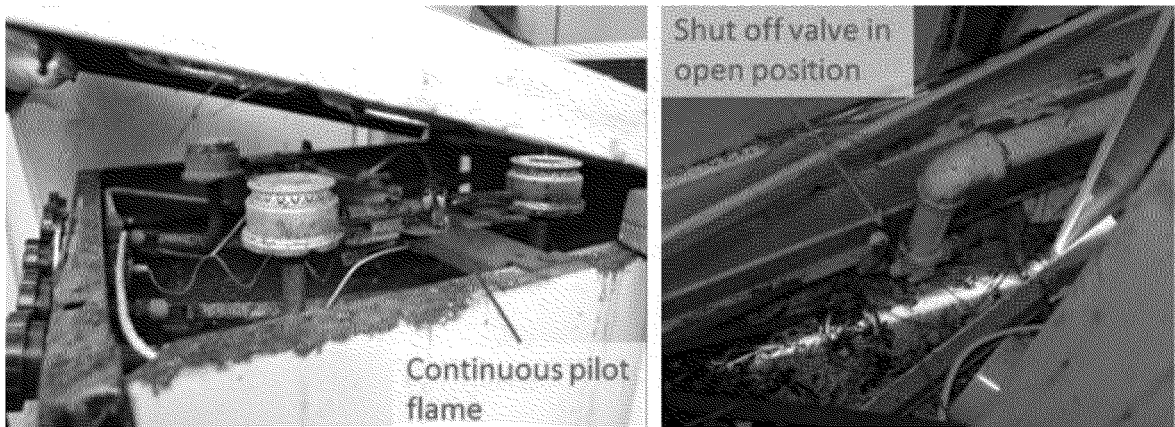
Stove: A kitchen stove was present in the subject house. The location of the stove is shown in Figure 20. The appliance shut-off valve for the stove was found in the open position and the stove was equipped with a continuous pilot flame (Figure 21). Based on these facts, the stove cannot be ruled out as a likely ignition source for the incident explosion.

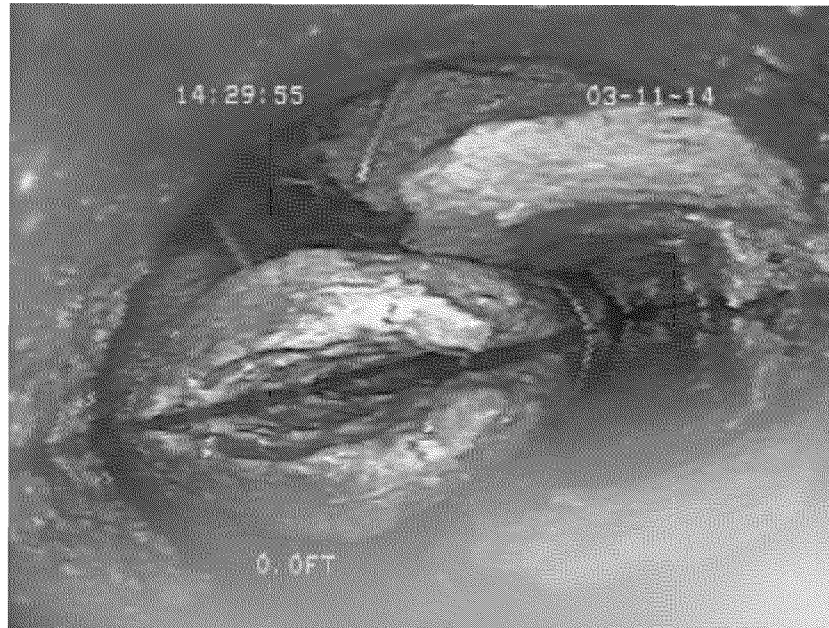
The sewer main south of the manhole along [Redacted] consisted of an unlined clay pipe, with an approximate diameter of 8 inches. A collapse was observed approximately 1½ to 2 feet

Figure 37. Collapse of sewer main along Redacted south of manhole. Standing water at bottom. Source: FES.

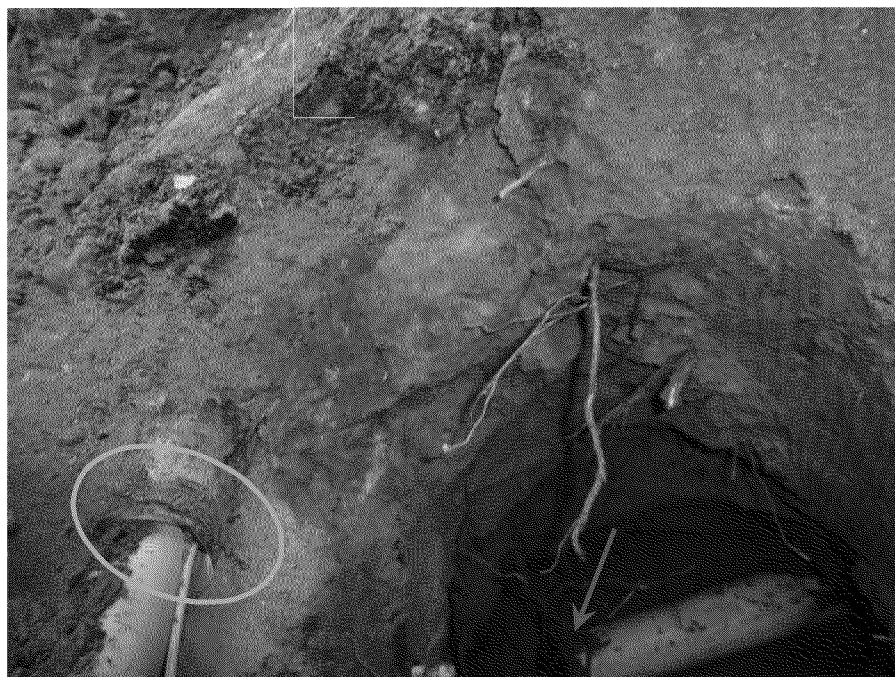
Flow through annular space: The released natural gas traveled through the annular space between the inserted plastic pipe and the steel pipe in both directions (east and west) along [Redacted] [Redacted], away from the plastic pipe leak. Upon reaching the end of the 2-inch steel pipe, the gas exited the annular space and flowed into the soil.

Figure 47. End of annular space in gas main along Redacted (yellow oval) in vicinity of sewer lateral offset joint (green arrow). Photograph by Exponent on March 21, 2014.
