# Threats Posed by Trees on ROW

For CPUC  
By Transmission Asset Integrity Management

April 23, 2014

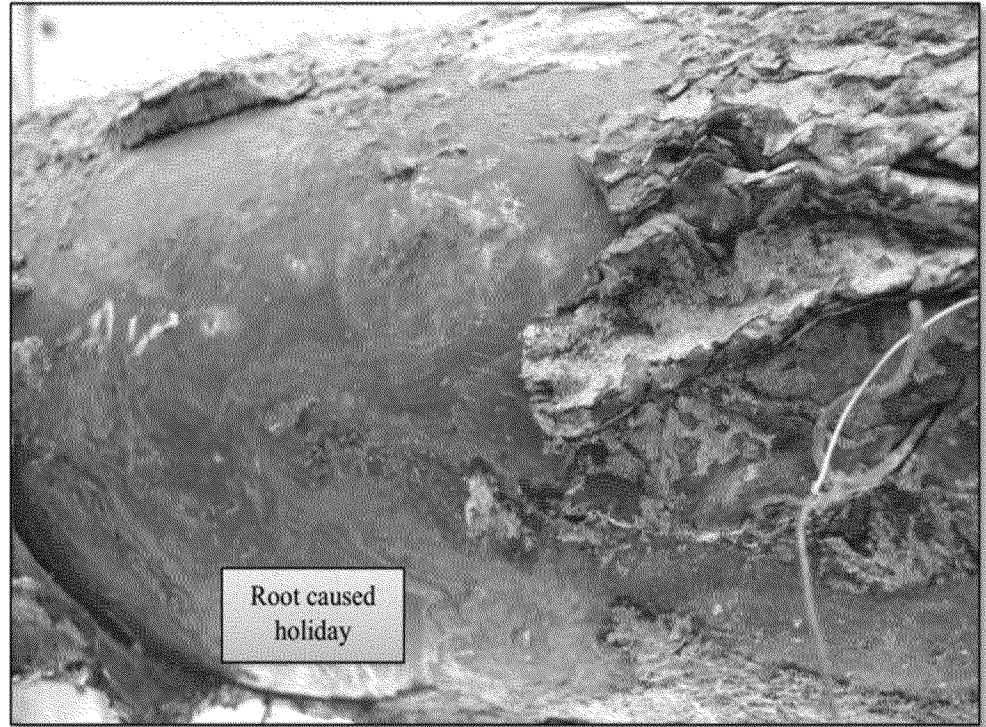
## ➤ Coating damage present due to root interference

- 25% of the surface area of the coating was damaged by root impact
- “Coating impressions” from a single root caused an identifiable groove or impression in the coating
- Approximately one half of the pipe section was affected by root contact

One of many large root-caused holidays.

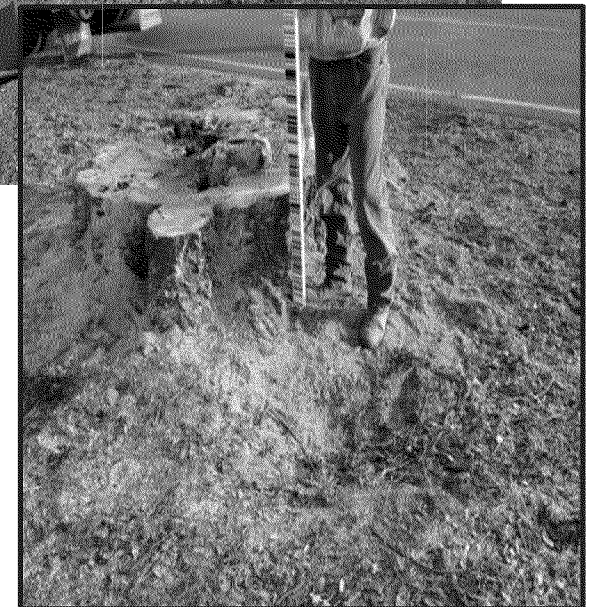
- **Minimal vertical displacement measured**
