Carmel Gas Incident

Doc. no. 1401752.000 - 6877

Pacific Gas and Electric (PG&E) has retained Exponent Failure Analysis Associates (Exponent) to conduct a failure analysis investigation of a gas leak and subsequent explosion on March 3, 2014 in Carmel-by-the-Sea (Carmel), California.

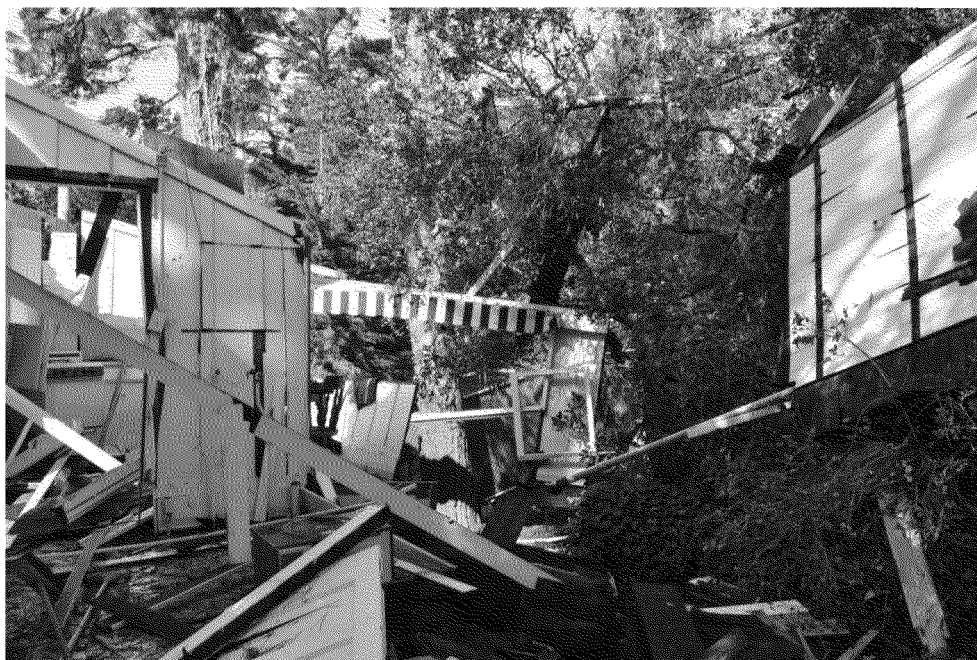
Figure 10. Incident house looking West into the laundry room. Roof section on right side of picture. Photograph by Exponent on March 4, 2014.

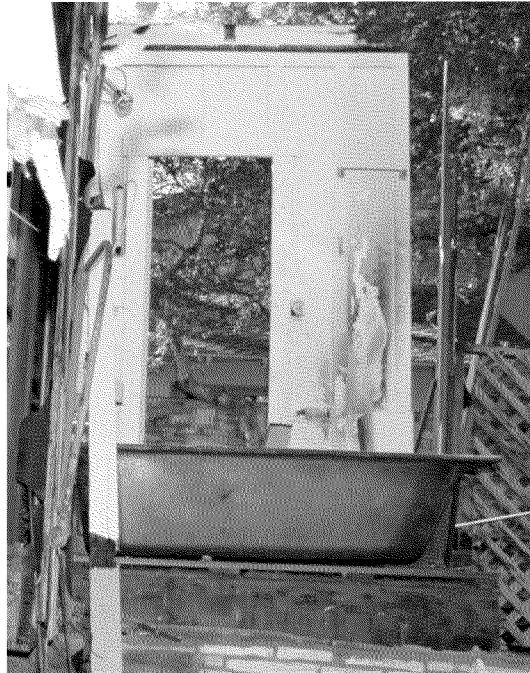
Figure 13. Fire pattern on bathroom wall, looking South from [Redacted] Photograph by Exponent on March 7, 2014.

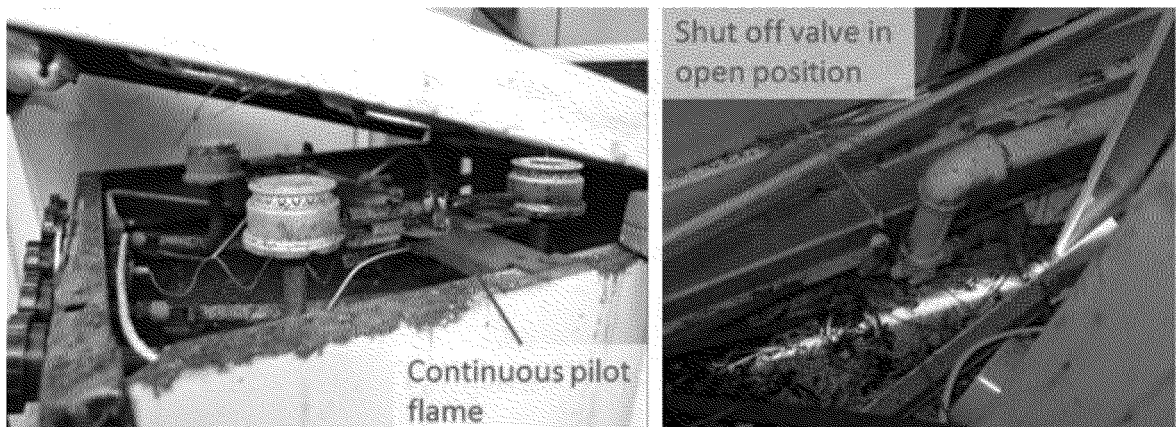
Figure 20. Location of kitchen stove. Photograph by Exponent on March 6, 2014.

Stove: A kitchen stove was present in the subject house. The location of the stove is shown in Figure 20. The appliance shut-off valve for the stove was found in the open position and the stove was equipped with a continuous pilot flame (Figure 21). Based on these facts, the stove cannot be ruled out as a likely ignition source for the incident explosion.

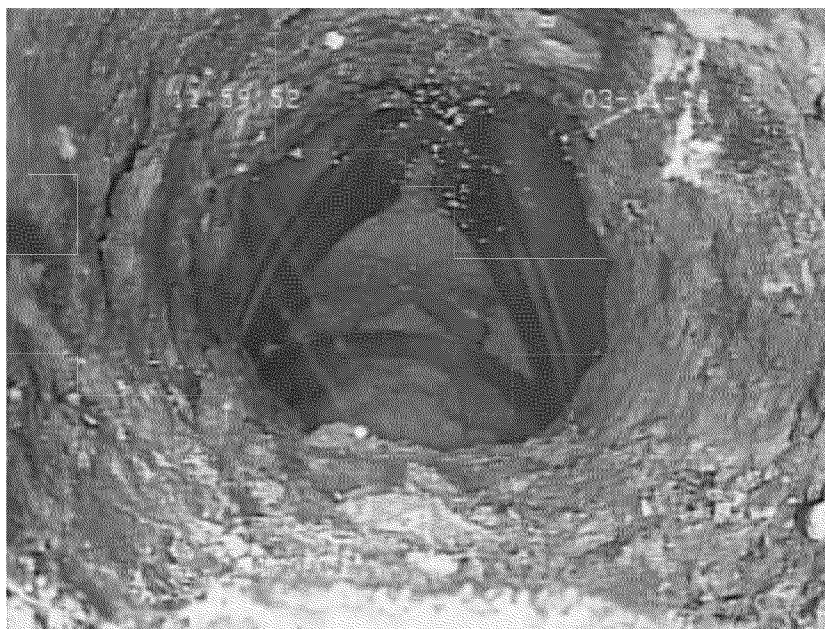
Gaps around the sewer lateral (at the break tap) and the sewer main were observed. The lateral was an approximately 4-inch cast iron pipe for the subject residence. As shown in Figure 36, the sewer lateral had debris accumulated around its interior perimeter and showed clear evidence of lack of recent use, including presence of spider webs, dryness and deterioration.

Figure 36. Sewer lateral conditions approximately 5 feet from tap with sewer main. Deterioration, spider webs and debris in cast iron pipe in area closest to camera. Separation and dislocation of lateral away from camera. Source: FES.

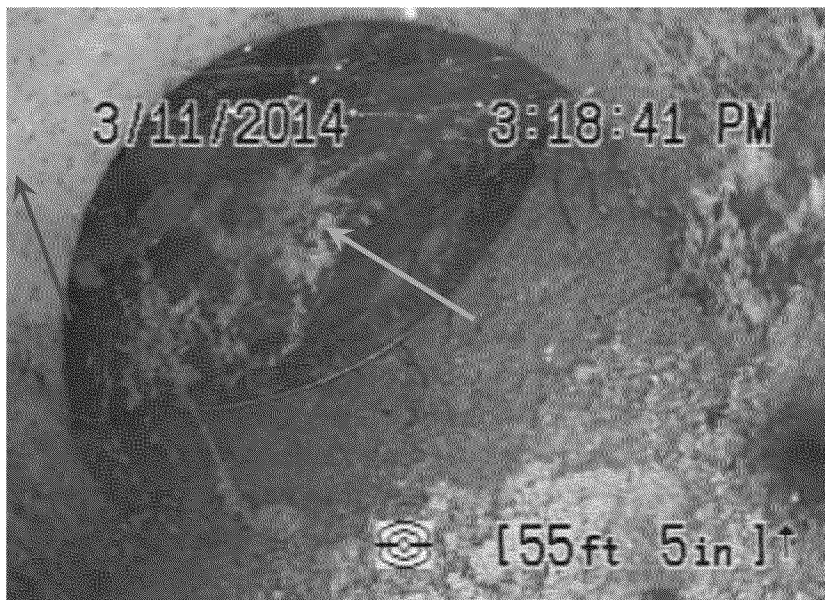
Figure 43. Sewer lateral joint offset at connection between white plastic pipe segment (green arrow) and apparent cast iron pipe (yellow arrow). Source: FES.

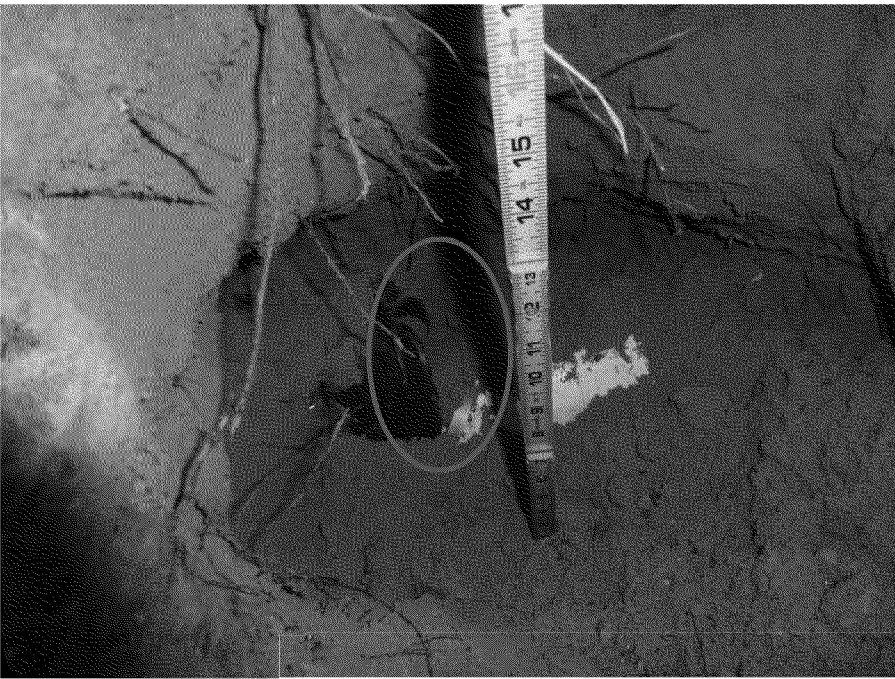
Figure 46. Sewer lateral offset joint (green oval), and white plastic segment of sewer lateral. Sand backfill surrounding sewer lateral. Photograph by Exponent on March 21, 2014.

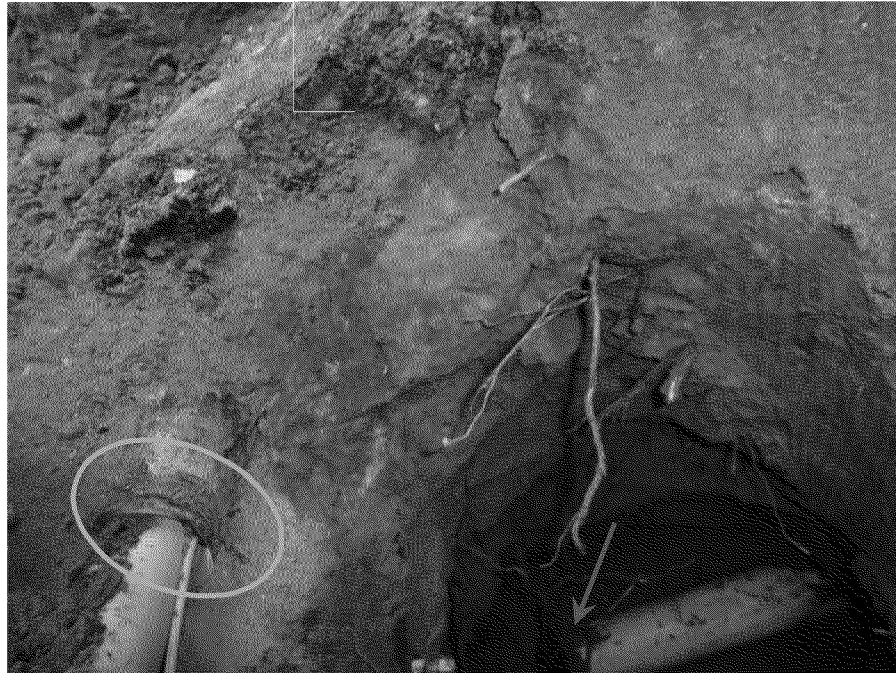
Figure 47. End of annular space in gas main along Redacted (yellow oval) in vicinity of sewer lateral offset joint (green arrow). Photograph by Exponent on March 21, 2014.
