**Carmel Gas Incident**

Prepared for

Sumeet Singh  
Pacific Gas and Electric Company  
6111 Bollinger Canyon Road  
San Ramon, CA 94583

Doc. no. 1401752.000 - 6877

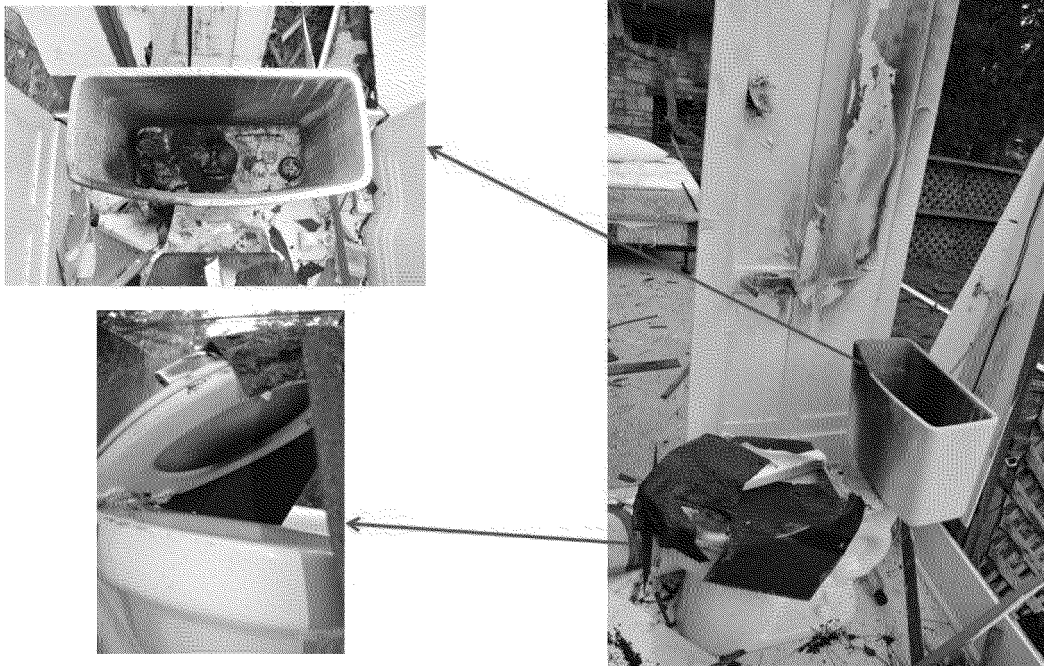
Figure 15. Damage to bathroom toilet. Burn marks below toilet seat and melted components inside toilet tank. Photographs by Exponent on March 6, 2014.

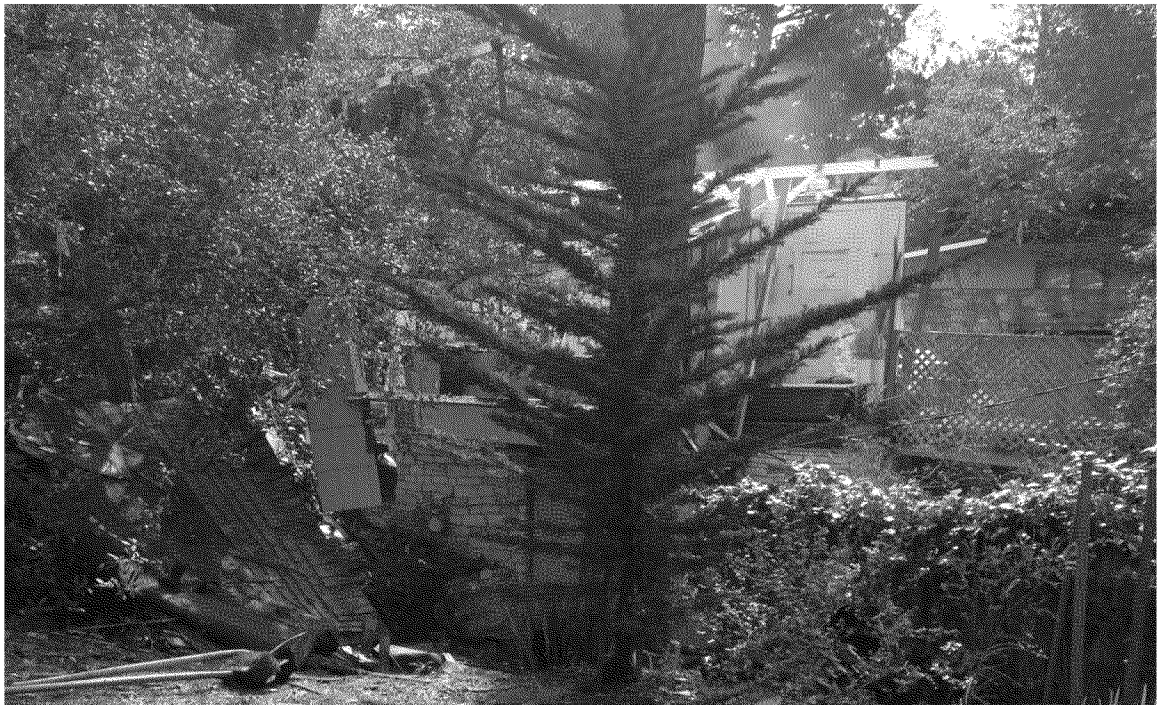
Figure 16. Photograph taken shortly after the explosion showing flames over bathroom toilet. Photograph provided to Exponent by PG&E.

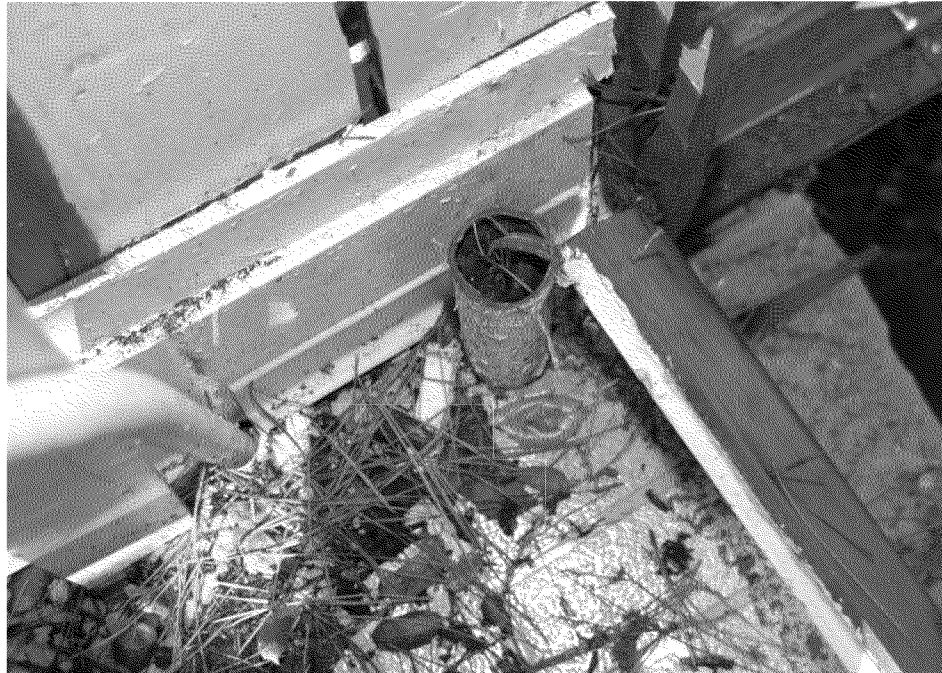
Figure 18. Sewer vent pipe (broken off) in the laundry room. Vent pipe likely broken off during the explosion. Photograph by Exponent on March 7, 2014.

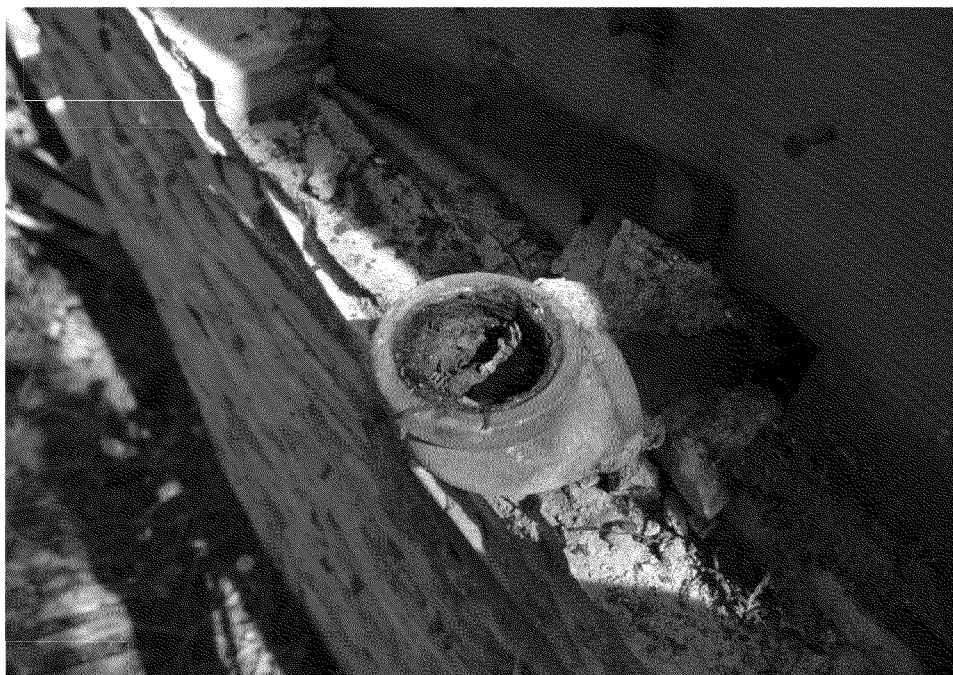
Figure 19. Vent pipe (broken off) in the bathroom. Vent pipe likely broken off during the explosion. Photograph by Exponent on March 7, 2014.

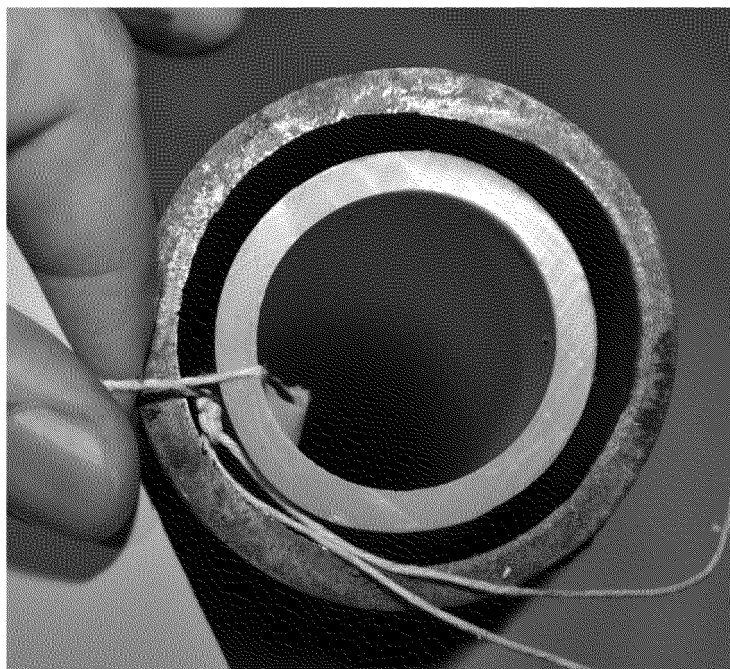
*Flow through annular space:* The released natural gas traveled through the annular space between the inserted plastic pipe and the steel pipe in both directions (east and west) along 3<sup>rd</sup> Avenue, away from the plastic pipe leak. Upon reaching the end of the 2-inch steel pipe, the gas exited the annular space and flowed into the soil.

Figure 28. Plastic gas line inserted into steel line. Photograph by Exponent on March 10, 2014.

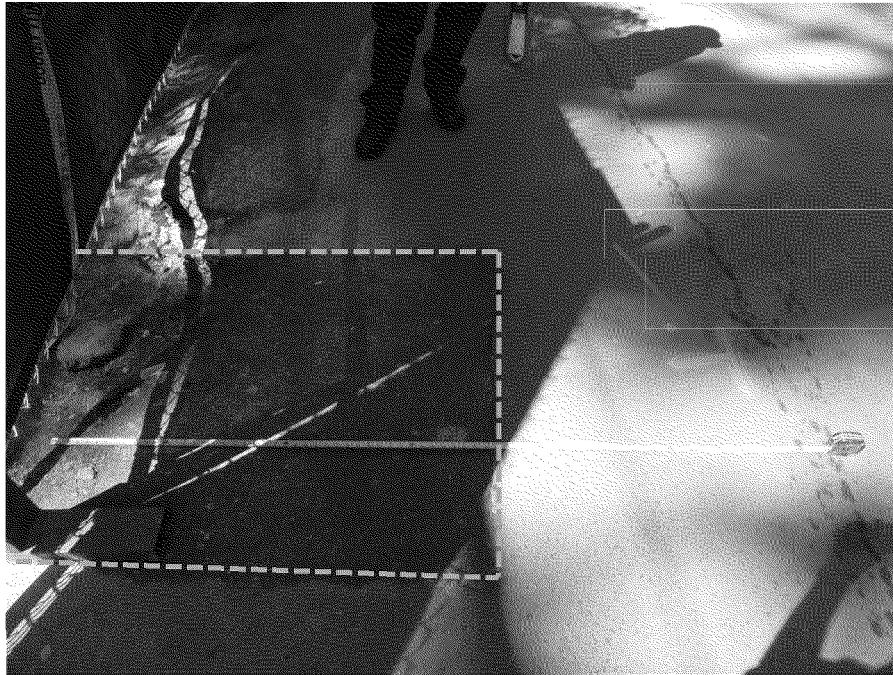
Along [Redacted] a sewer lateral break tap<sup>2</sup> at the sewer main was observed. The sewer main and sewer lateral are in close proximity to the gas service tee.

by PG&E for the gas service line. As shown in this figure, the sewer line is in close proximity to the gas service tee.

Figure 35. Relative location of cold asphalt patch for gas service tee (dashed yellow lines) and sewer lateral tap connection to sewer main (green arrow) for subject residence. Residence is to the left in photograph. Photograph by Exponent on March 11, 2014.

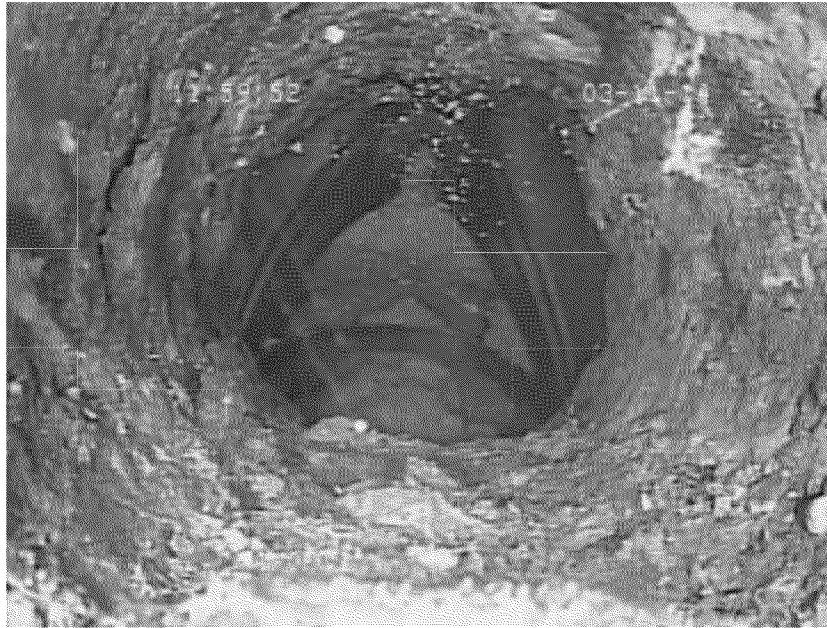
Gaps around the sewer lateral (at the break tap) and the sewer main were observed. The lateral was an approximately 4-inch cast iron pipe for the subject residence. As shown in Figure 36, the sewer lateral had debris accumulated around its interior perimeter and showed clear evidence of lack of recent use, including presence of spider webs, dryness and deterioration.

Figure 36. Sewer lateral conditions approximately 5 feet from tap with sewer main. Deterioration, spider webs and debris in cast iron pipe in area closest to camera. Separation and dislocation of lateral away from camera. Source: FES.

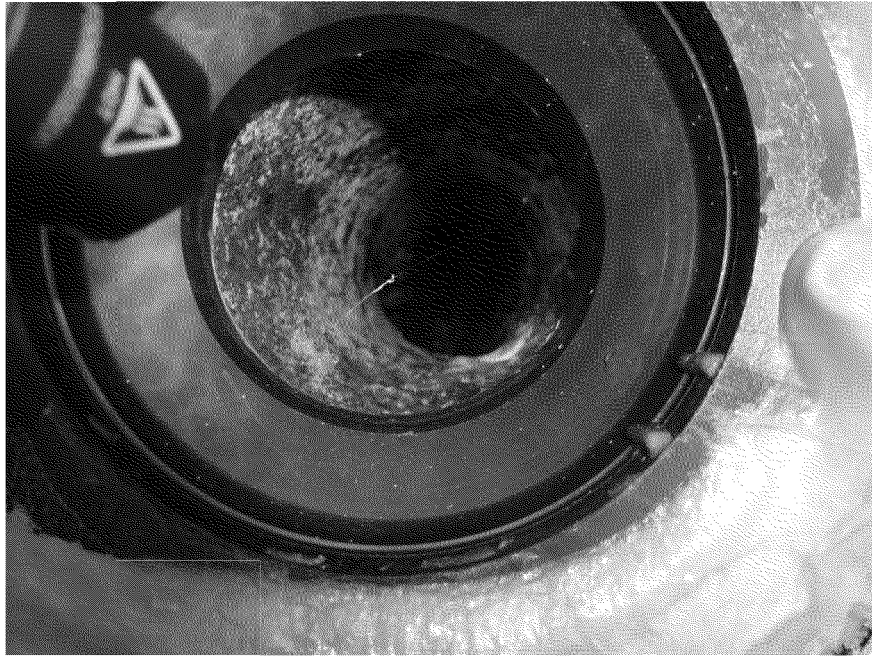
Figure 40. Sewer pipe riser below toilet. Cast iron pipe is dry, spider webs are visible. Photograph by Exponent on March 11, 2014.

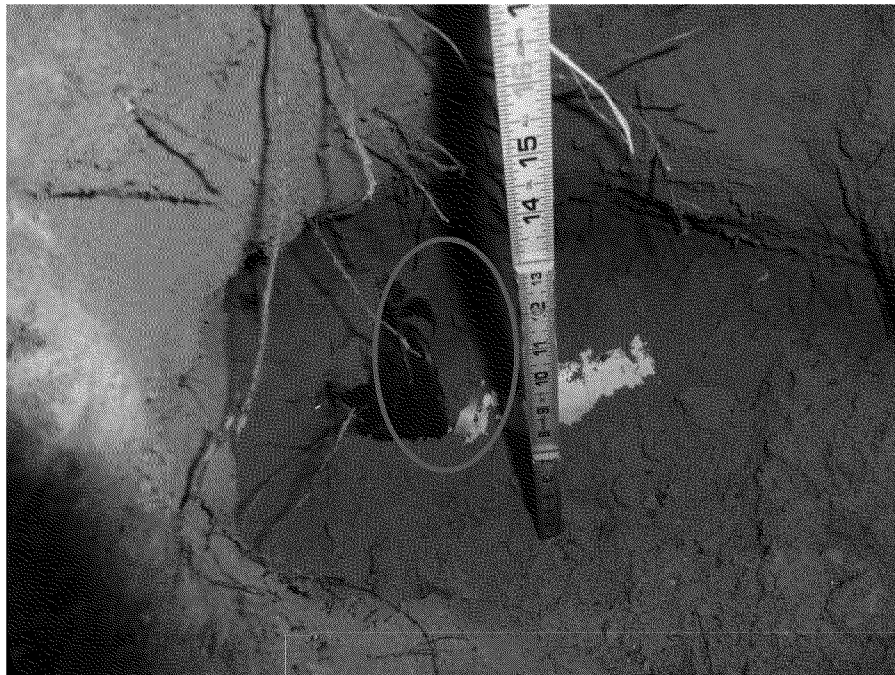
Figure 46. Sewer lateral offset joint (green oval), and white plastic segment of sewer lateral. Sand backfill surrounding sewer lateral. Photograph by Exponent on March 21, 2014.

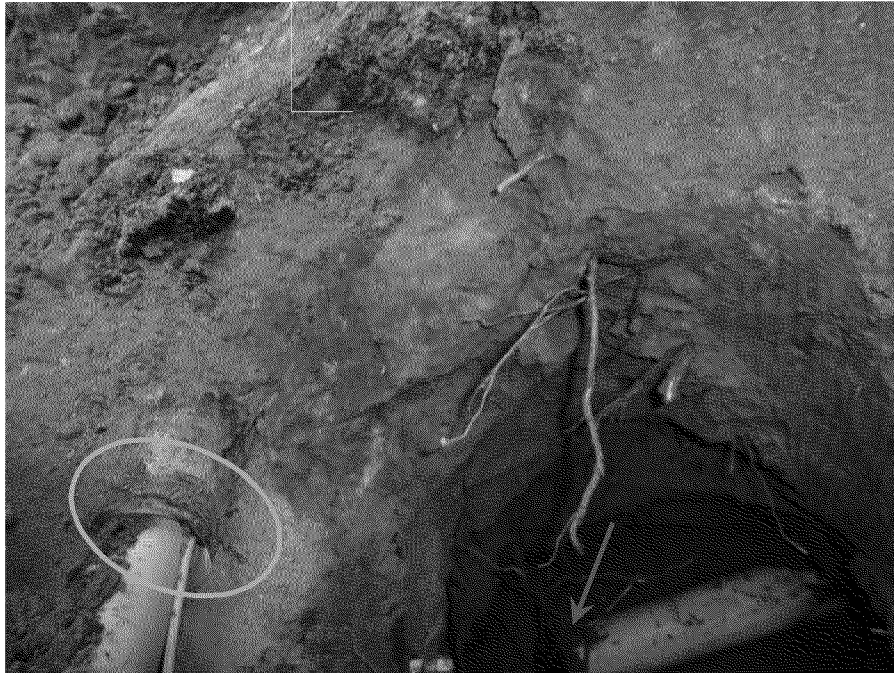
Figure 47. End of annular space in gas main along 3<sup>rd</sup> Avenue (yellow oval) in vicinity of sewer lateral offset joint (green arrow). Photograph by Exponent on March 21, 2014.

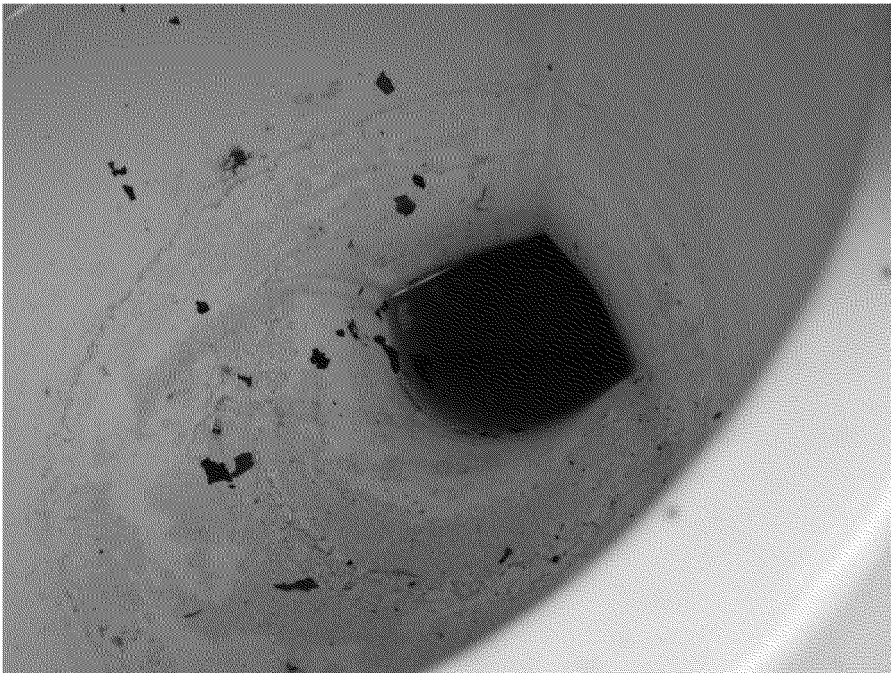
Figure 50. Low water level in the bathroom toilet bowl three days after explosion. Photograph by Exponent on March 6, 2014.

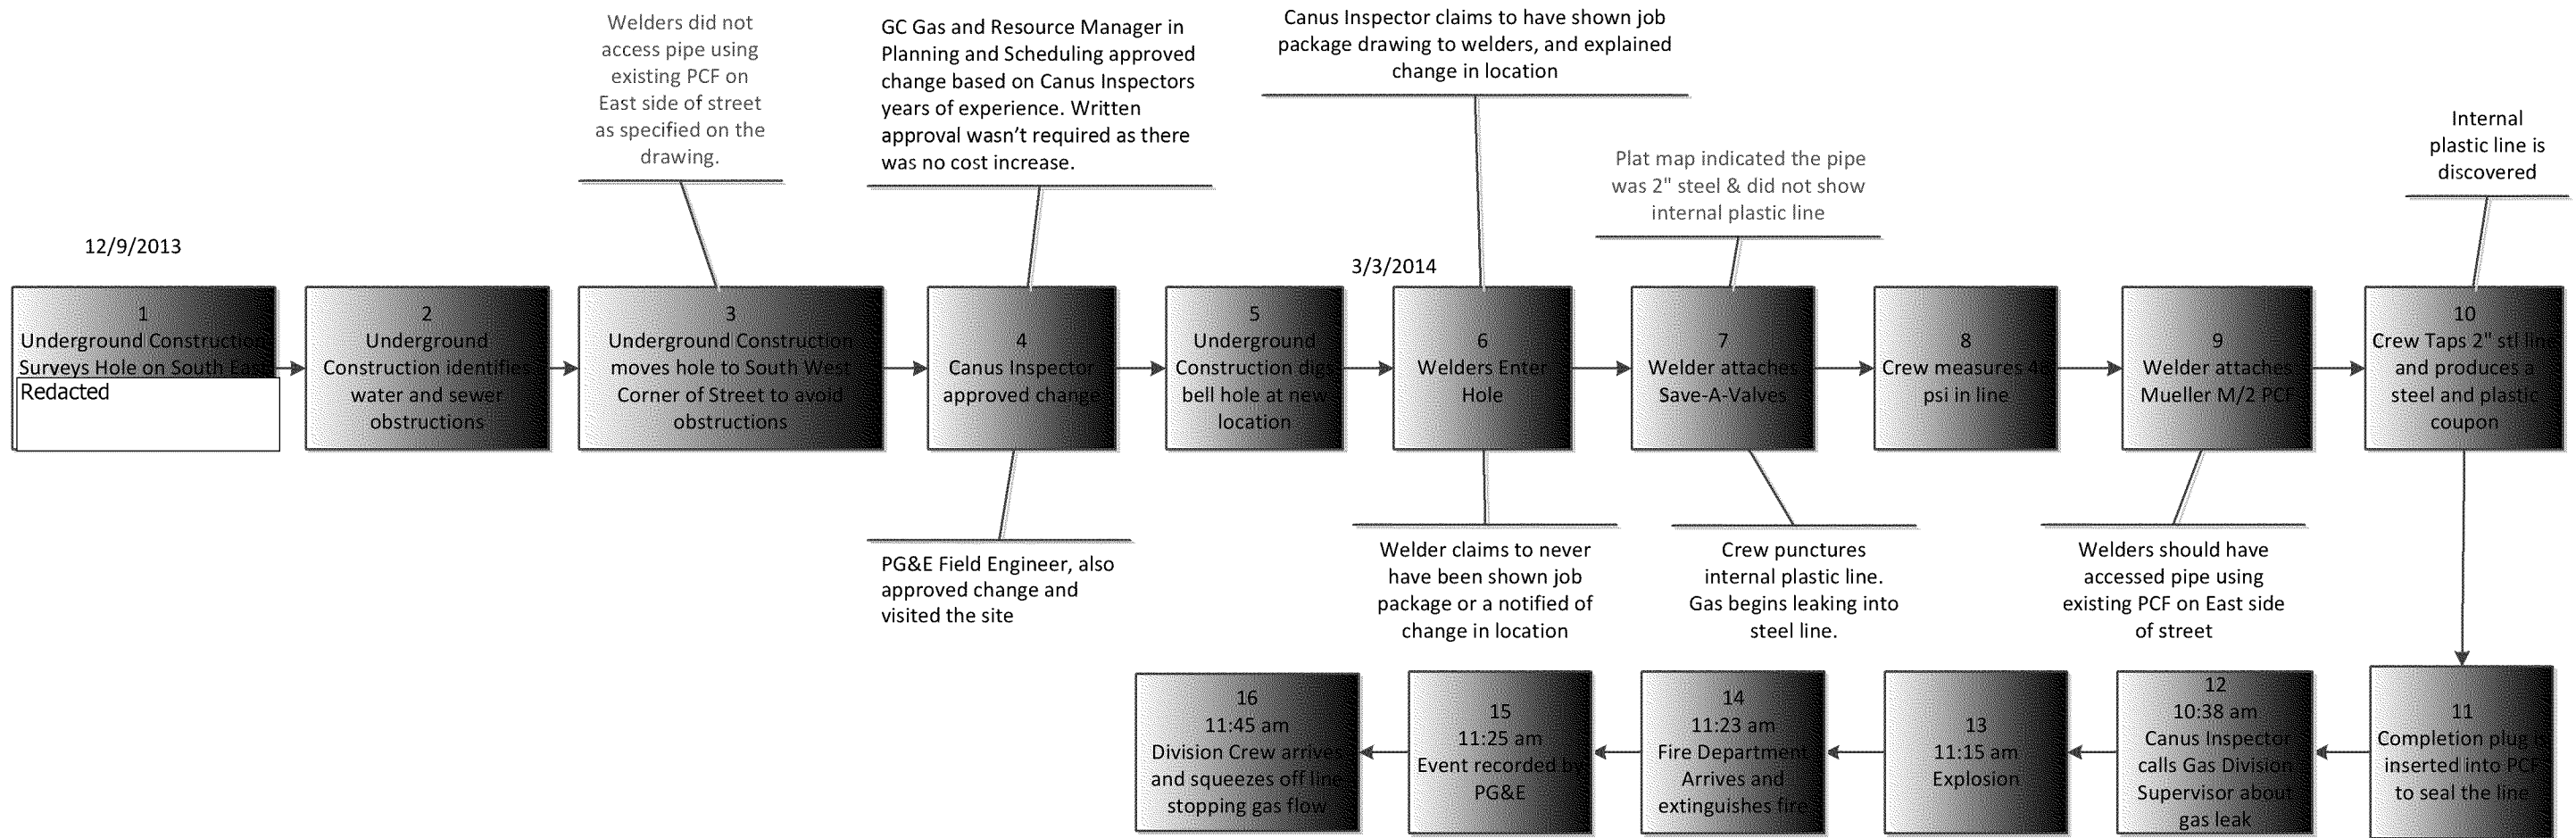
## Carmel Gas Leak and Explosion Root Cause Diagram

***Inadequate verification of system status and configuration  
when performing work on a live line.***
