**FINAL REPORT
VOLUME I
R-PG&E-20140117**

Pacific Gas and Electric Company

Tree Root Interference Assessment

January 17, 2014

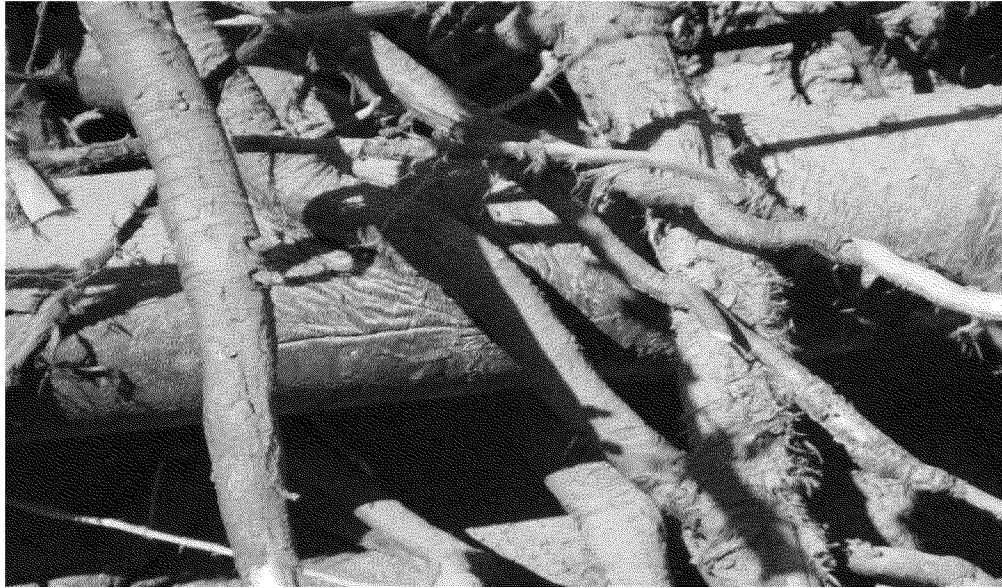
Figure 3. RWVIM-107-13 (Weber Lane)
(CTE coating damage)

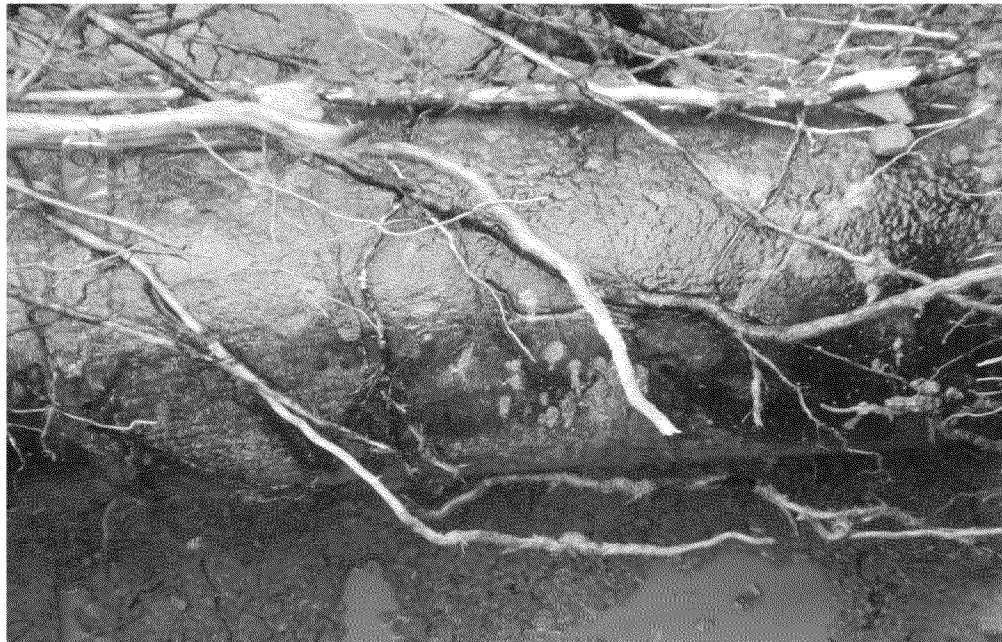
Figure 4. RWVIM-74-13 (Atascadero)
(Tape coating damage)

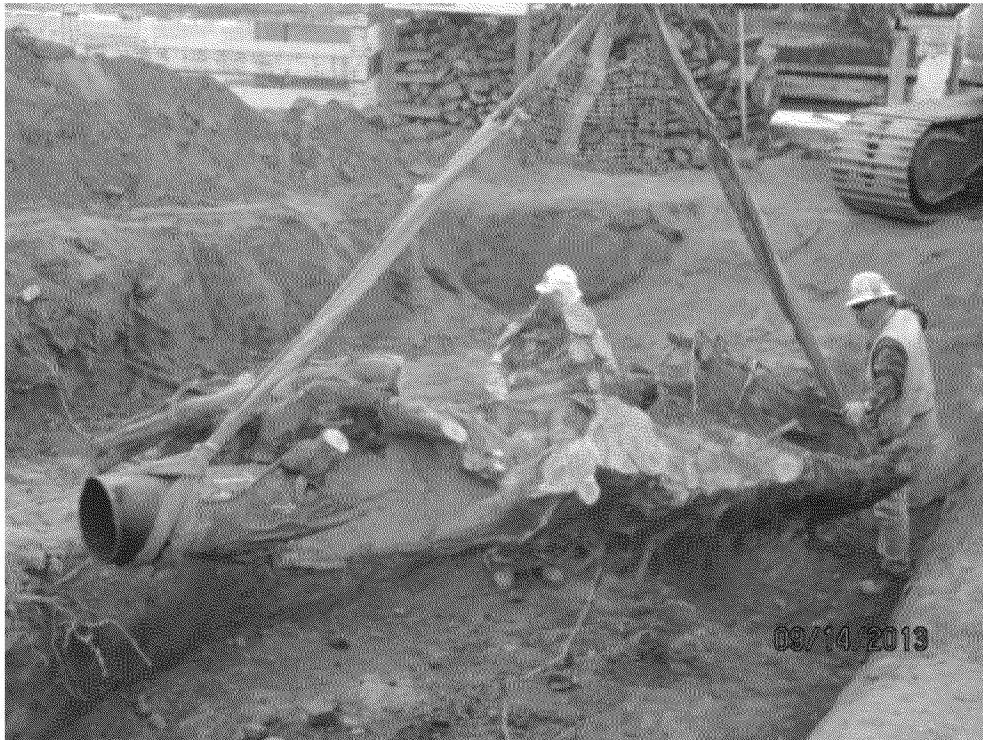
Figure 6. RWVIM-90-13 (Hall Road)

Tree root and pipeline interactive conditions were reviewed relative to the potential for pipeline structural damage. An example of one location where the tree root ball was situated directly on top of the pipe and the tree roots encapsulated the buried pipe is presented in Figure 6 (RWVIM-90-13, Hall Road).

The Hall Road site provides evidence of what can occur when a tree root ball and root system is located in close proximity to a buried pipeline. A primary concern under these conditions is that weather (e.g., high force winds, flooding, seismic events) may cause tree and root movement, resulting in pipe damage. In addition, since the buried pipeline and tree root systems are interconnected, a lightning strike to the tree would most likely also impact the pipeline and provide an electrical path for the strike and may also provide a path for the electrical discharge.
