Threats Posed by Trees on ROW

For CPUC
By Transmission Asset Integrity Management

April 23, 2014

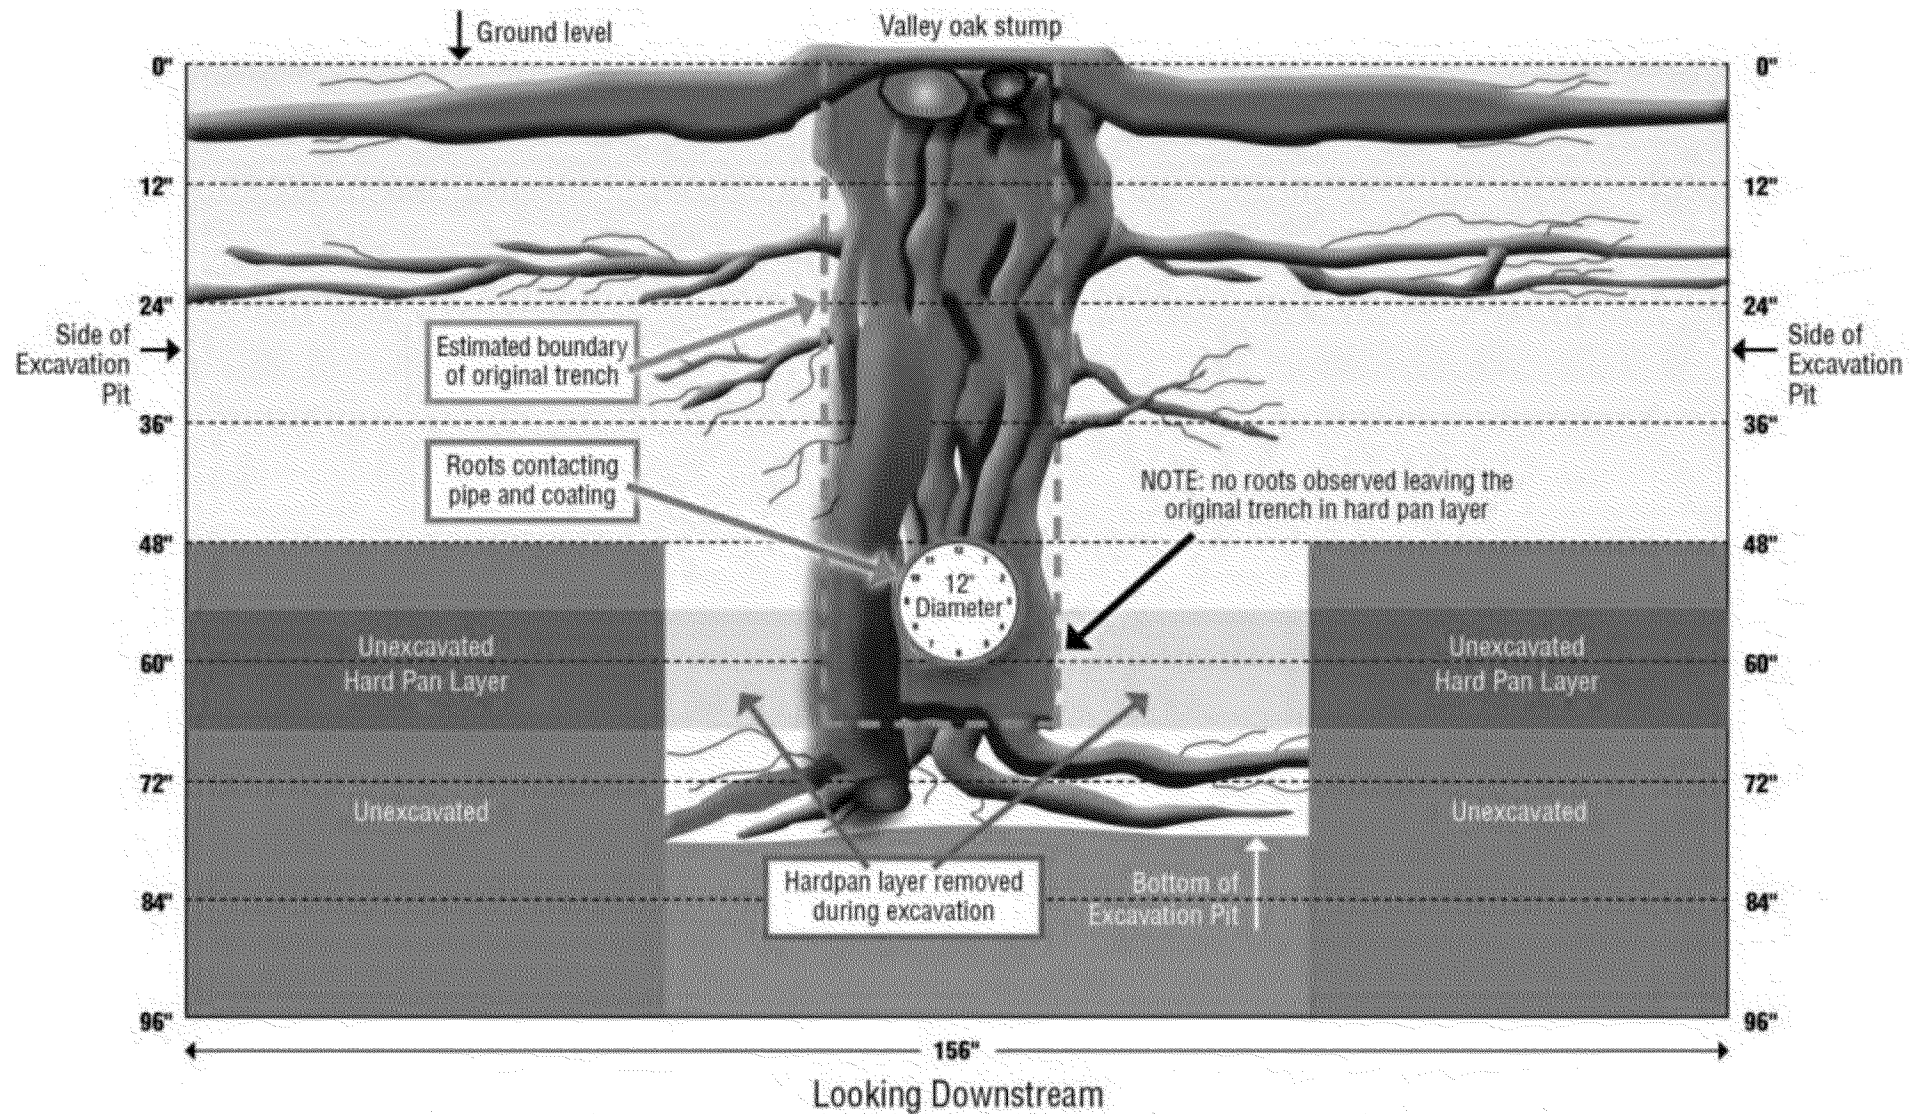
Hall Road Case Study

Excavation was accomplished by destructive methods using a trackhoe excavator. The integrity of the root system could not be maintained as the excavation proceeded, therefore, this graphic is strictly the root inspector and graphic artist's best estimate of the actual root architecture that existed underground.

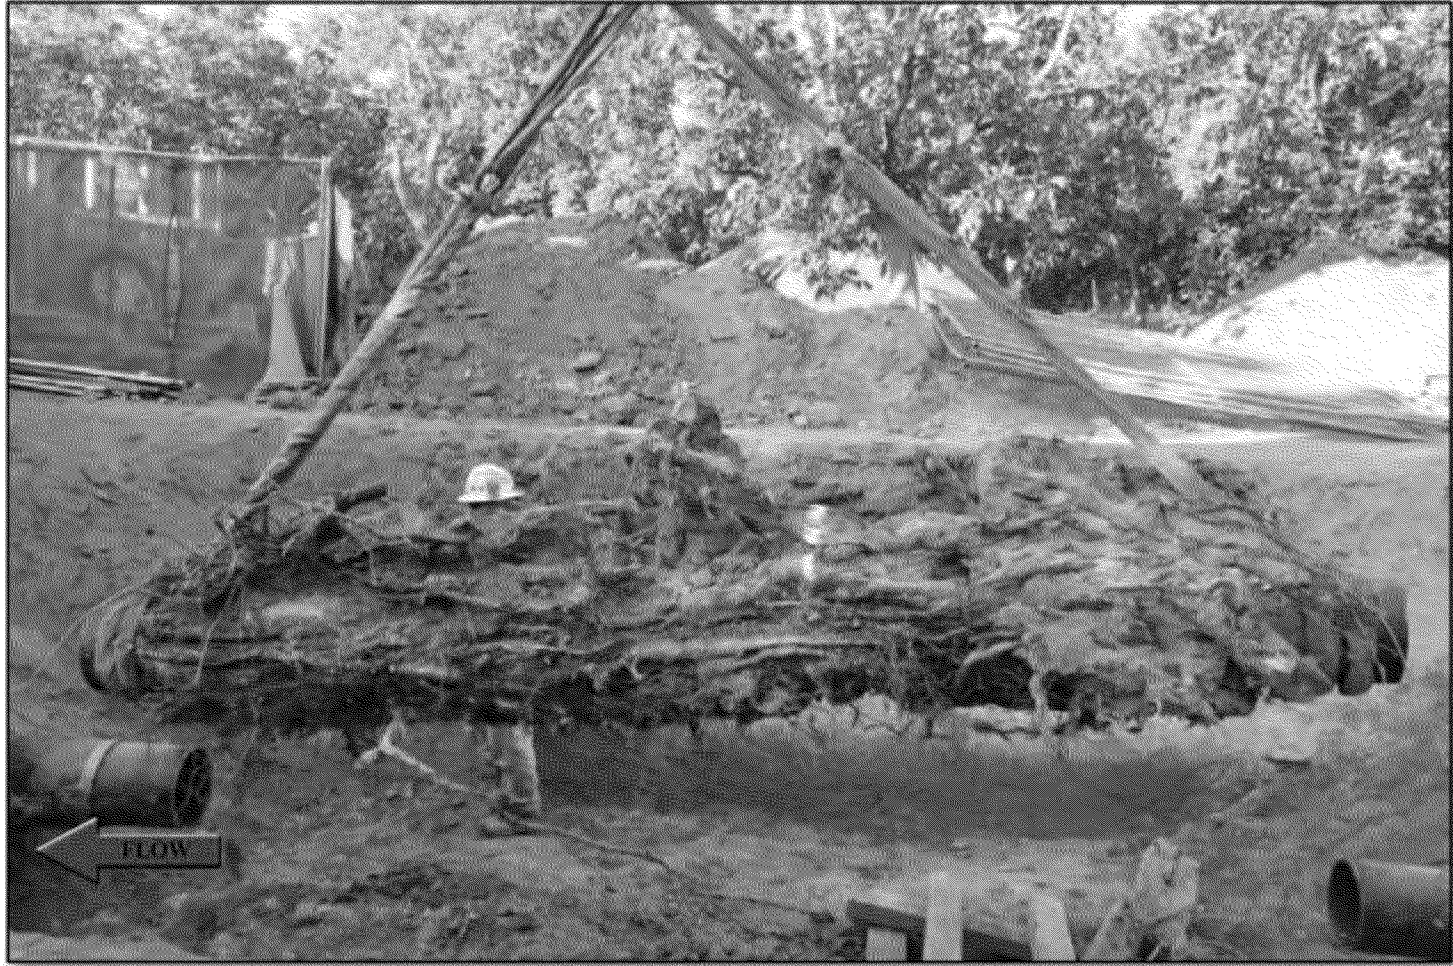
Hall Road Case Study

A 15-foot section of pipe with roots intact was extracted from the construction site.

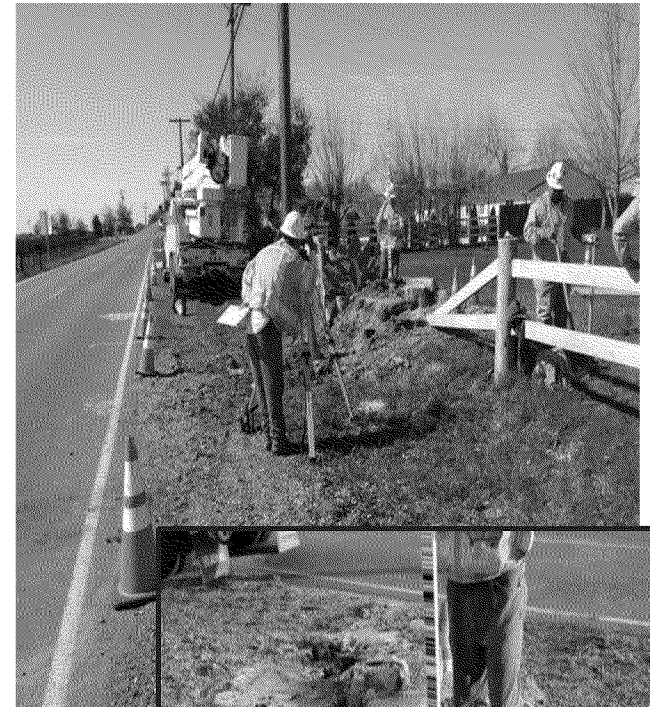
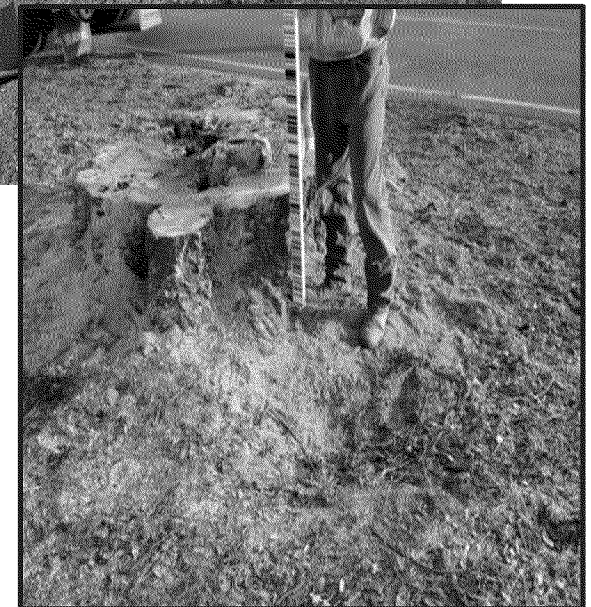
- **Minimal vertical displacement measured**
