# Threats Posed by Trees on ROW

For CPUC  
By Transmission Asset Integrity Management

April 23, 2014

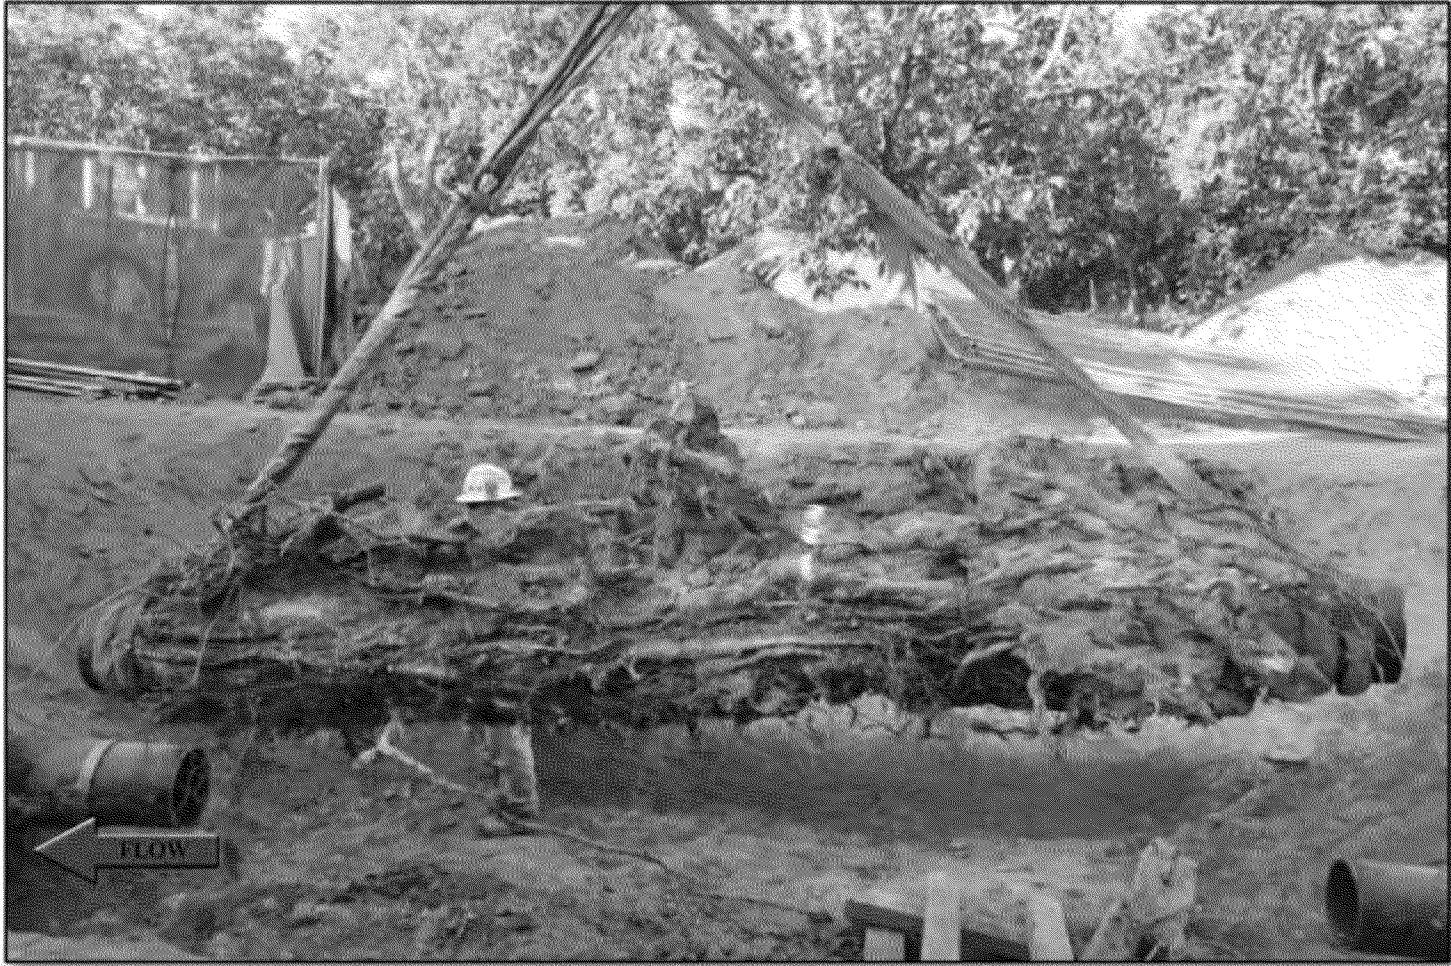
A 15-foot section of pipe with roots intact was extracted from the construction site.

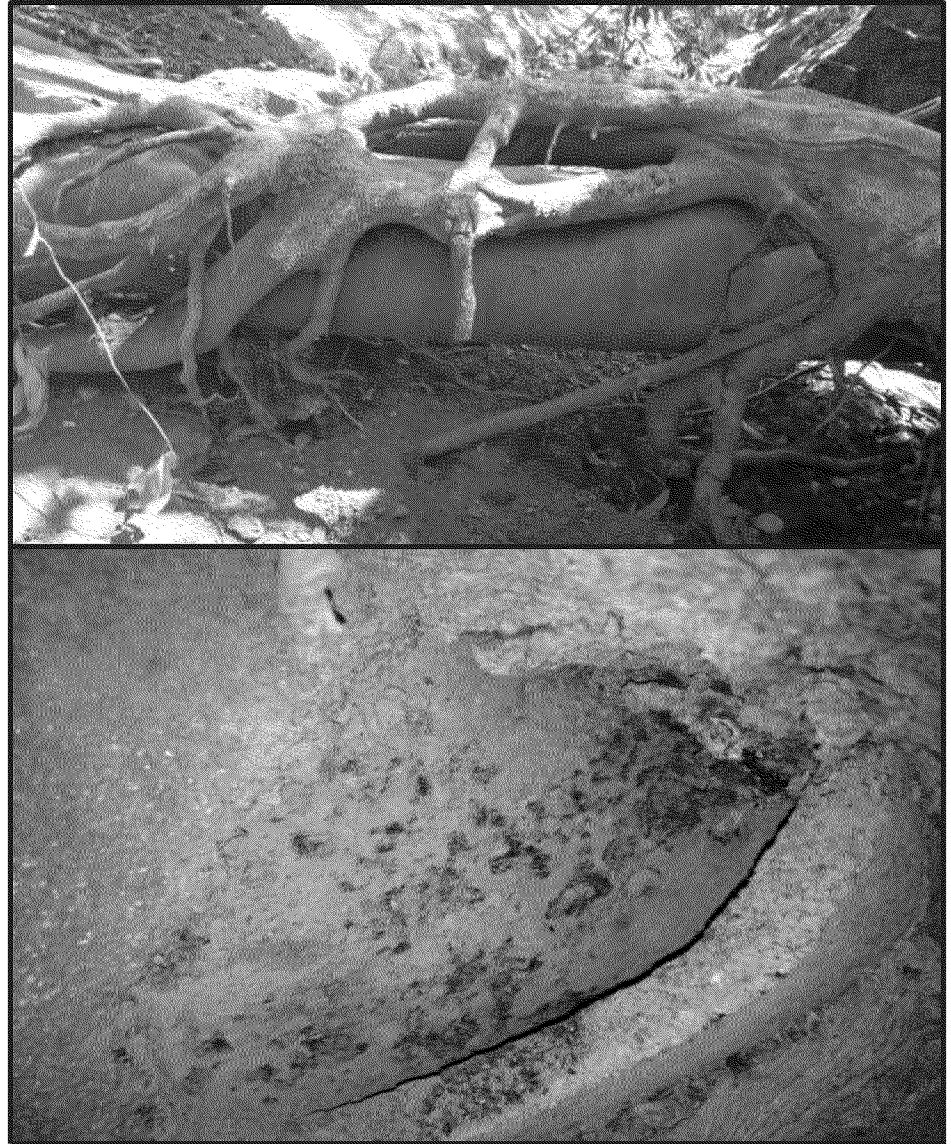
- **Coating damage was observed in 75% of excavated sites**
- **Corrosion observed in 38% of the excavated sites**
- **Extent of damage varies by coating type and other local conditions; unclear whether any difference by tree type.**

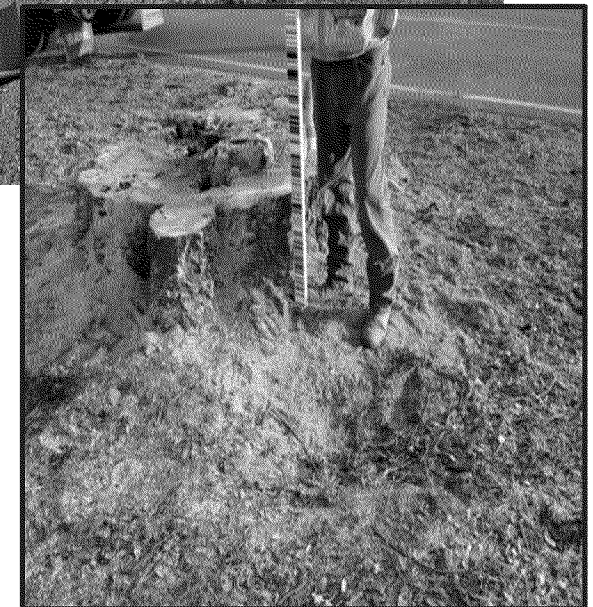
- **Minimal vertical displacement measured**
