**Carmel Gas Incident**

April 2014

Doc. no. 1401752.000 - 6877

Pacific Gas and Electric (PG&E) has retained Exponent Failure Analysis Associates (Exponent) to conduct a failure analysis investigation of a gas leak and subsequent explosion on March 3, 2014 in Carmel-by-the-Sea (Carmel), California.

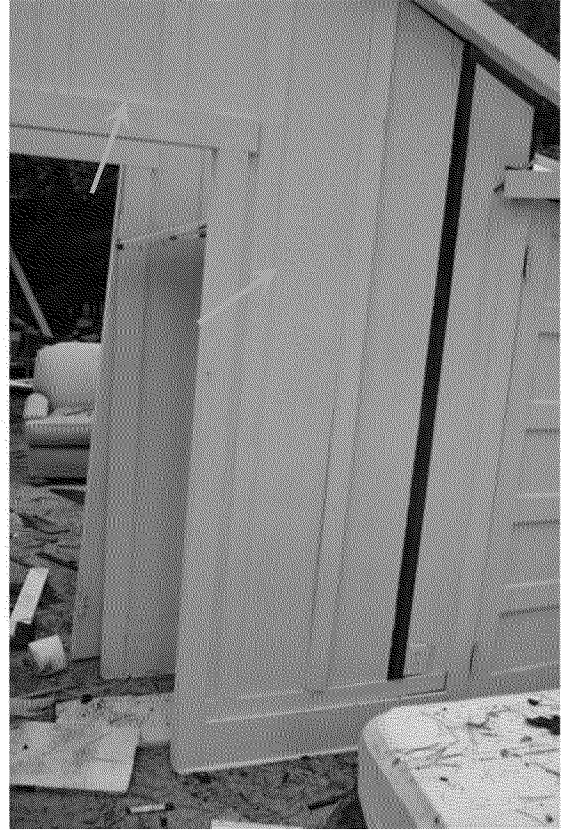
Figure 11. Interior walls and furniture. An unburned couch in the living room is visible in the background and the corner of an unburned mattress is visible in the foreground. Yellow arrows indicate some areas of wall blistering. Photograph by Exponent on March 6, 2014.

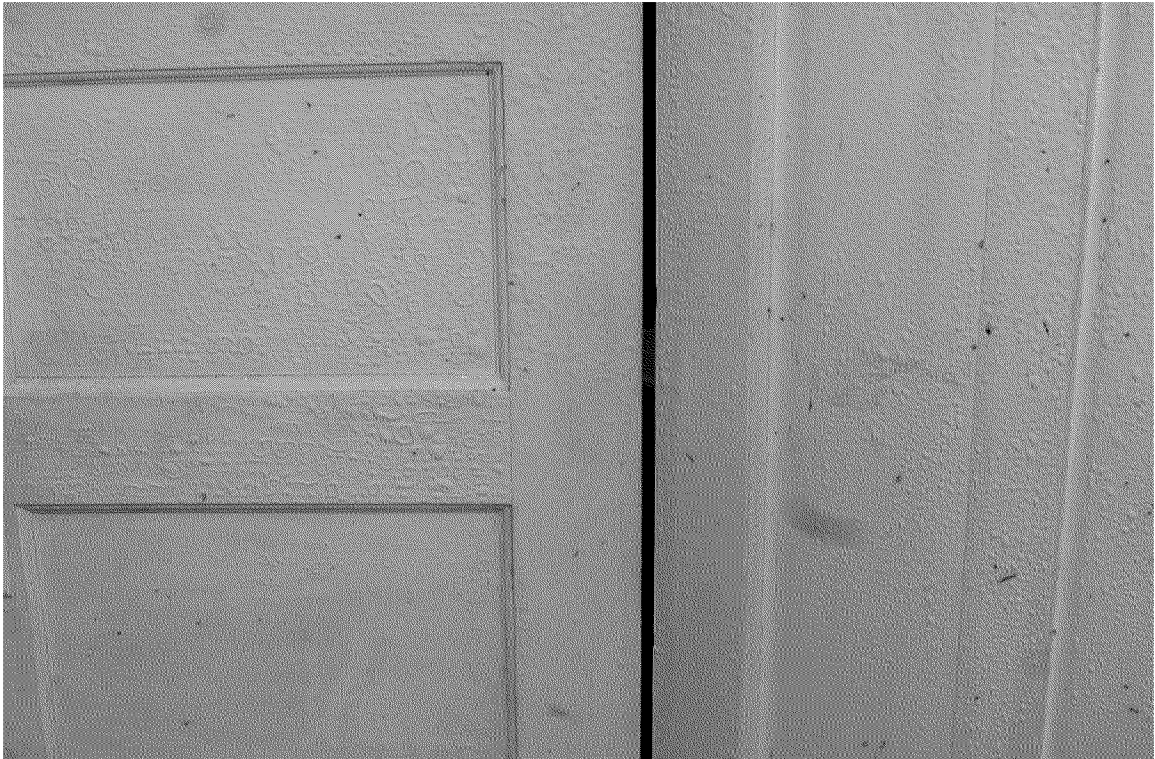
Figure 12. Close-up of the paint blistering on bedroom wall and door. Photograph by Exponent on March 7, 2014.

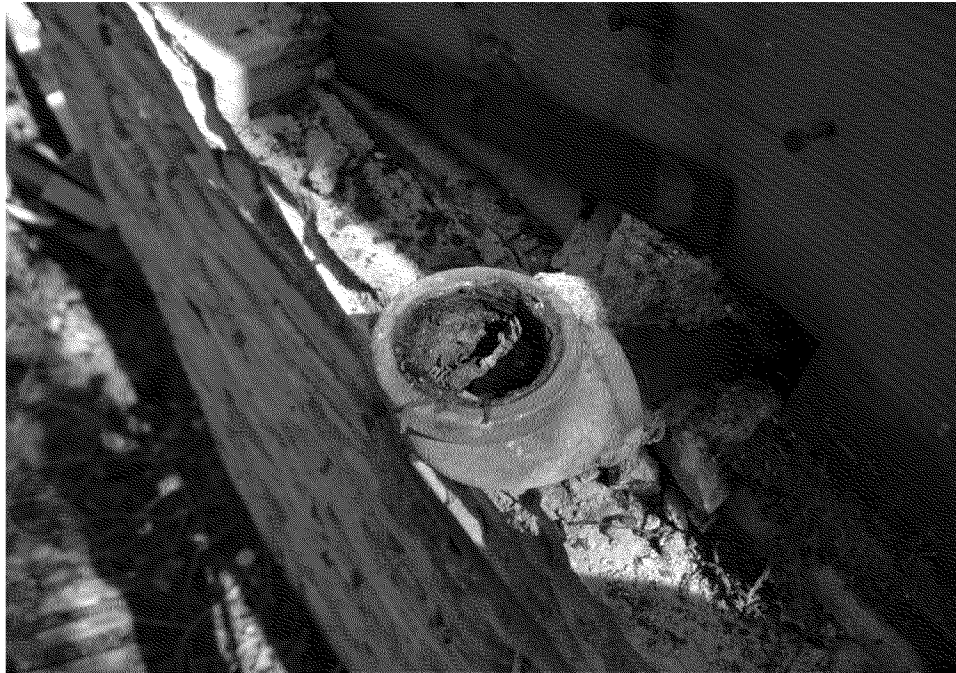
Figure 19. Vent pipe (broken off) in the bathroom. Vent pipe likely broken off during the explosion. Photograph by Exponent on March 7, 2014.

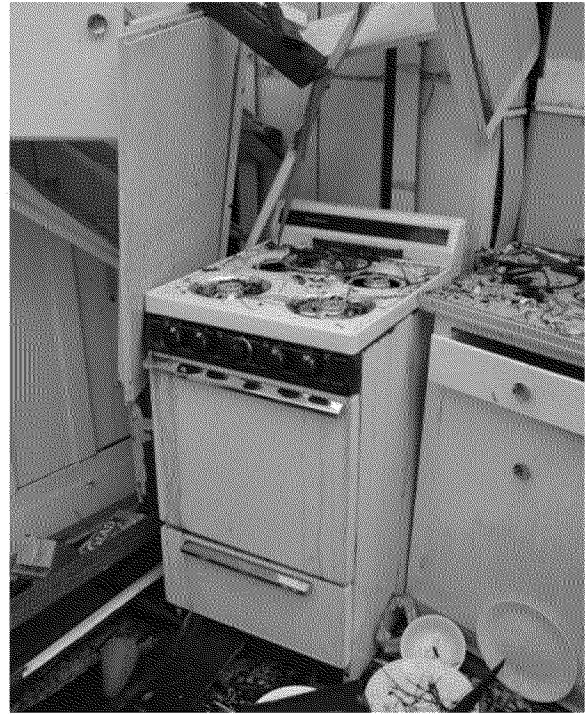
*Stove:* A kitchen stove was present in the subject house. The location of the stove is shown in Figure 20. The appliance shut-off valve for the stove was found in the open position and the stove was equipped with a continuous pilot flame (Figure 21). Based on these facts, the stove cannot be ruled out as a likely ignition source for the incident explosion.

Figure 20. Location of kitchen stove. Photograph by Exponent on March 6, 2014.

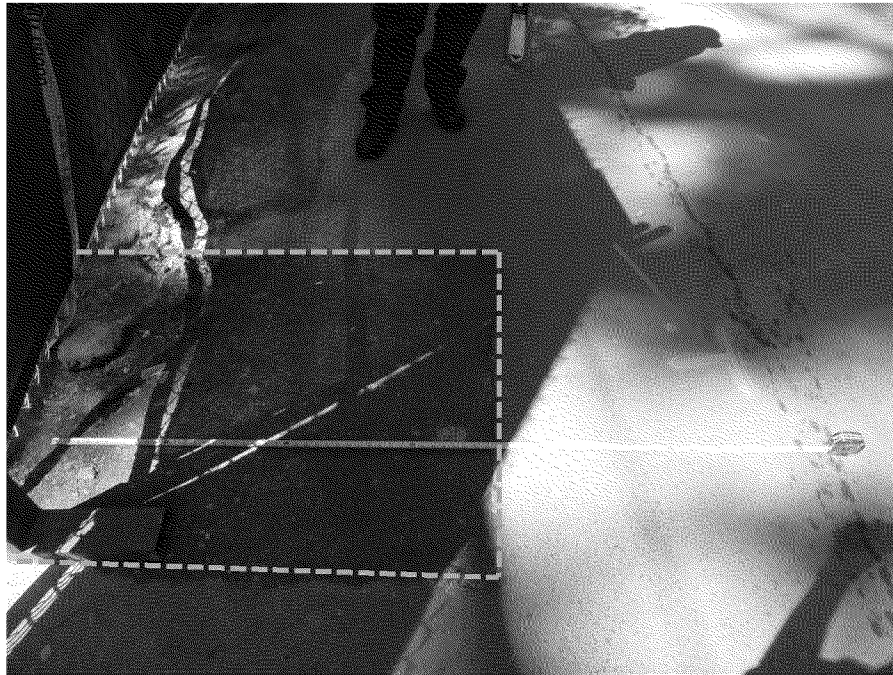
Along [Redacted] approximately 50 feet west of the manhole at [Redacted] a break tap was observed. This was the first lateral entry point from the aforementioned manhole. Figure 35 shows the street marking for the location of the sewer lateral and the asphalt patch performed

by PG&E for the gas service line. As shown in this figure, the sewer line is in close proximity to the gas service tee.

Figure 35. Relative location of cold asphalt patch for gas service tee (dashed yellow lines) and sewer lateral tap connection to sewer main (green arrow) for subject residence. Residence is to the left in photograph. Photograph by Exponent on March 11, 2014.

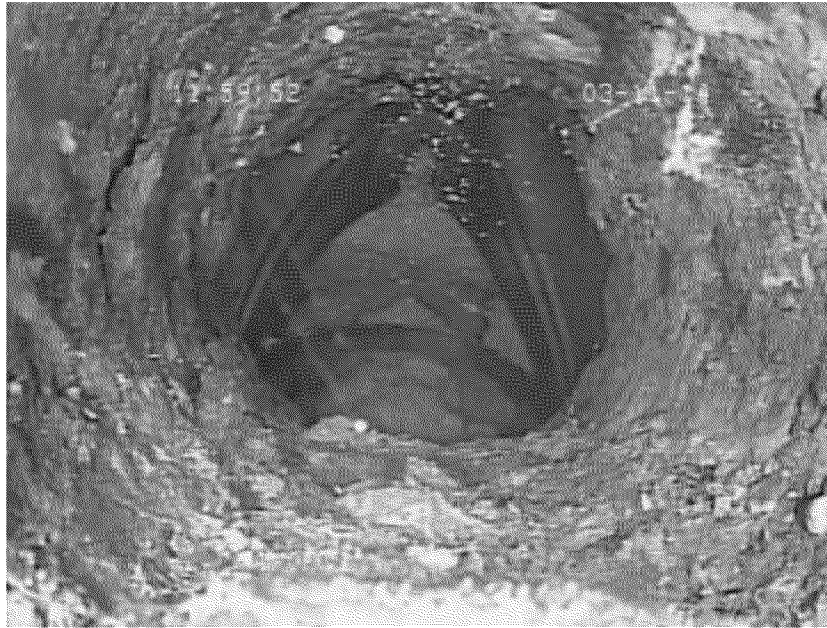
Gaps around the sewer lateral (at the break tap) and the sewer main were observed. The lateral was an approximately 4-inch cast iron pipe for the subject residence. As shown in Figure 36, the sewer lateral had debris accumulated around its interior perimeter and showed clear evidence of lack of recent use, including presence of spider webs, dryness and deterioration.

Figure 36. Sewer lateral conditions approximately 5 feet from tap with sewer main. Deterioration, spider webs and debris in cast iron pipe in area closest to camera. Separation and dislocation of lateral away from camera. Source: FES.

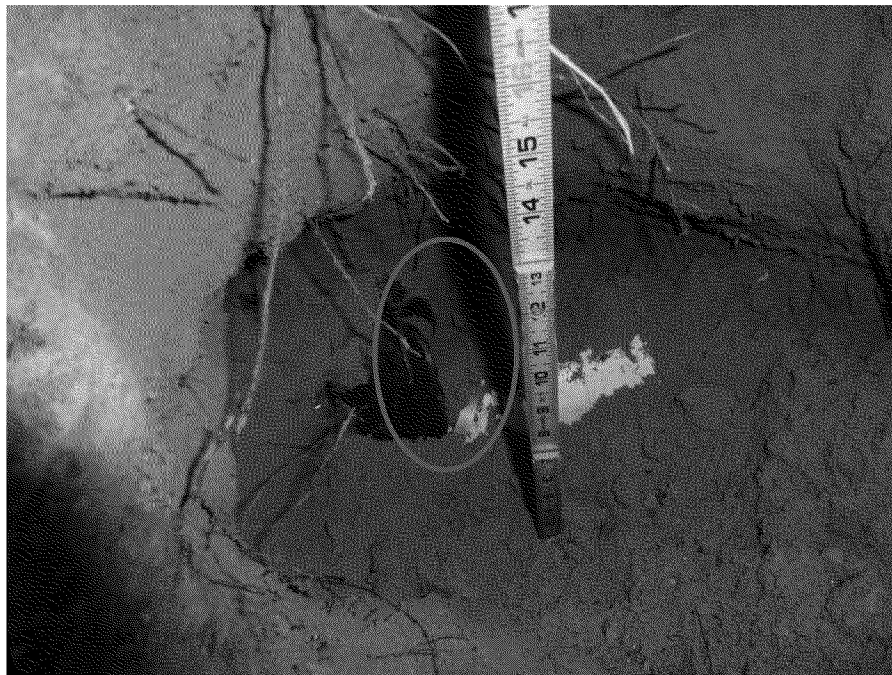
Figure 46. Sewer lateral offset joint (green oval), and white plastic segment of sewer lateral. Sand backfill surrounding sewer lateral. Photograph by Exponent on March 21, 2014.

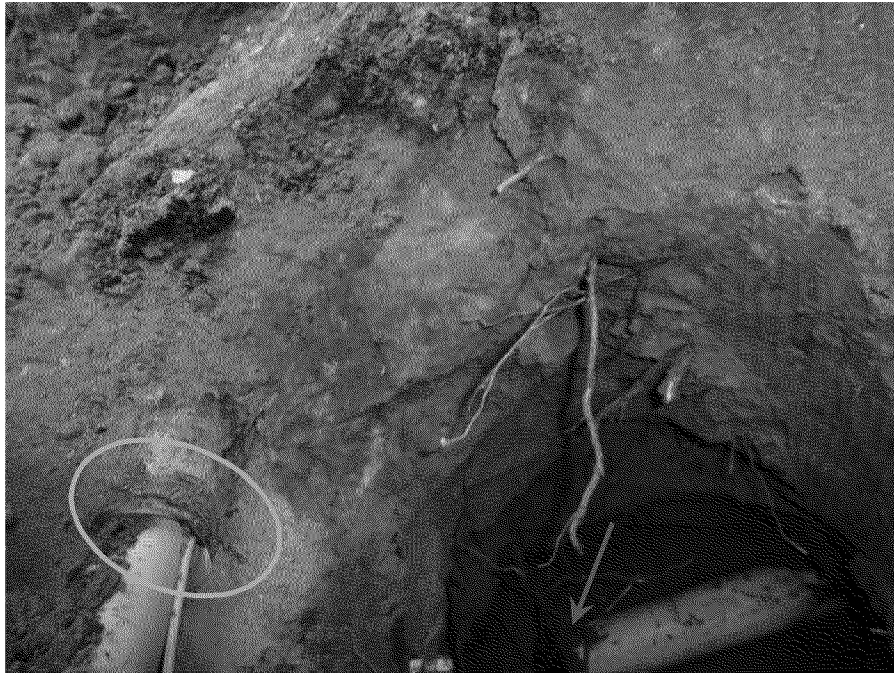
Figure 47. End of annular space in gas main along Redacted (yellow oval) in vicinity of sewer lateral offset joint (green arrow). Photograph by Exponent on March 21, 2014.

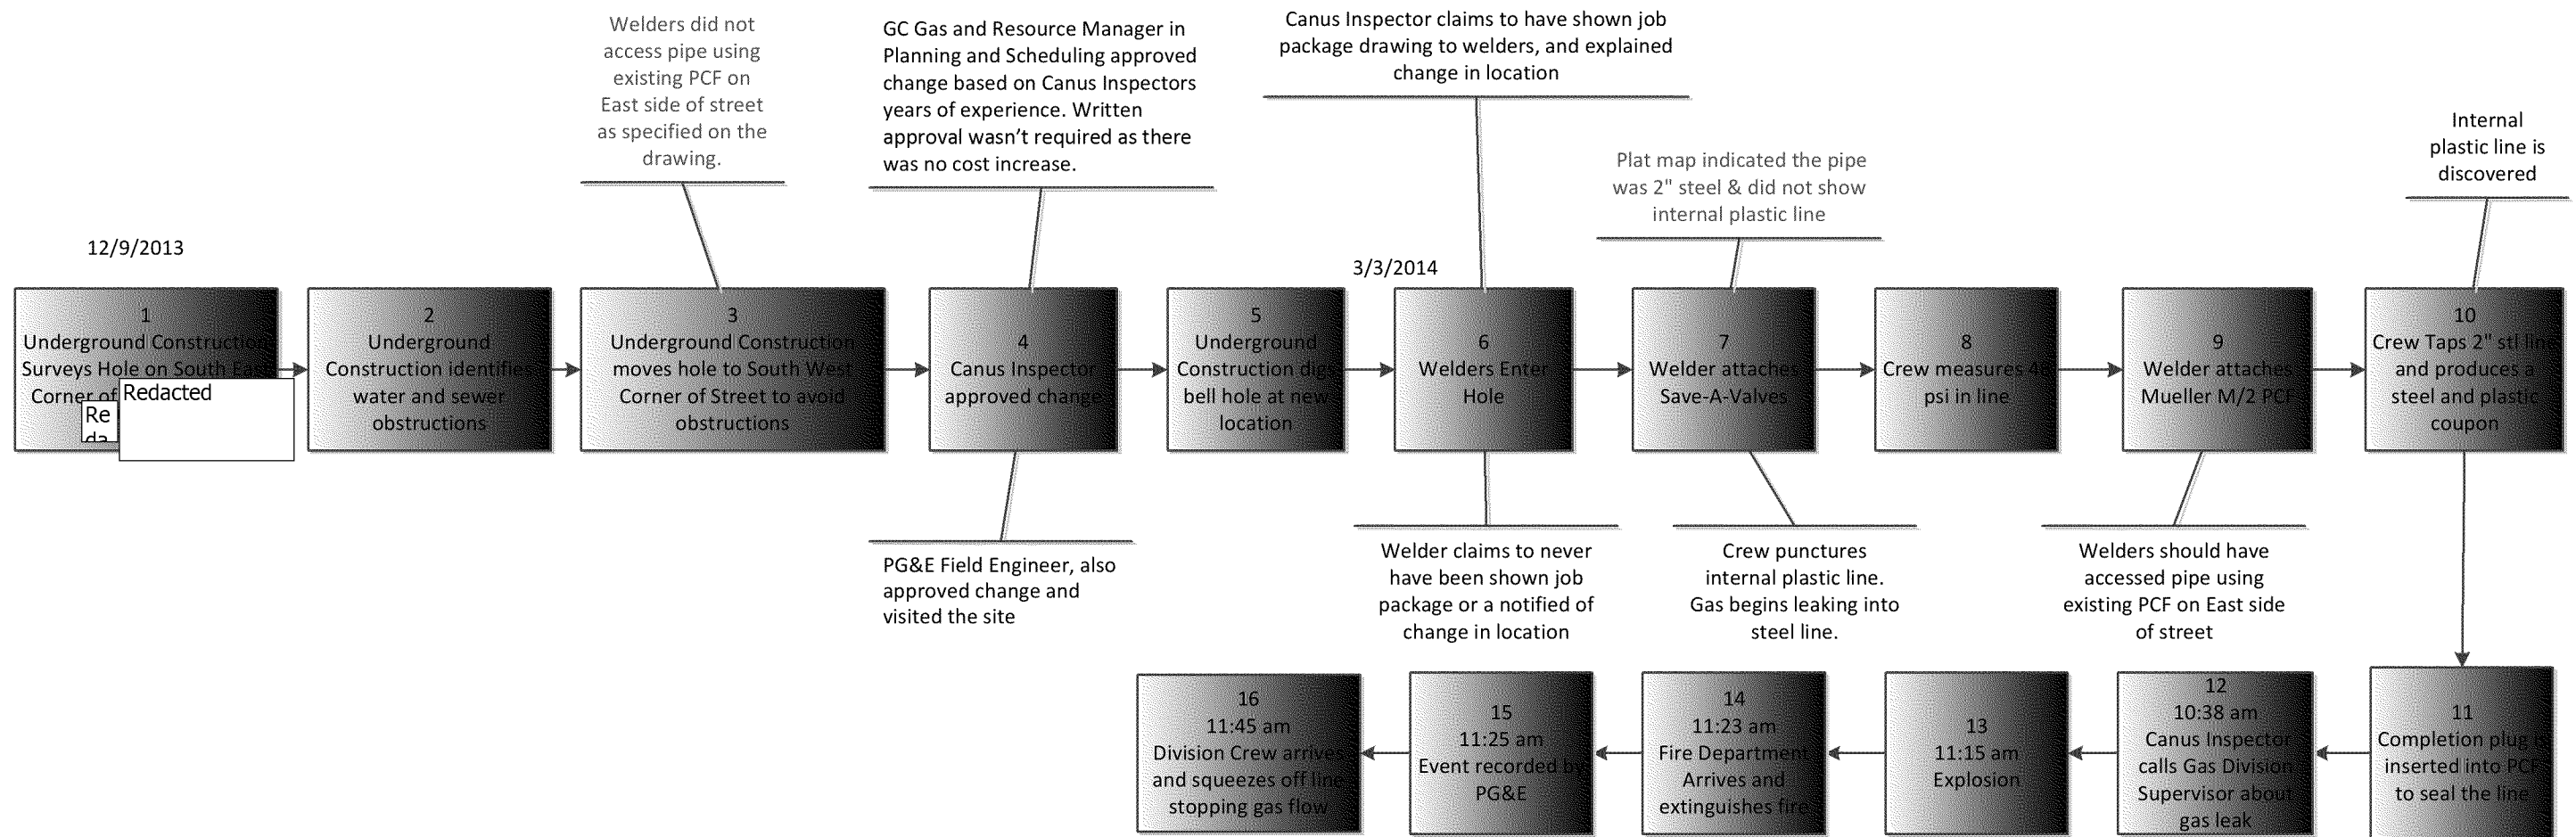
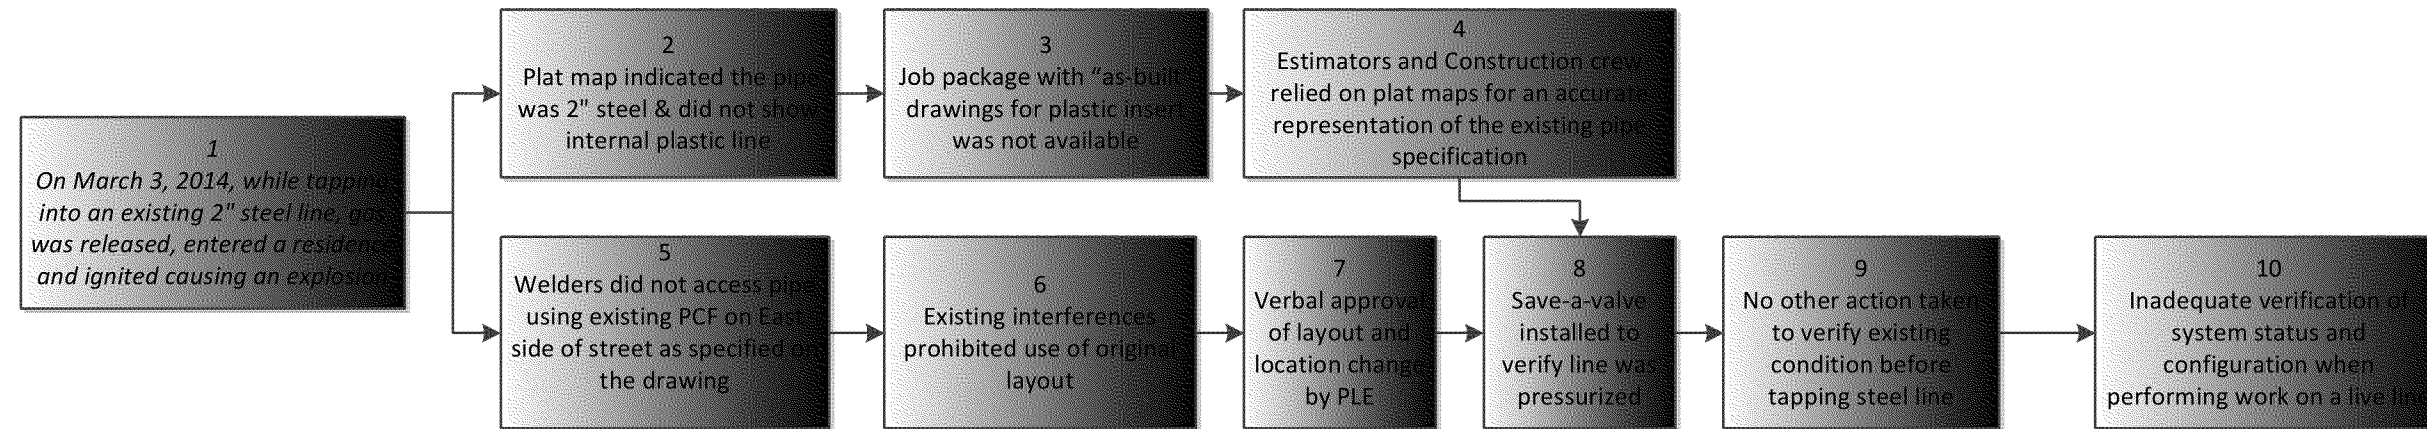
## Carmel Gas Leak and Explosion Root Cause Diagram

***Inadequate verification of system status and configuration  
when performing work on a live line.***
