Failure Analysis Associates

Carmel Gas Incident

April 2014

Doc. no. 1401752.000 - 6877

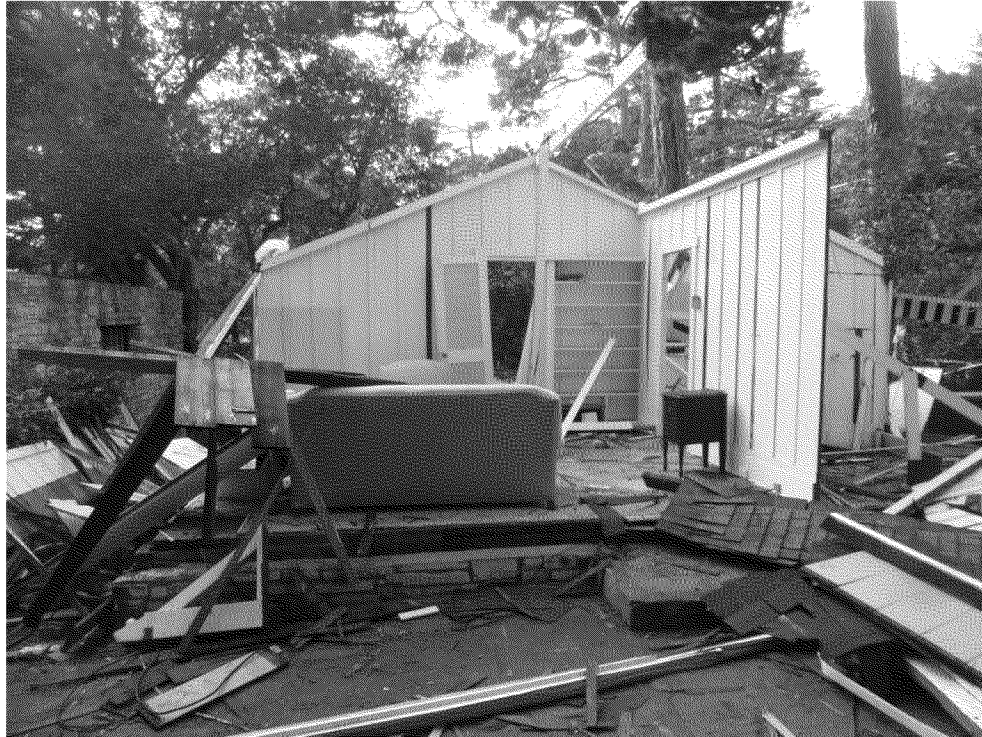
some of the interior walls remained in place (Figure 9 and Figure 10). Debris was scattered across the property and in nearby trees.

Figure 9. Incident house looking West from the entryway. Photograph by Exponent on March 4, 2014.

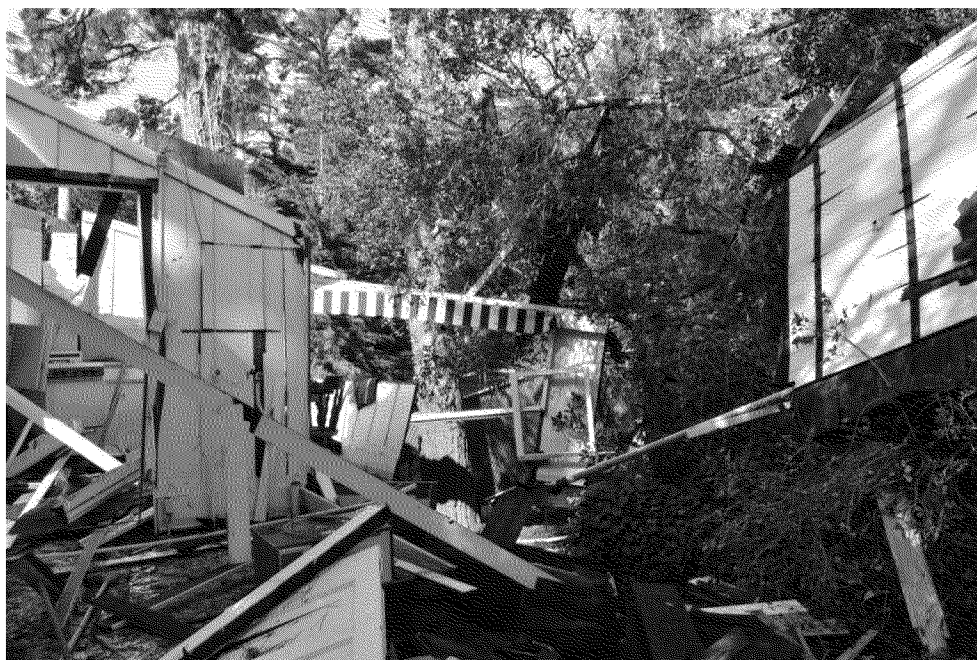
Figure 10. Incident house looking West into the laundry room. Roof section on right side of picture. Photograph by Exponent on March 4, 2014.

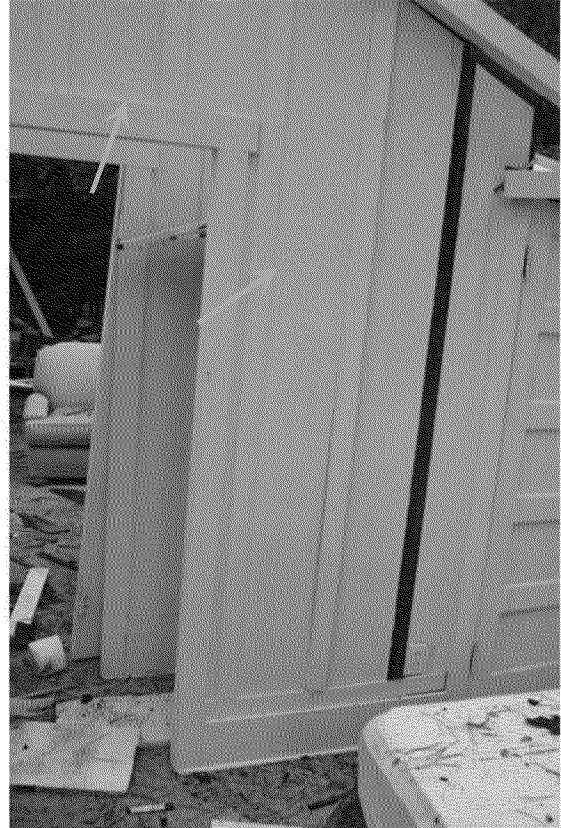
Figure 11. Interior walls and furniture. An unburned couch in the living room is visible in the background and the corner of an unburned mattress is visible in the foreground. Yellow arrows indicate some areas of wall blistering. Photograph by Exponent on March 6, 2014.

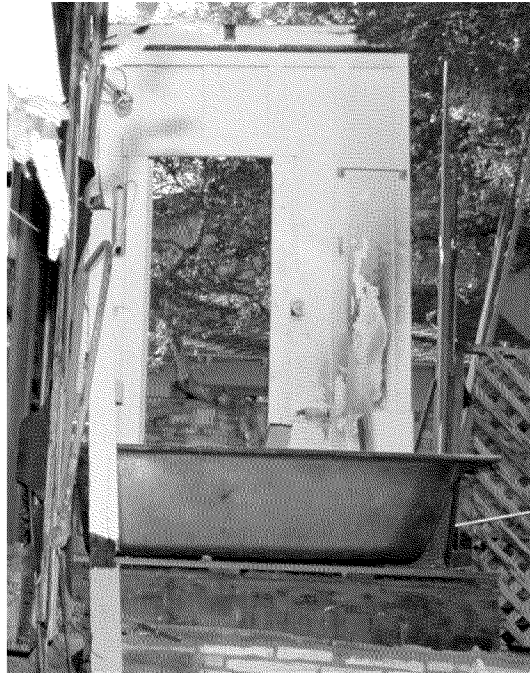
Figure 13. Fire pattern on bathroom wall, looking South from Redacted Photograph by Exponent on March 7, 2014.

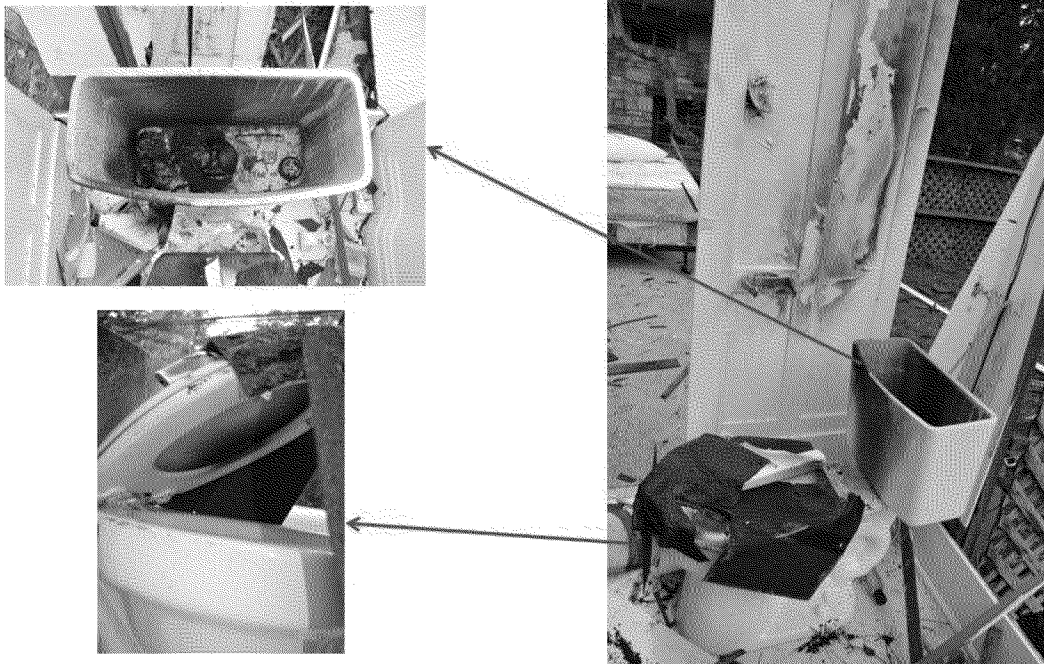
Figure 15. Damage to bathroom toilet. Burn marks below toilet seat and melted components inside toilet tank. Photographs by Exponent on March 6, 2014.

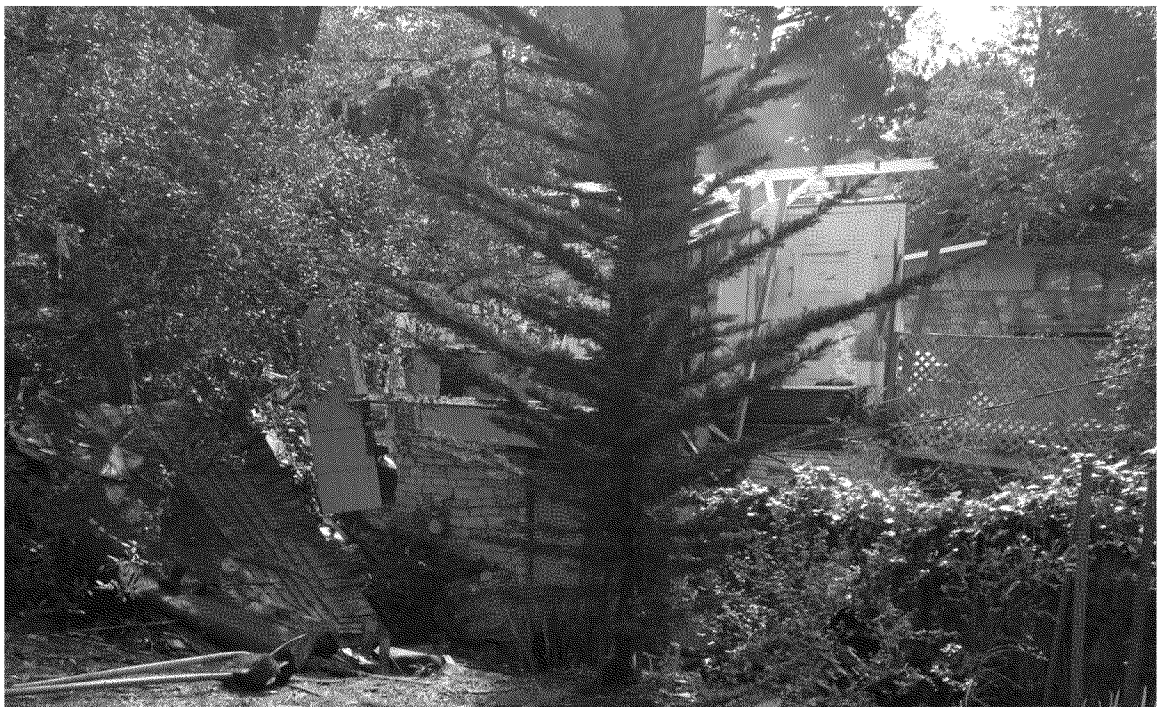
Figure 16. Photograph taken shortly after the explosion showing flames over bathroom toilet. Photograph provided to Exponent by PG&E.

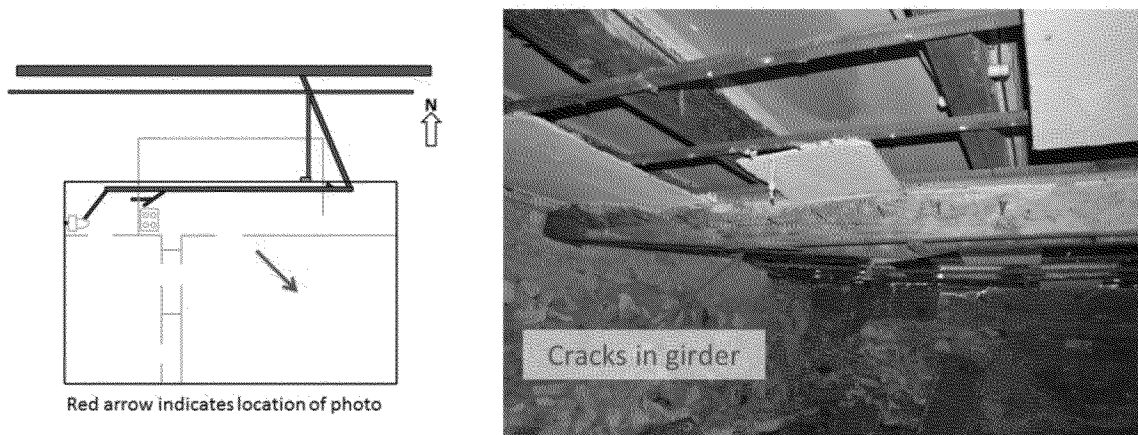
The basement area showed limited damage compared to the main floor. The perimeter walls did not show evidence of damage from the recent explosion and the windows' glasses were undamaged. The ceiling finishes had collapsed in several areas and two of the wooden beams showed longitudinal cracks (Figure 17).

An Exponent engineer deemed the first floor of the structure unsafe due to recent damage to joists and girder framing. Shoring of the first floor from the basement level was recommended in order to continue inspection on the first floor. Recommendations were also made to remove falling hazards from trees, neighboring bushes, and cantilevered portions of the structure.

Figure 17. Incident house basement. Ceiling girder with multiple longitudinal cracks. Photograph by Exponent on March 5, 2014.

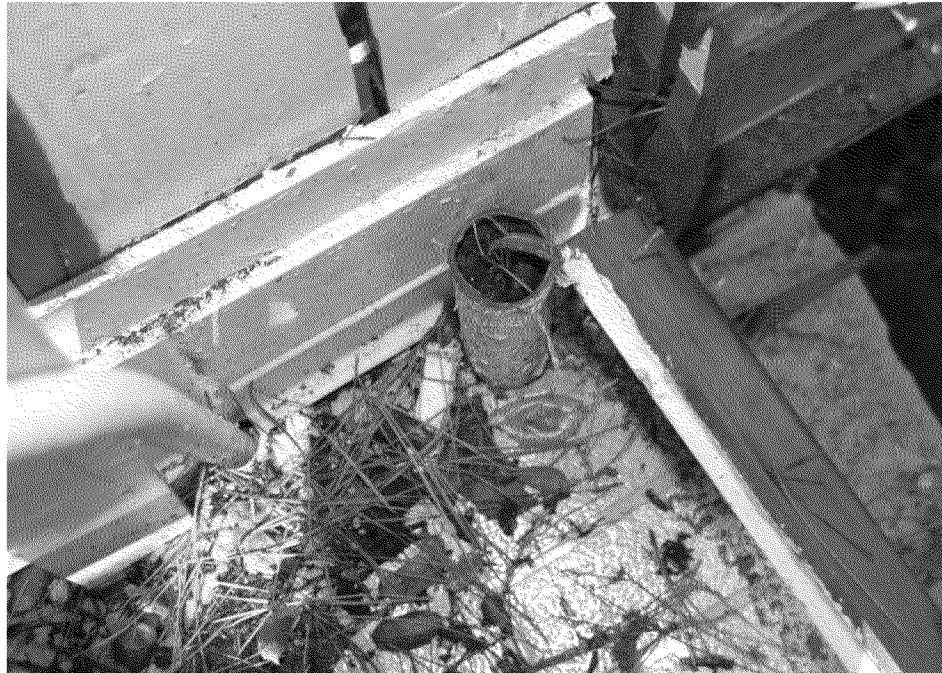
Figure 18. Sewer vent pipe (broken off) in the laundry room. Vent pipe likely broken off during the explosion. Photograph by Exponent on March 7, 2014.

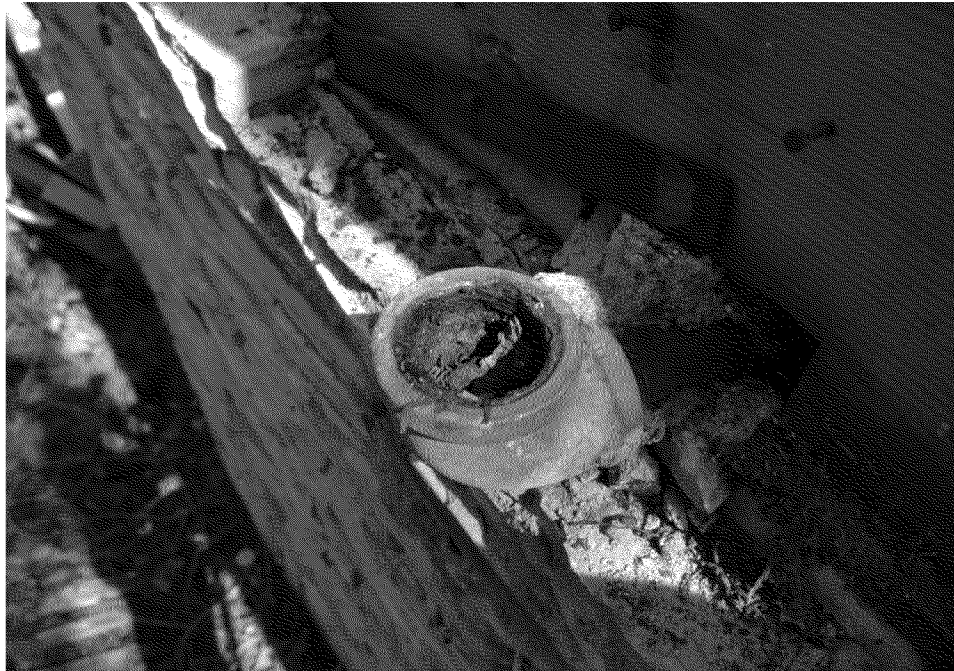
Figure 19. Vent pipe (broken off) in the bathroom. Vent pipe likely broken off during the explosion. Photograph by Exponent on March 7, 2014.

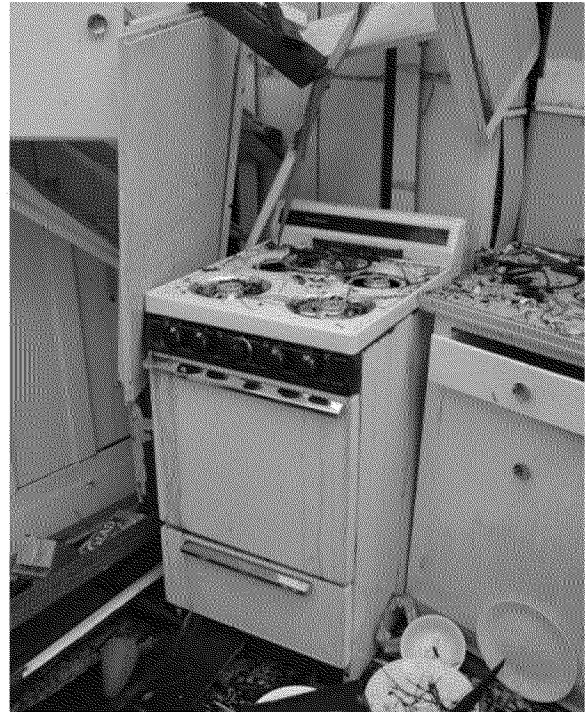
Stove: A kitchen stove was present in the subject house. The location of the stove is shown in Figure 20. The appliance shut-off valve for the stove was found in the open position and the stove was equipped with a continuous pilot flame (Figure 21). Based on these facts, the stove cannot be ruled out as a likely ignition source for the incident explosion.

Figure 20. Location of kitchen stove. Photograph by Exponent on March 6, 2014.

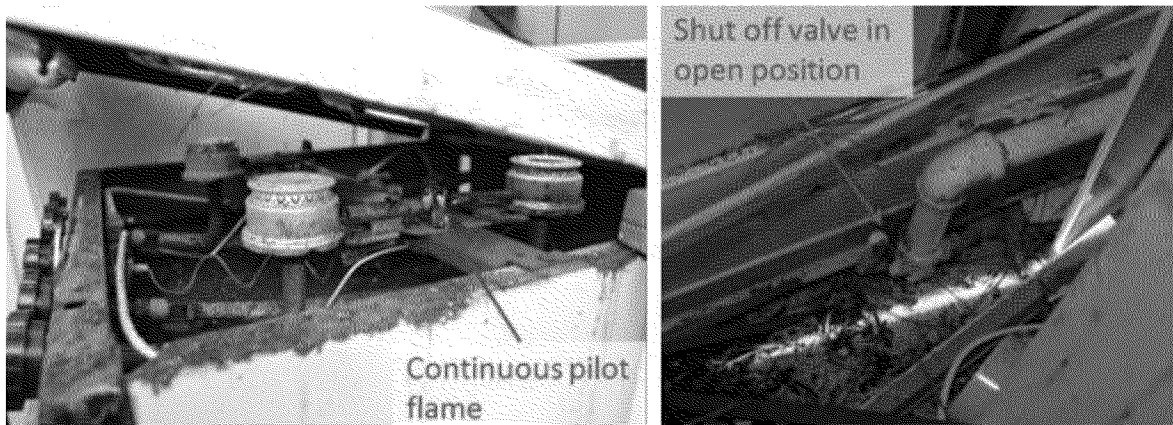
Figure 21. Kitchen stove components. Photographs by Exponent on March 6, 2014.

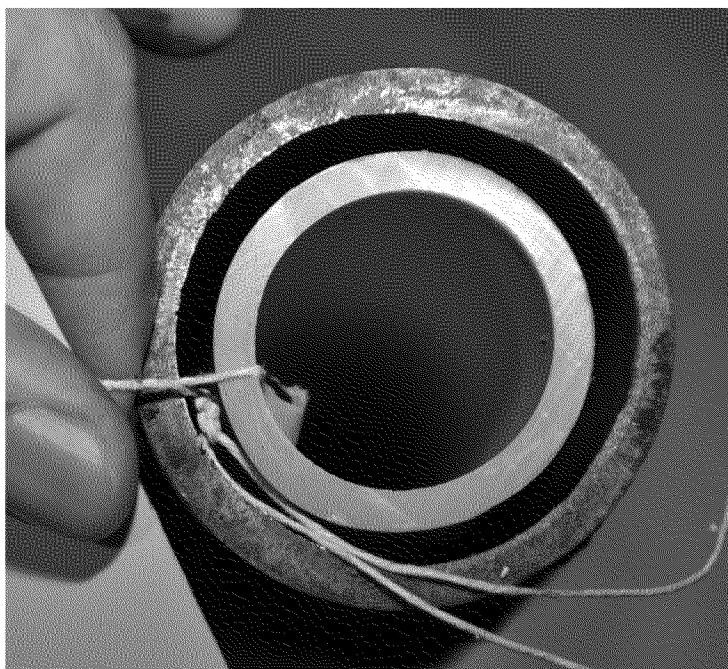
Flow through annular space: The released natural gas traveled through the annular space between the inserted plastic pipe and the steel pipe in both directions (east and west) along 3rd Avenue, away from the plastic pipe leak. Upon reaching the end of the 2-inch steel pipe, the gas exited the annular space and flowed into the soil.

Figure 28. Plastic gas line inserted into steel line. Photograph by Exponent on March 10, 2014.

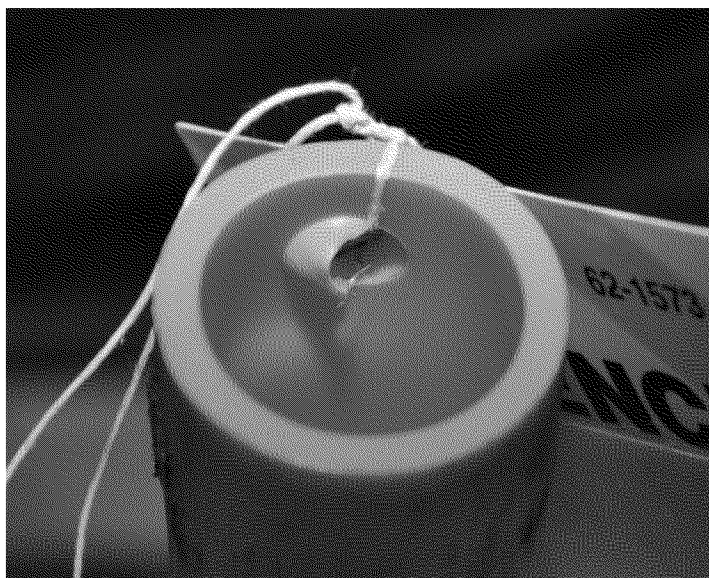
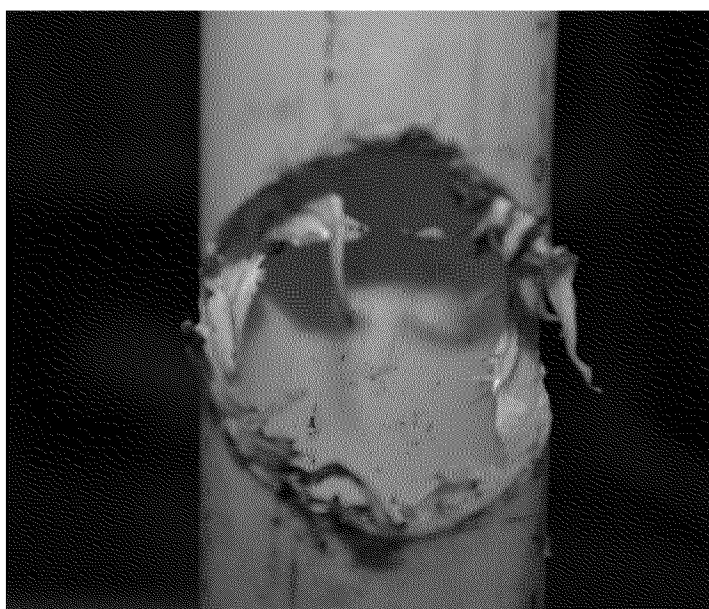
Gas leak: Inspection of the 2-inch gas main and inserted 1¼-inch plastic piping shows that there was a hole created in the plastic pipe after the Save-a-valve was tapped. This hole resulted in a pressurized natural gas release from the plastic pipe. The gas leak at this location may have started when the Save-a-valve was welded onto the steel pipe, before the Save-a-valve was tapped. A second hole was introduced into the plastic pipe when an M/2 line stopper fitting was tapped a short time after the first tapping operation. This second hole caused additional gas to leak.

pipes (Figure 28). The plastic line segment has two perforations that correspond to the Save-a-Valve and M/2 fittings (Figure 29). There are some markings printed along the exterior of the pipe. A portion of the writing is associated with the fabrication date; in this particular piece only the year is visible, 1997 (Figure 30).

Figure 29. Perforations in plastic gas line: Save-a-Valve fitting (top) and M/2 fitting (bottom). Photographs by Exponent on March 10, 2014.

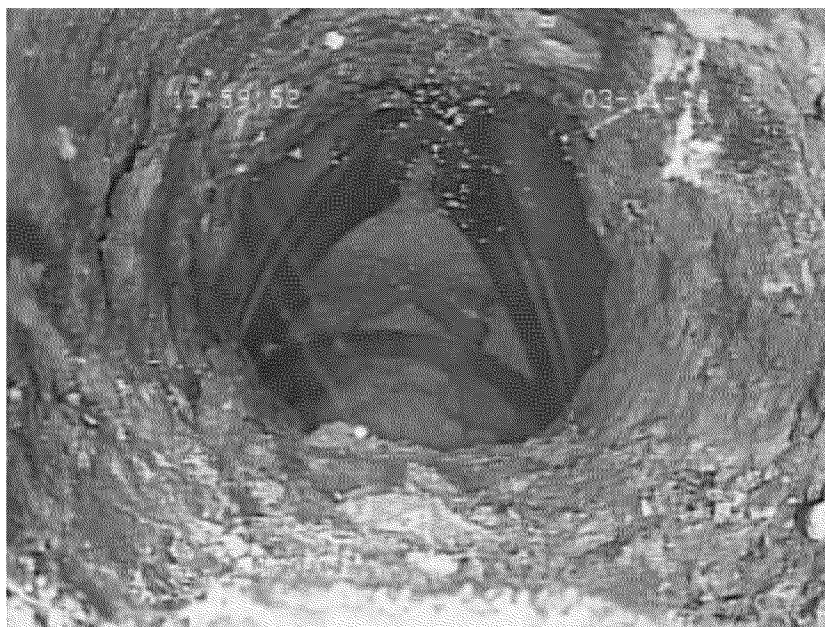
As shown in Figure 36, approximately 8 feet from the tap at the sewer main, the sewer lateral had a joint offset and opening. The green painted dot marked inside the left side of the cold asphalt patch shown in Figure 35 indicates the approximate location of this joint offset. More than 50 percent of the cross-sectional area of the pipe was offset, exposing the backfill around the pipe. The lateral-launch camera was unable to continue beyond this joint offset.

Figure 36. Sewer lateral conditions approximately 5 feet from tap with sewer main. Deterioration, spider webs and debris in cast iron pipe in area closest to camera. Separation and dislocation of lateral away from camera. Source: FES.

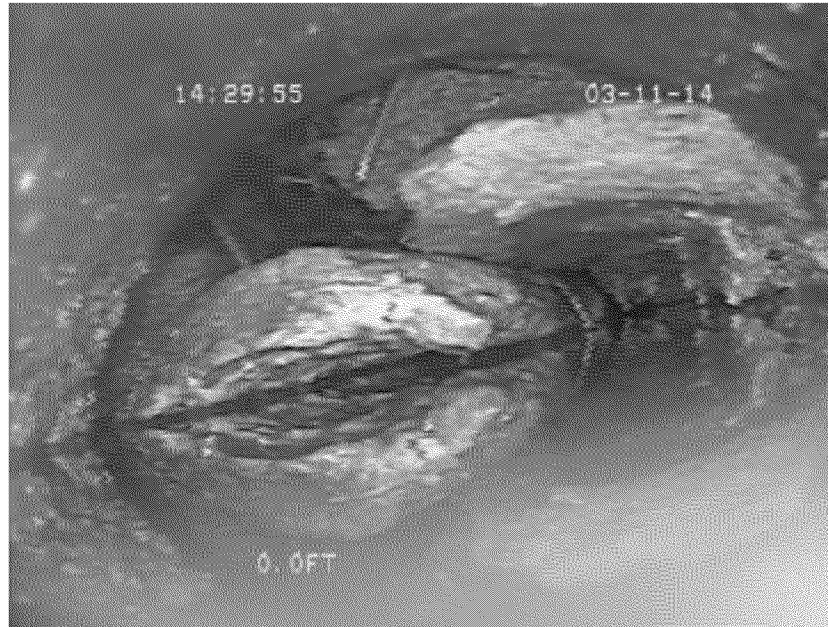
The sewer main south of the manhole along [Redacted] consisted of an unlined clay pipe, with an approximate diameter of 8 inches. A collapse was observed approximately 1½ to 2 feet

south of the manhole (Figure 37). Standing water was observed in the collapsed area. The area of the observed collapse appears to be aligned with the storm pipe system.

Figure 37. Collapse of sewer main along Redacted south of manhole. Standing water at bottom. Source: FES.

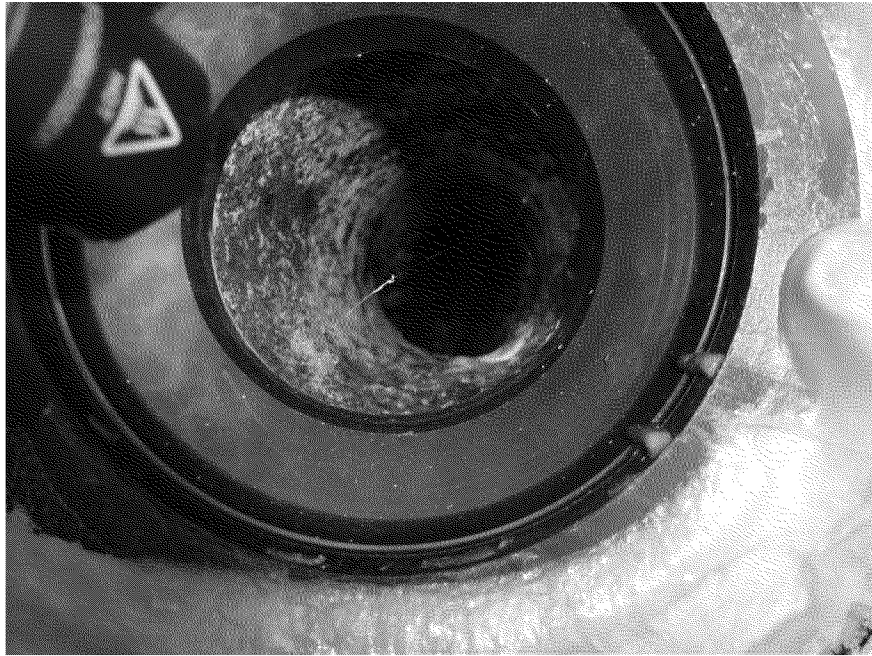
Figure 40. Sewer pipe riser below toilet. Cast iron pipe is dry, spider webs are visible. Photograph by Exponent on March 11, 2014.

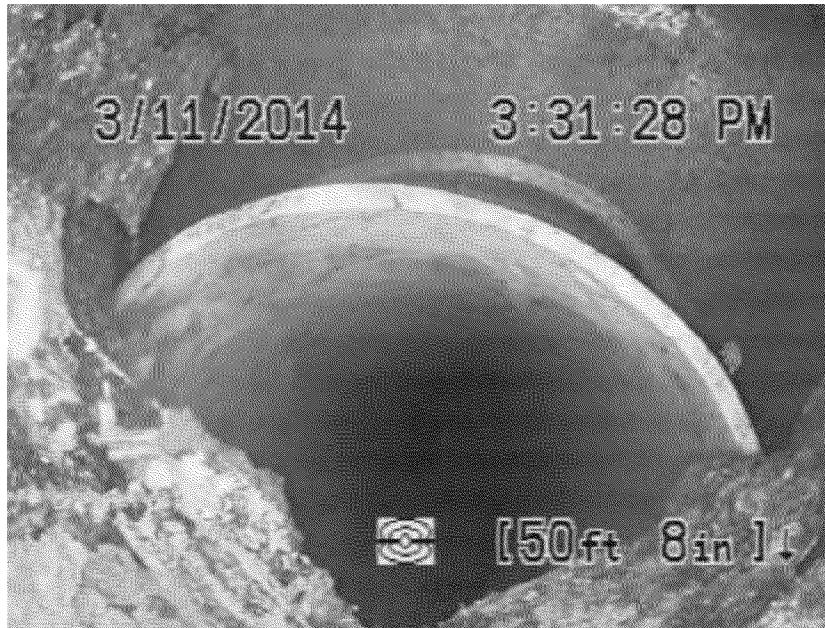
Figure 42. Dislocated joint between an apparently white plastic pipe and cast iron sewer lateral. Source: FES.

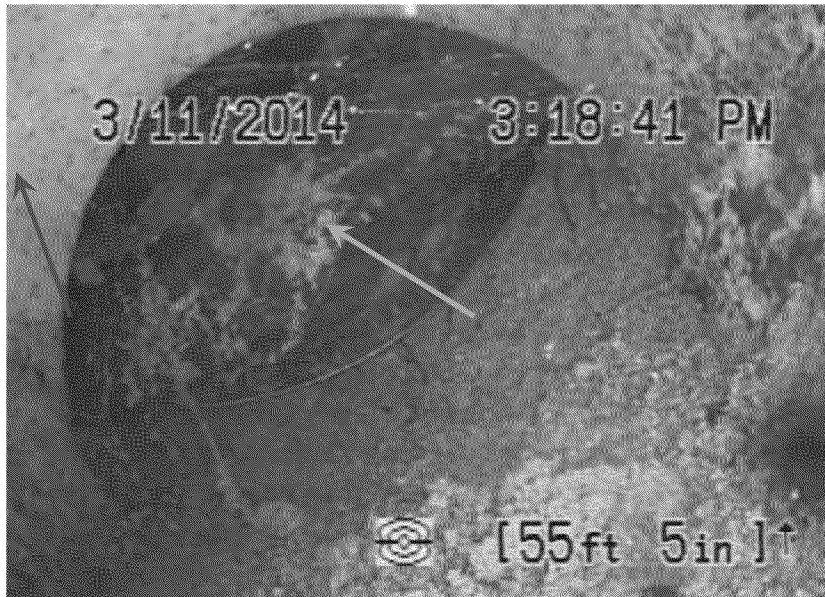
Figure 43. Sewer lateral joint offset at connection between white plastic pipe segment (green arrow) and apparent cast iron pipe (yellow arrow). Source: FES.

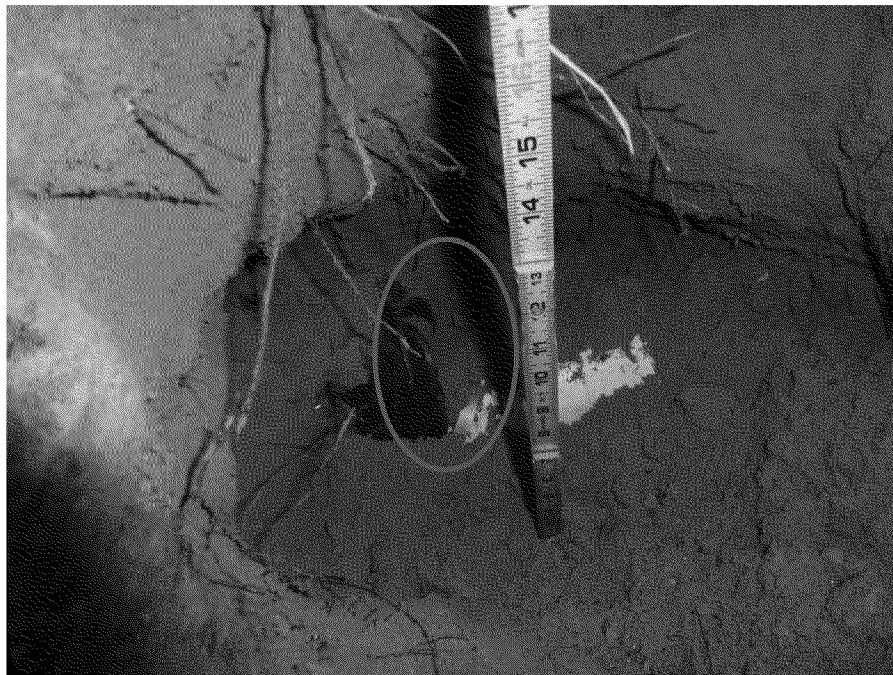
Figure 46. Sewer lateral offset joint (green oval), and white plastic segment of sewer lateral. Sand backfill surrounding sewer lateral. Photograph by Exponent on March 21, 2014.

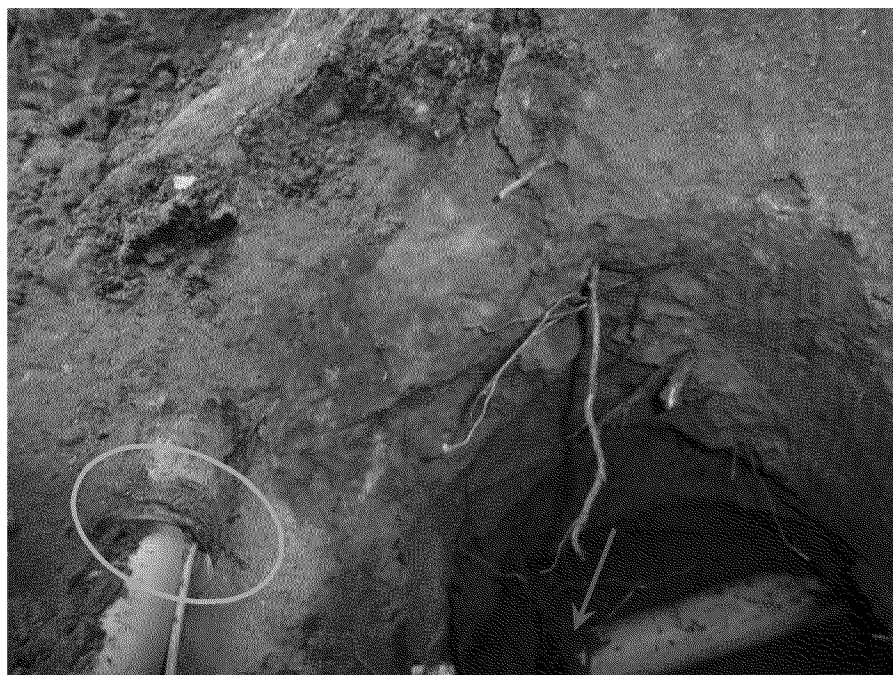
Figure 47. End of annular space in gas main along Redacted (yellow oval) in vicinity of sewer lateral offset joint (green arrow). Photograph by Exponent on March 21, 2014.

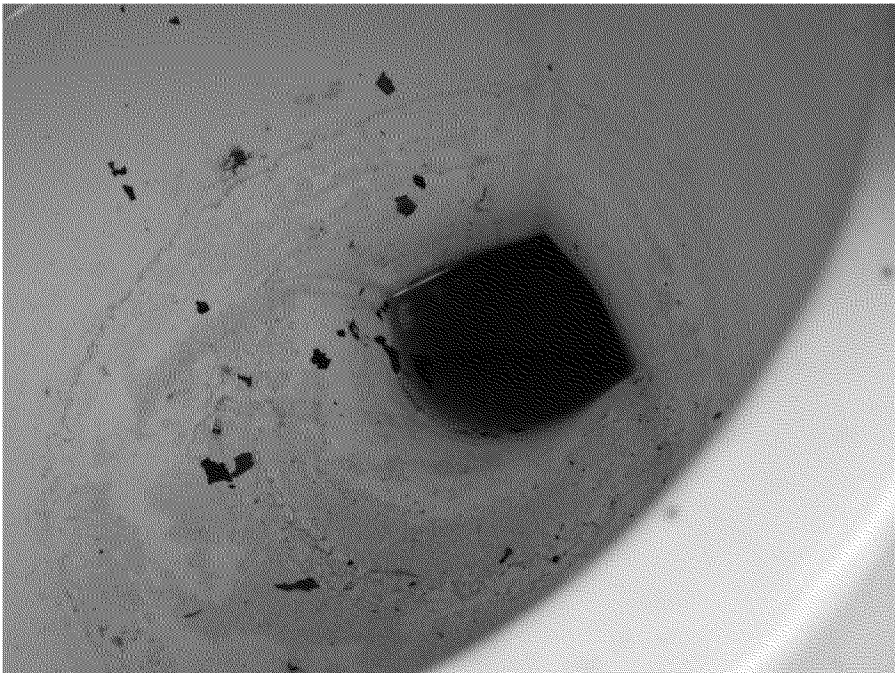
Figure 50. Low water level in the bathroom toilet bowl three days after explosion. Photograph by Exponent on March 6, 2014.

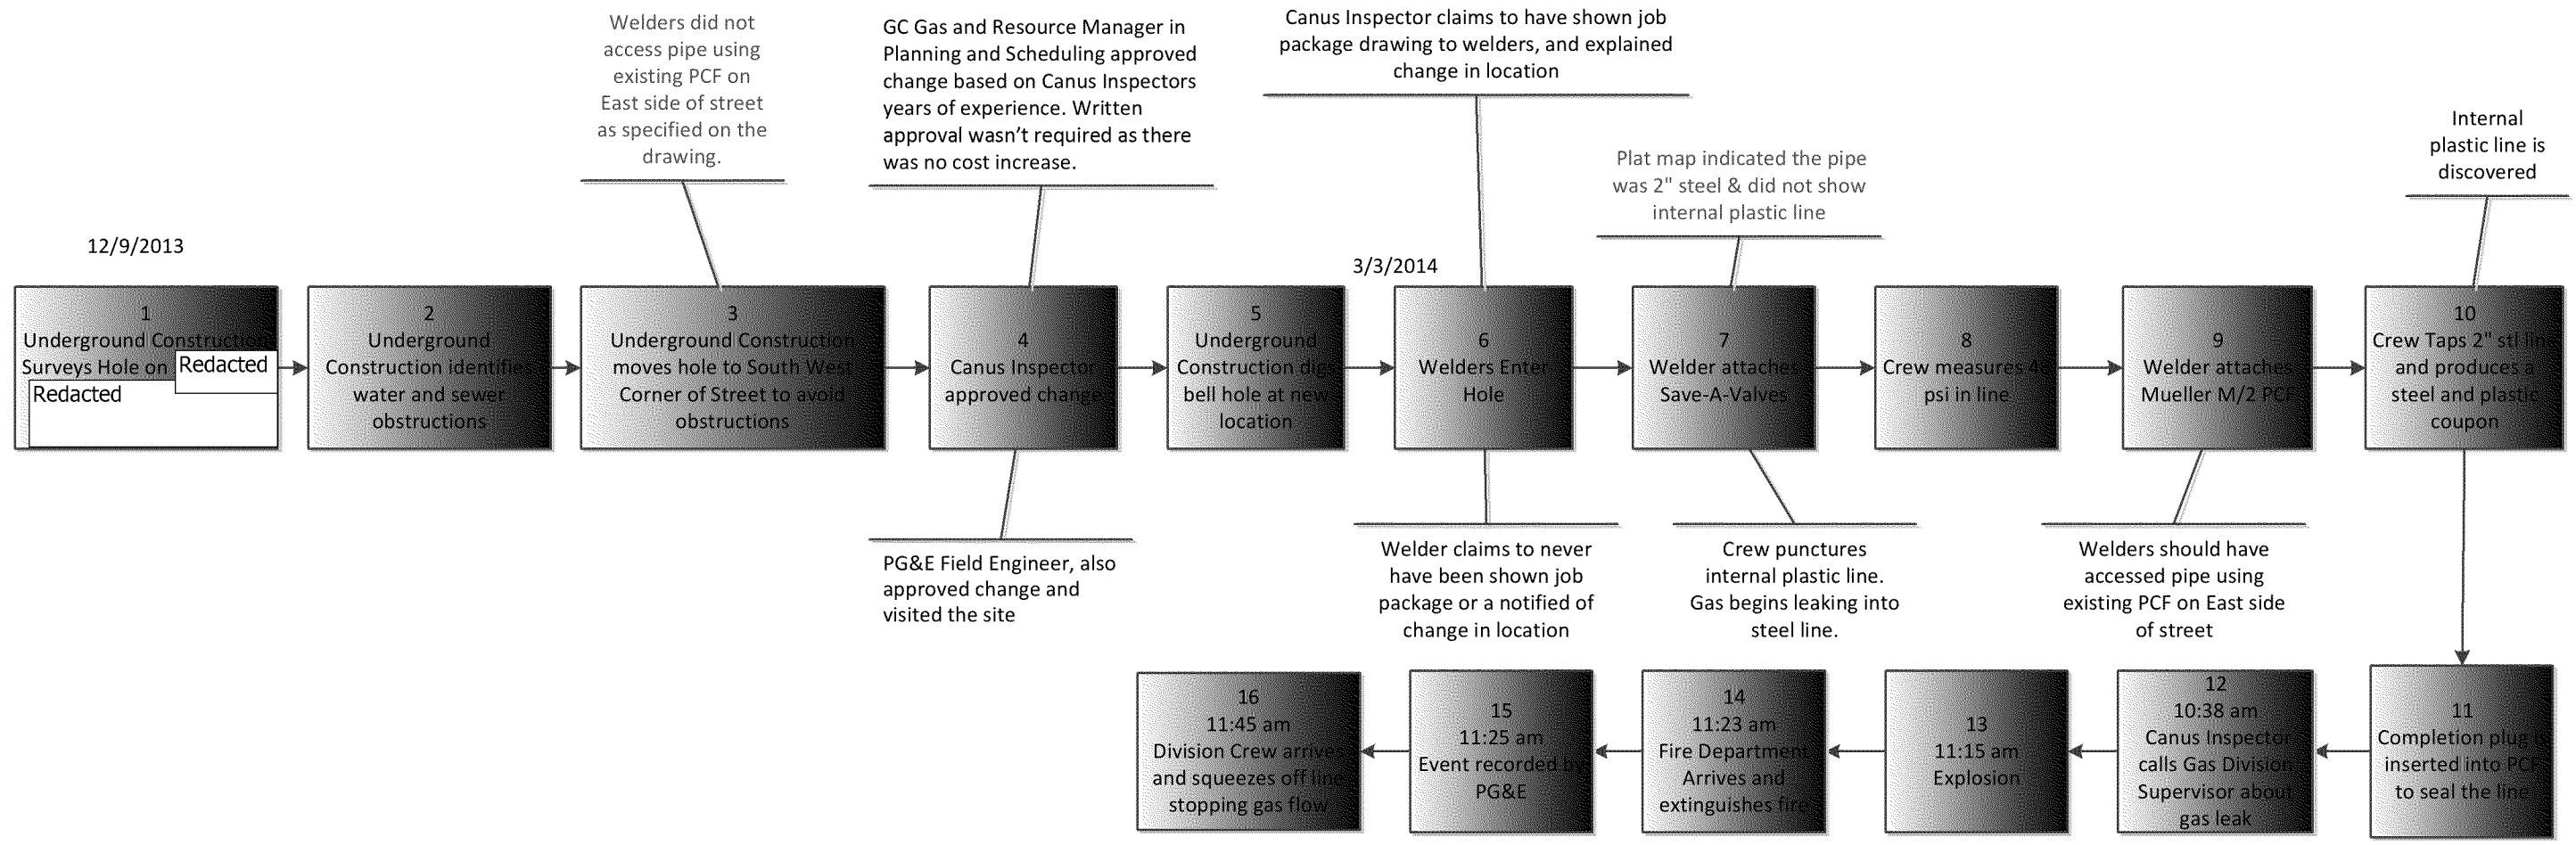
Carmel Gas Leak and Explosion Root Cause Diagram

***Inadequate verification of system status and configuration
when performing work on a live line.***
