Surge Arrester Grounding

Briefing for SED

April 22, 2014

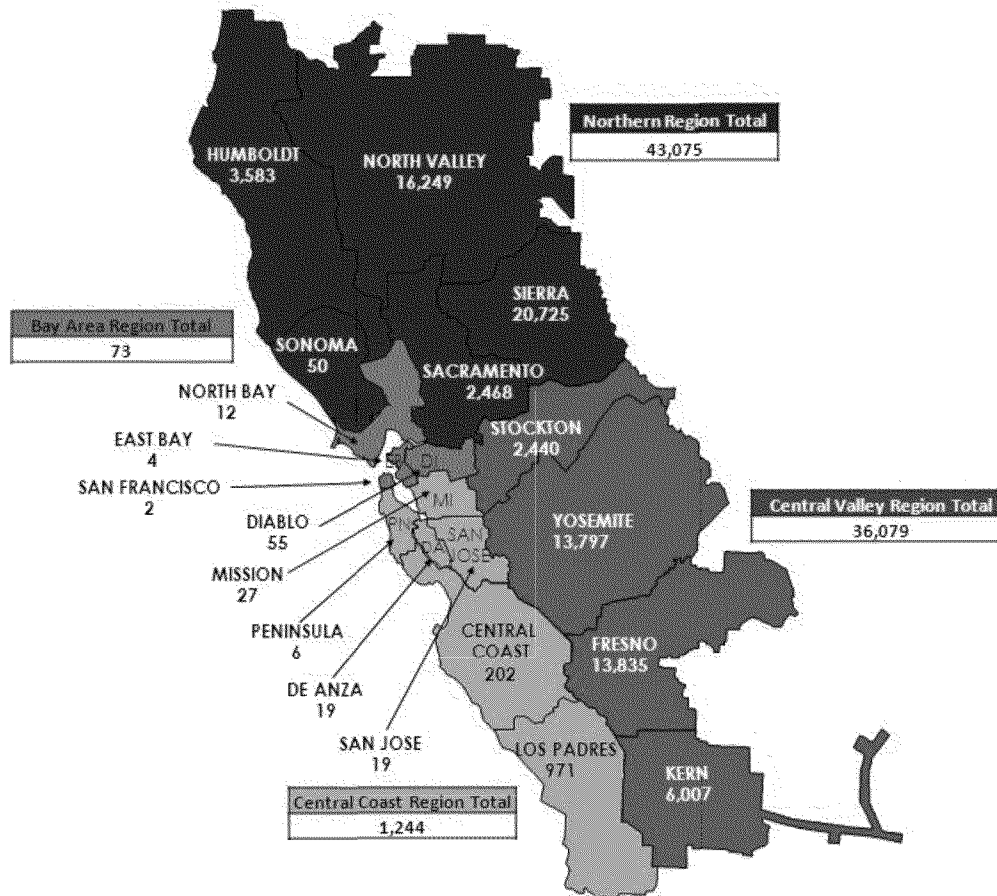
Transformers with Surge Arresters Installed 1975 - 2008

80,471 transformer locations with surge arrester installed in 1975 – 2008 were identified in the Centralized Electric Distribution System Assets (CEDSA) data base.
