**FINAL REPORT
VOLUME I
R-PG&E-20140117**

Pacific Gas and Electric Company

Tree Root Interference Assessment

January 17, 2014

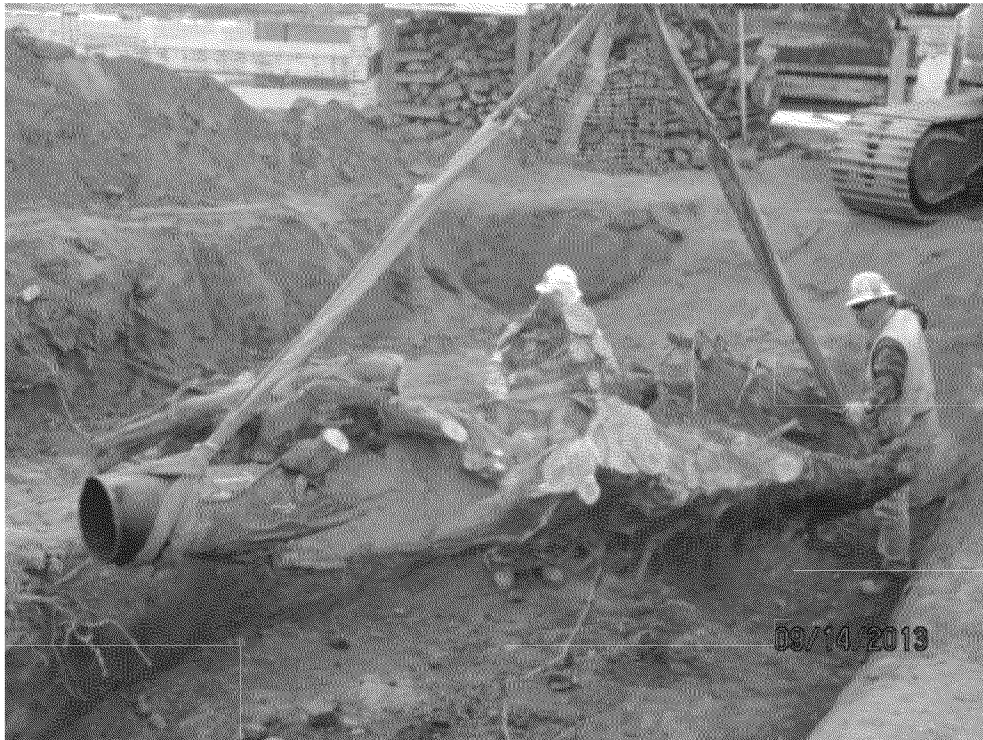
Figure 6. RWVIM-90-13 (Hall Road)

Tree root and pipeline interactive conditions were reviewed relative to the potential for pipeline structural damage. An example of one location where the tree root ball was situated directly on top of the pipe and the tree roots encapsulated the buried pipe is presented in Figure 6 (RWVIM-90-13, Hall Road).

The Hall Road site provides evidence of what can occur when a tree root ball and root system is located in close proximity to a buried pipeline. A primary concern under these conditions is that weather (e.g., high force winds, flooding, seismic events) may cause tree and root movement, resulting in pipe damage. In addition, since the buried pipeline and tree root systems are interconnected, a lightning strike to the tree would most likely also impact the pipeline and provide an electrical path for the strike and may also provide a path for the electrical discharge.
