Carmel Gas Incident

April 2014

Doc. no. 1401752.000 - 4253

Pacific Gas and Electric (PG&E) has retained Exponent Failure Analysis Associates (Exponent) to conduct a failure analysis investigation of a gas leak and subsequent explosion on March 3, 2014 in Carmel-by-the-Sea (Carmel), California.

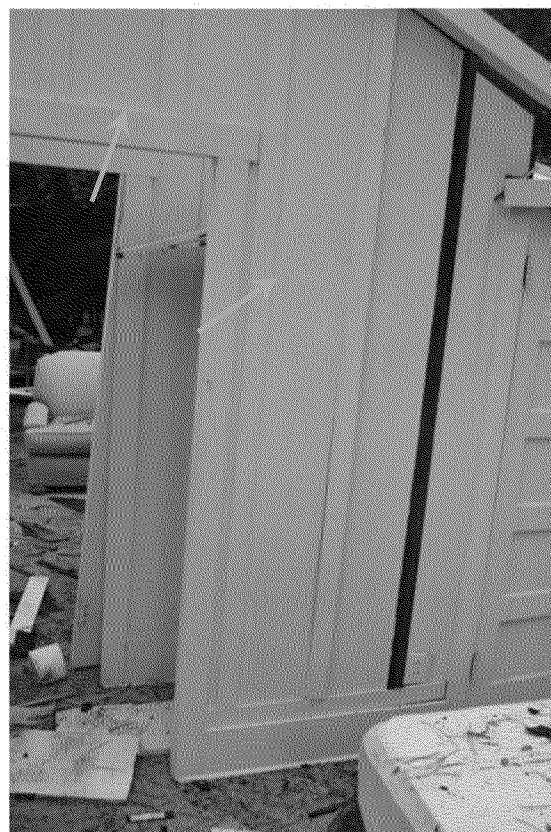
Exponent's interior inspections of the subject house⁹ discovered limited evidence of fire inside the house. Some of the paint on the walls of the living and bedrooms had signs of high temperature (blistering), but very few signs of sustained flame impingement (Figure 11 and Figure 12). Some of the debris showed a small amount of charring. The bathroom was the only place where clear signs of sustained fire were observable. There was a distinct fire pattern on the South wall next to the toilet and on the toilet bowl, toilet seat, and tank (Figure 13 through Figure 15). PG&E provided Exponent with a photograph taken shortly after the explosion (Figure 16). The photograph shows flames in the bathroom, matching the location of the observed fire patterns.

Figure 11. Interior walls and furniture. An unburned couch in the living room is visible in the background and the corner of an unburned mattress is visible in the foreground. Yellow arrows indicate some areas of wall blistering. Photograph by Exponent on March 6, 2014.

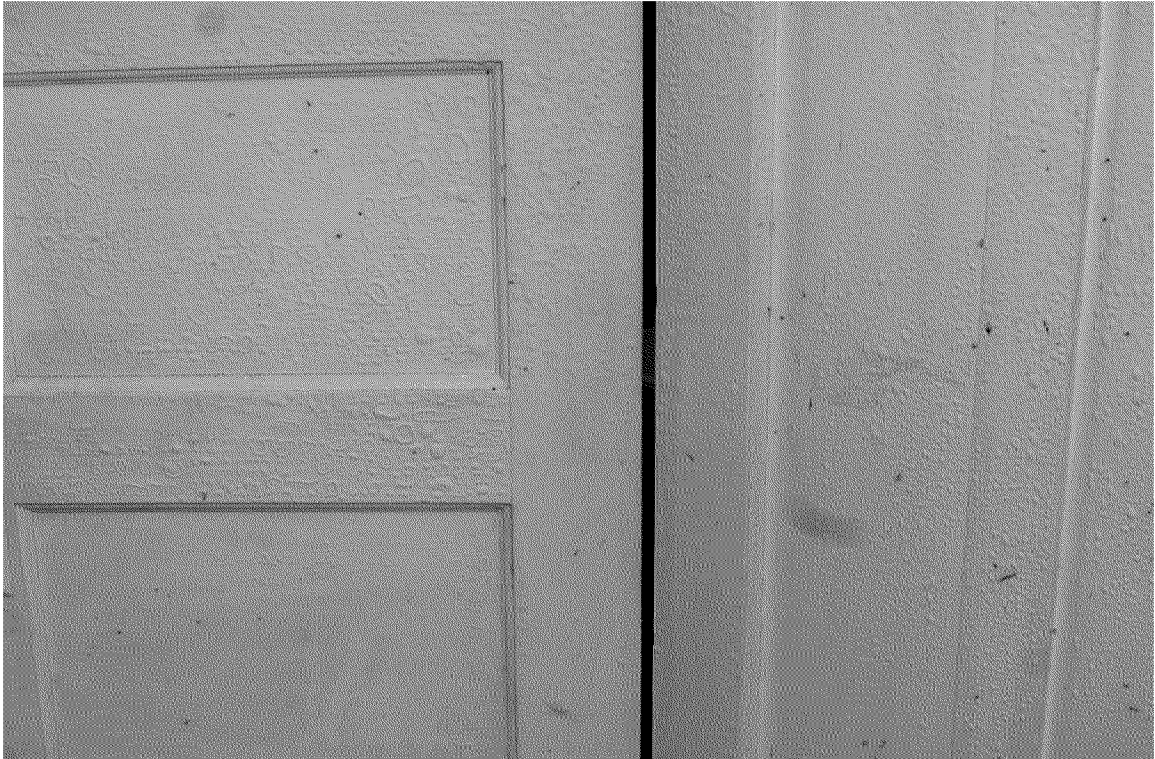
Figure 12. Close-up of the paint blistering on bedroom wall and door. Photograph by Exponent on March 7, 2014.

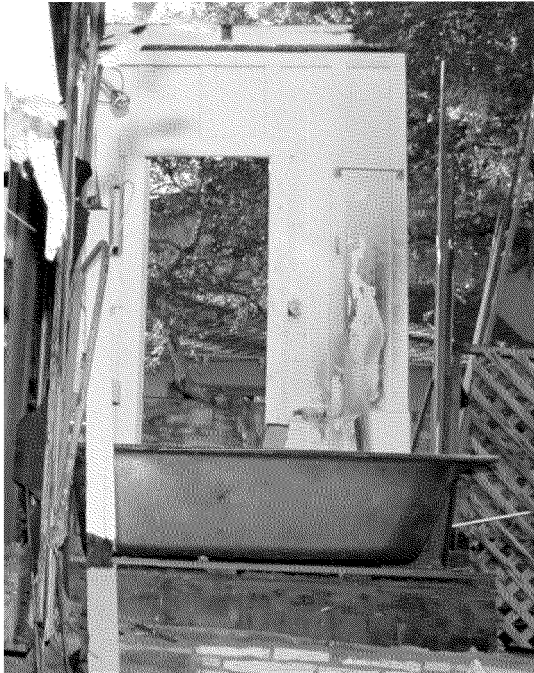
Figure 13. Fire pattern on bathroom wall, looking South from [Redacted] Photograph by Exponent on March 7, 2014.

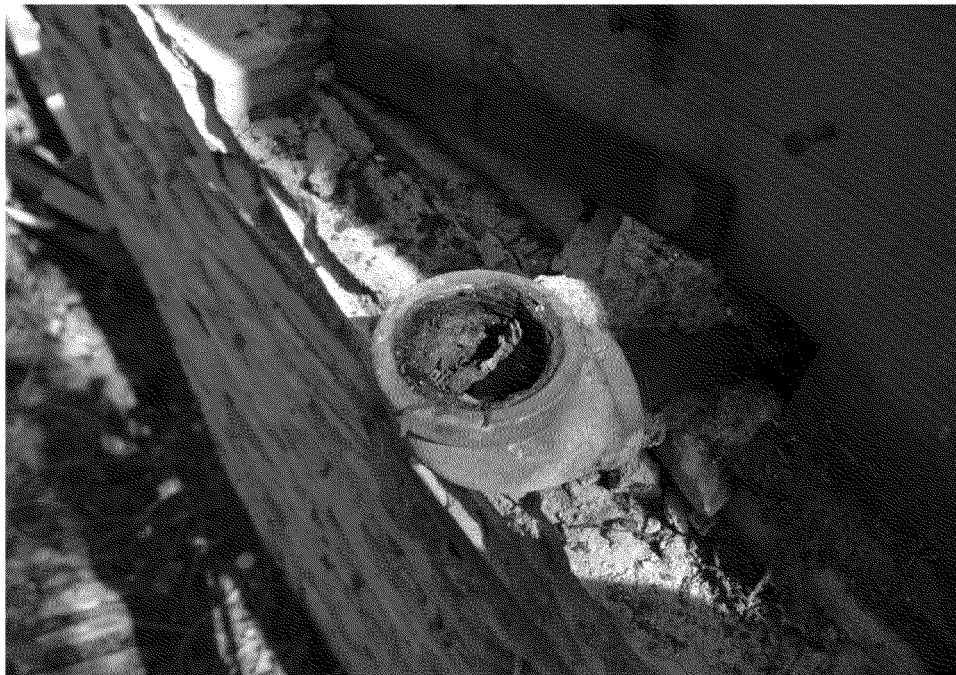
Figure 19. Vent pipe (broken off) in the bathroom. Photograph by Exponent on March 7, 2014.

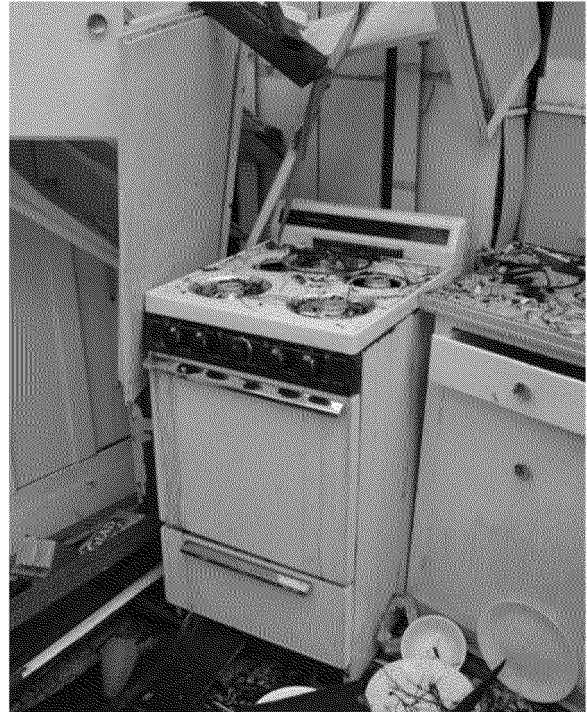
Figure 20. Location of kitchen stove. Photograph by Exponent on March 6, 2014.

Stove – A kitchen stove was present in the subject house. The location of the stove is shown in Figure 20. The appliance shut-off valve for the stove was found in the open position and the stove was equipped with a continuous pilot flame (Figure 21). Based on these facts, the stove cannot be ruled out as a likely ignition source for the incident explosion.

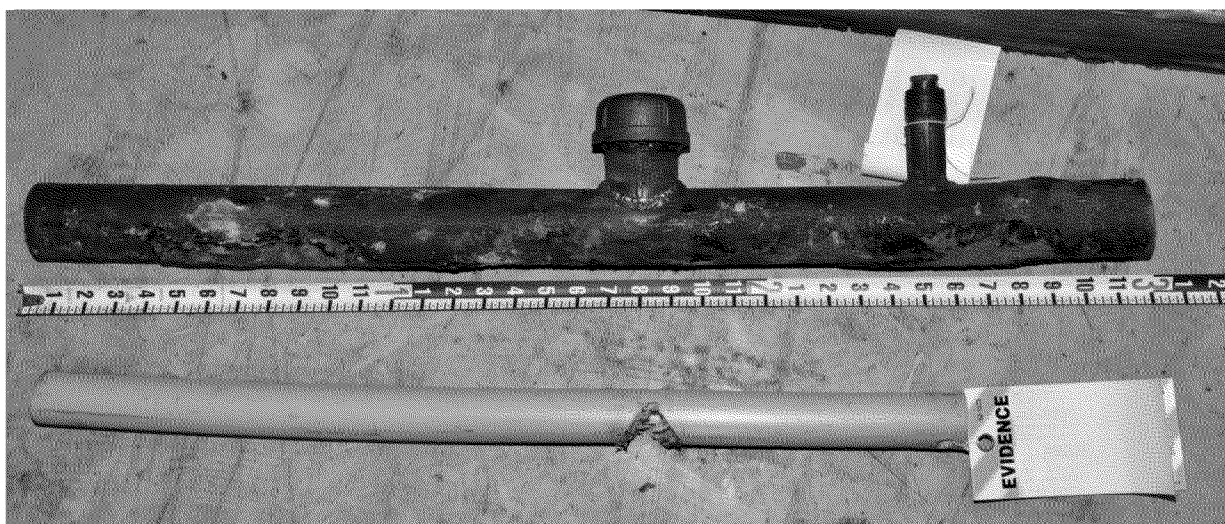
A three foot long section of the 2-inch steel main running along [Redacted] was removed from the bell hole at the intersection of [Redacted] (Figure 27). The steel pipe segment has two welded fittings that were installed on March 3, 2014; one is a one-inch Save-a-valve fitting and the other is a two-inch M/2 line stopper fitting. There were no obstructions either in the main pipe or the two ports.

Figure 27. Portion of the gas main along [Redacted]. Steel pipe (top) with welded fittings and plastic pipe insert. Photograph by Exponent on March 10, 2014.

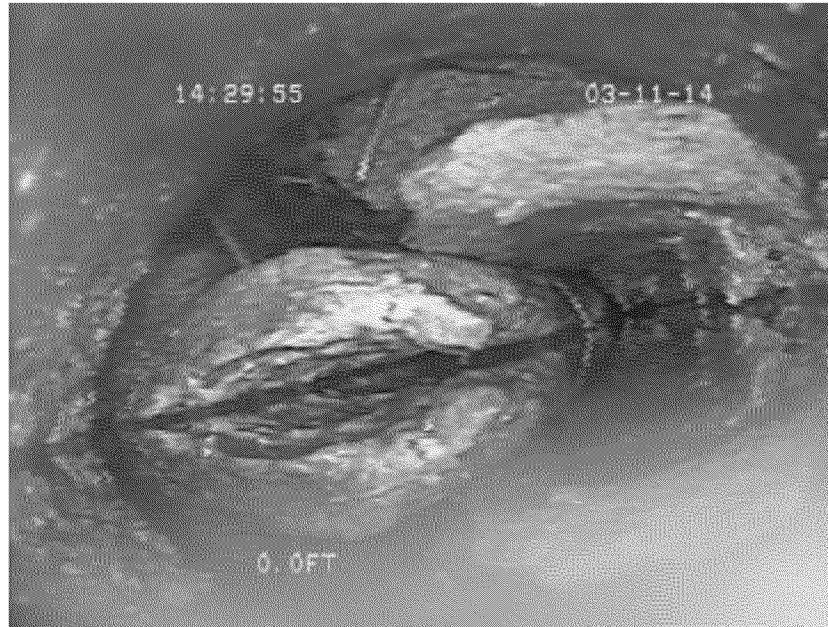
The sewer main south of the manhole along [Redacted] consisted of an unlined clay pipe, with an approximate diameter of 8 inches. A collapse was observed approximately 1-½ to 2 feet

south of the manhole (Figure 37). Standing water was observed in the collapsed area. The area of the observed collapse appears to be aligned with the storm pipe system.

Figure 37. Collapse of sewer main along Redacted south of manhole. Standing water at bottom. Source: FES.

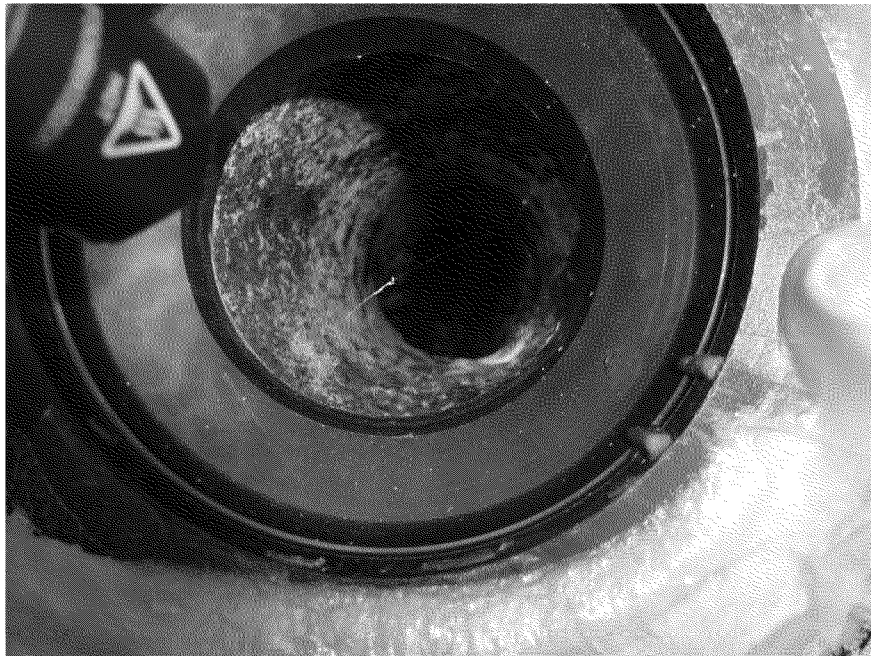
Figure 40. Sewer pipe raiser below toilet. Cast iron pipe is dry, spider webs are visible. Photograph by Exponent on March 11, 2014.

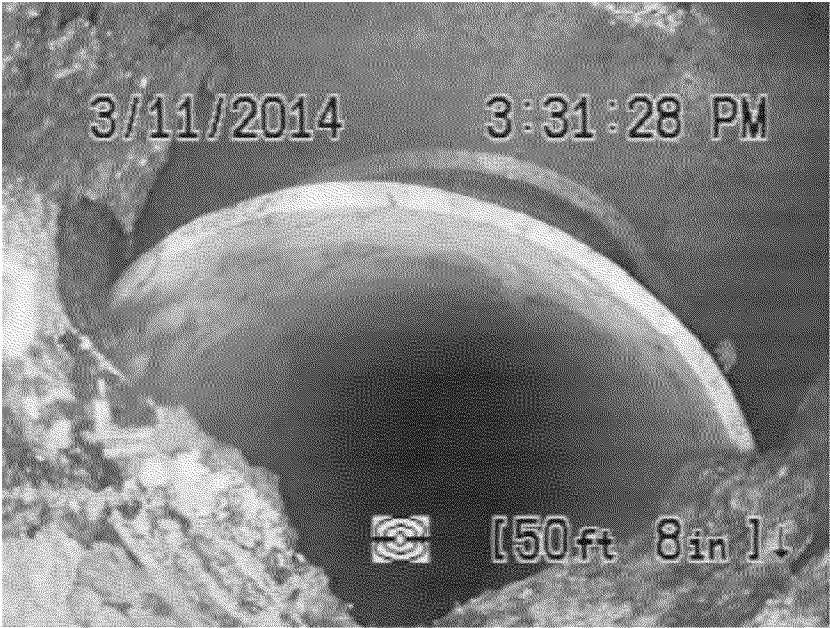
Figure 42. Dislocated joint between an apparently white plastic pipe and cast iron sewer lateral. Source: FES.

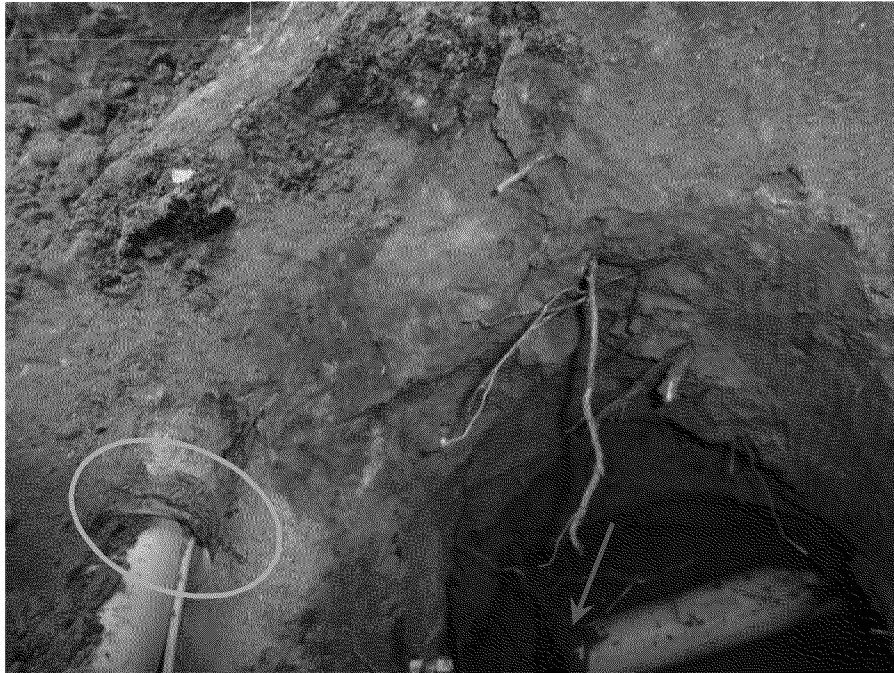
Flow through annular space: The released natural gas traveled through the annular space between the inserted plastic pipe and the steel pipe in both directions (east and west) along [Redacted] away from the plastic pipe leak. Upon reaching the end of the 2-inch steel pipe, the gas exited the annular space and flowed into the soil.

Figure 47. End of annular space in gas main along [Redacted] (yellow oval) in vicinity of sewer lateral offset joint (green arrow). Photograph by Exponent on March 21, 2014.
