Threats Posed by Trees on ROW

For CPUC
By Transmission Asset Integrity Management

April 23, 2014

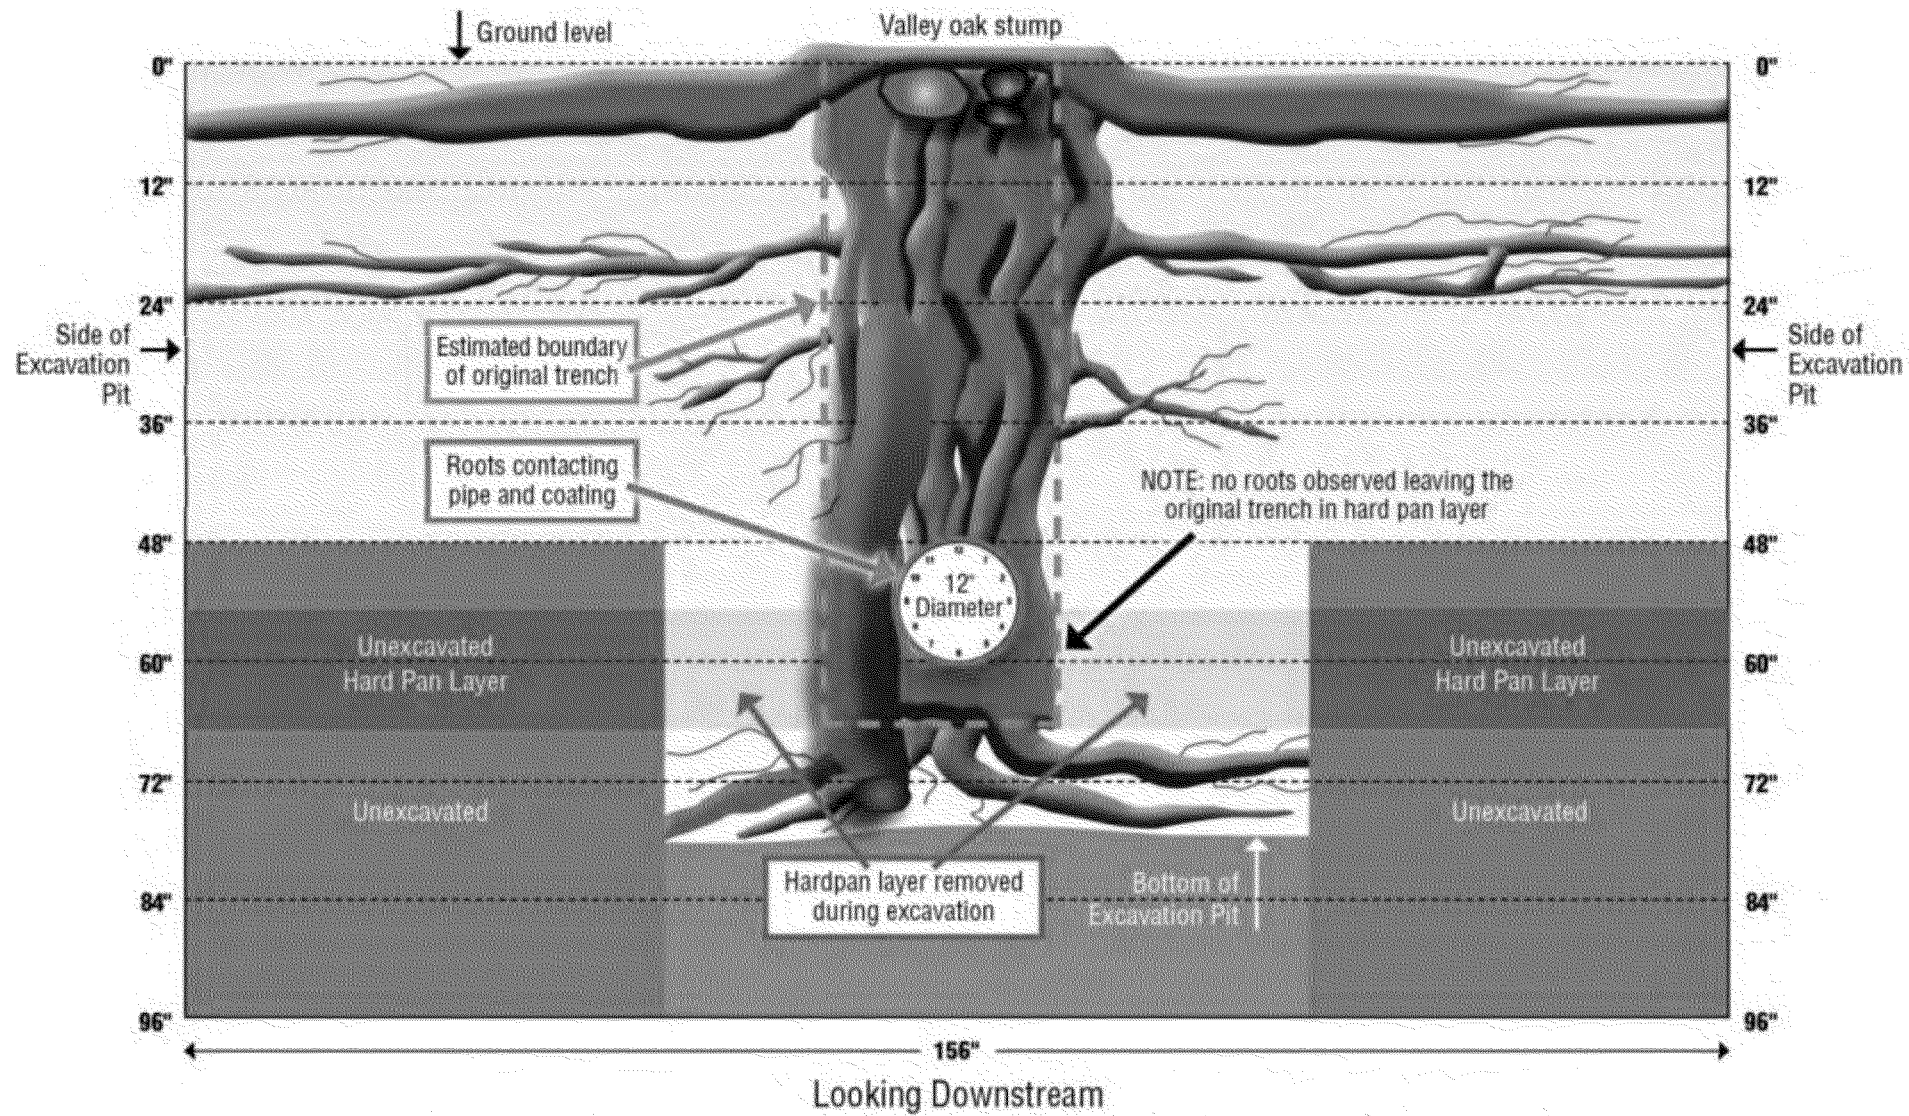
Hall Road Case Study

Excavation was accomplished by destructive methods using a trackhoe excavator. The integrity of the root system could not be maintained as the excavation proceeded, therefore, this graphic is strictly the root inspector and graphic artist's best estimate of the actual root architecture that existed underground.

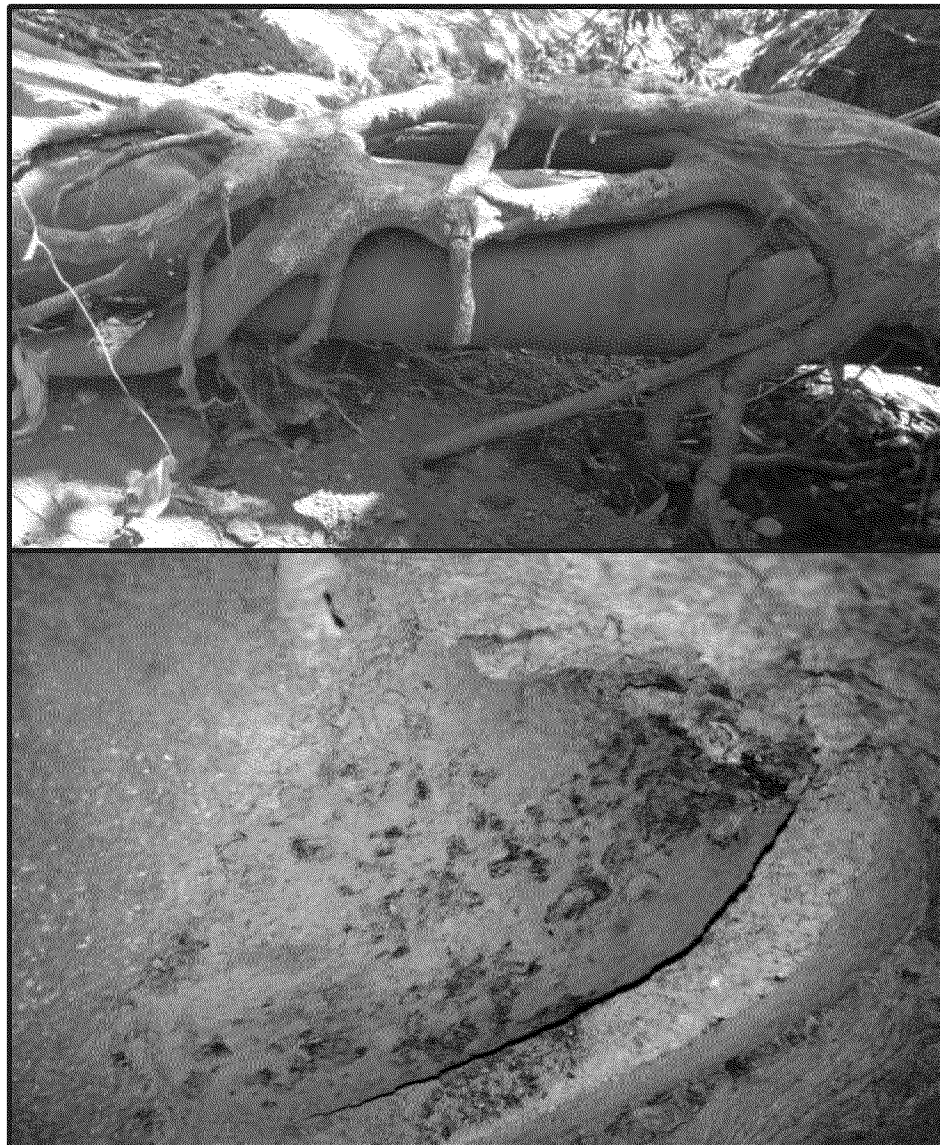
- **Coating damage was observed in 75% of excavated sites**
- **Corrosion observed in 38% of the excavated sites**
- **Extent of damage varies by coating type and other local conditions; unclear whether any difference by tree type.**

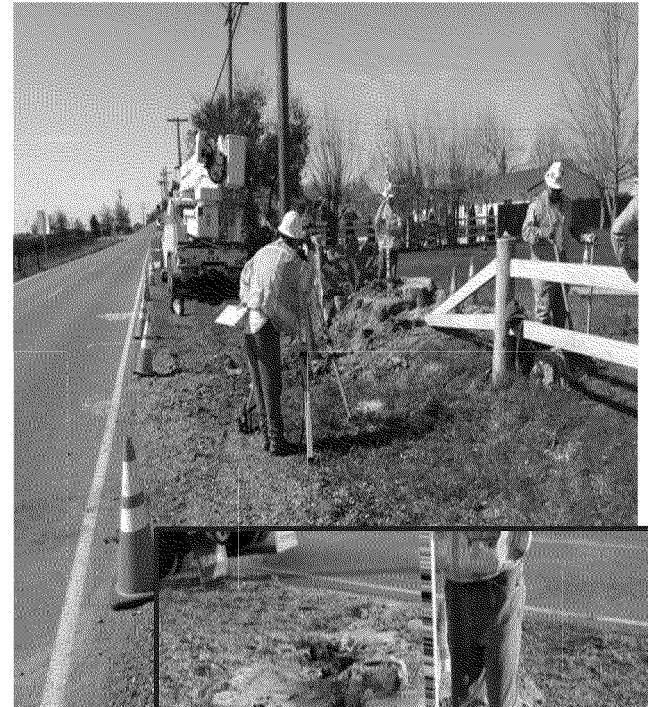
- **Minimal vertical displacement measured**
