Carmel Gas Incident

Prepared for

Sumeet Singh
Pacific Gas and Electric Company
6111 Bollinger Canyon Road
San Ramon, CA 94583

Doc. no. 1401752.000 - 6877

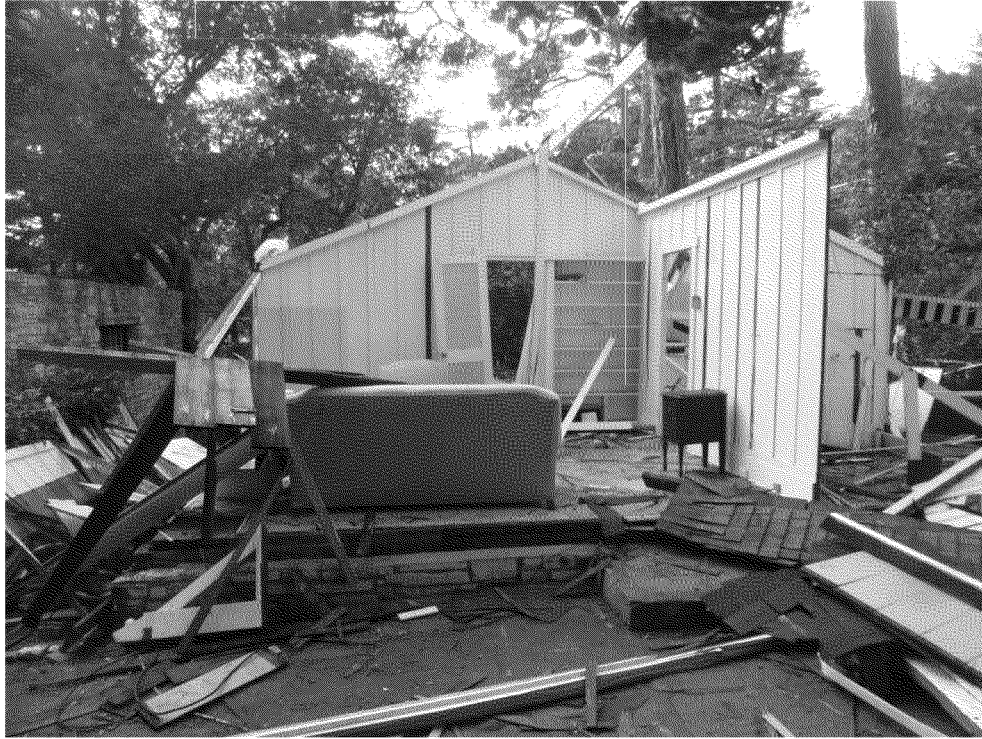
Exponent's initial site inspection of the house after the explosion, on March 4, 2014, revealed extensive low-order and high-order damage to the first floor areas that were visible from the perimeter of the property.¹¹ All exterior first floor walls of the subject residence had been blown out and the roof had been torn into pieces and scattered in the surrounding area. Only

some of the interior walls remained in place (Figure 9 and Figure 10). Debris was scattered across the property and in nearby trees.

Figure 9. Incident house looking West from the entryway. Photograph by Exponent on March 4, 2014.

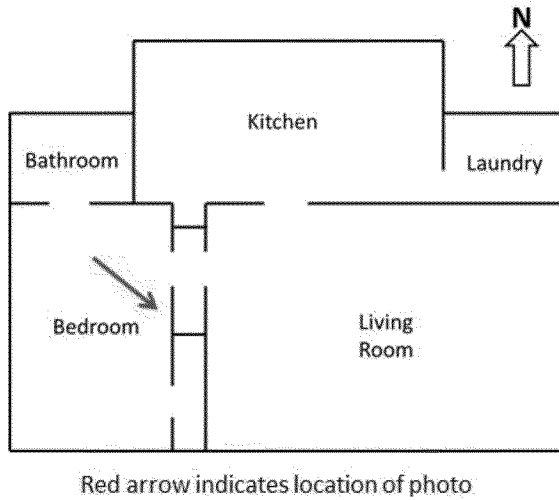
Figure 11. Interior walls and furniture. An unburned couch in the living room is visible in the background and the corner of an unburned mattress is visible in the foreground. Yellow arrows indicate some areas of wall blistering. Photograph by Exponent on March 6, 2014.

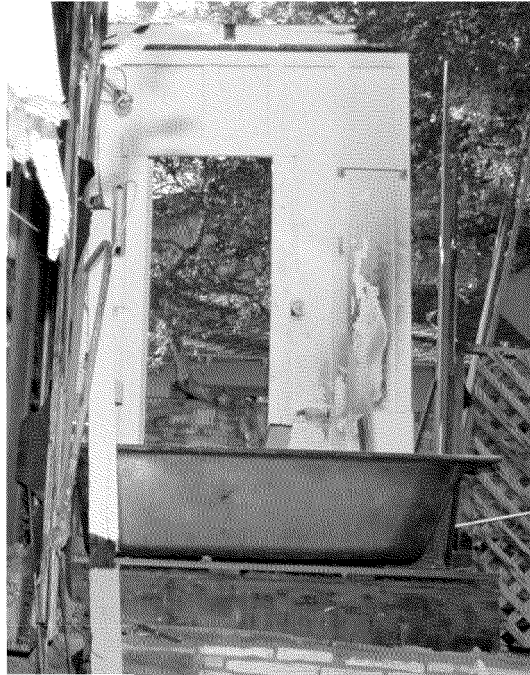
Figure 13. Fire pattern on bathroom wall, looking South from [Redacted] Photograph by Exponent on March 7, 2014.

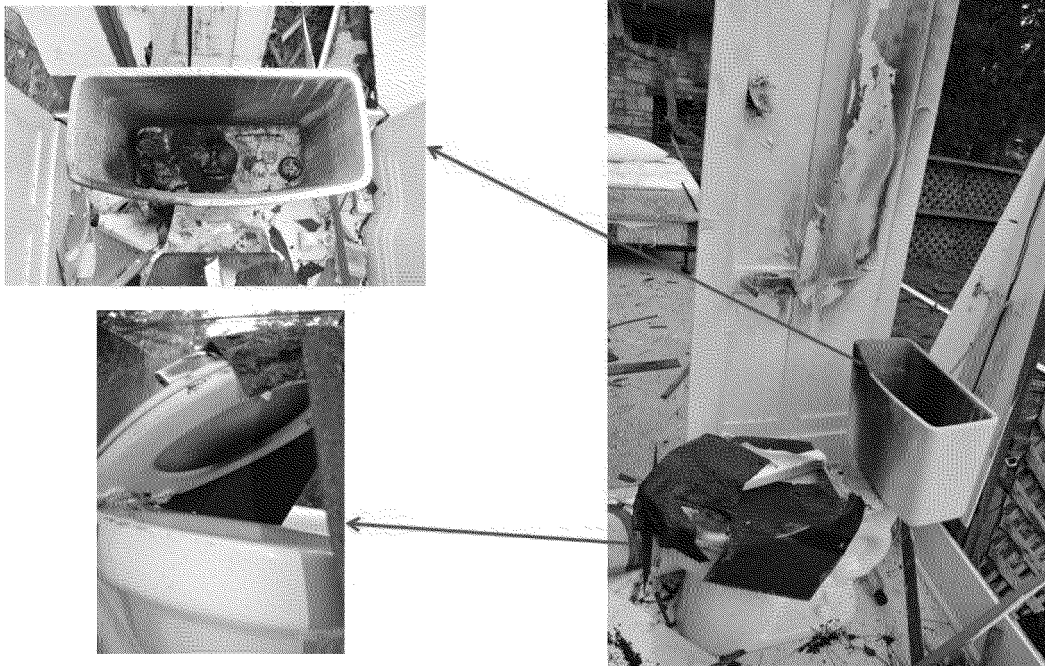
Figure 15. Damage to bathroom toilet. Burn marks below toilet seat and melted components inside toilet tank. Photographs by Exponent on March 6, 2014.

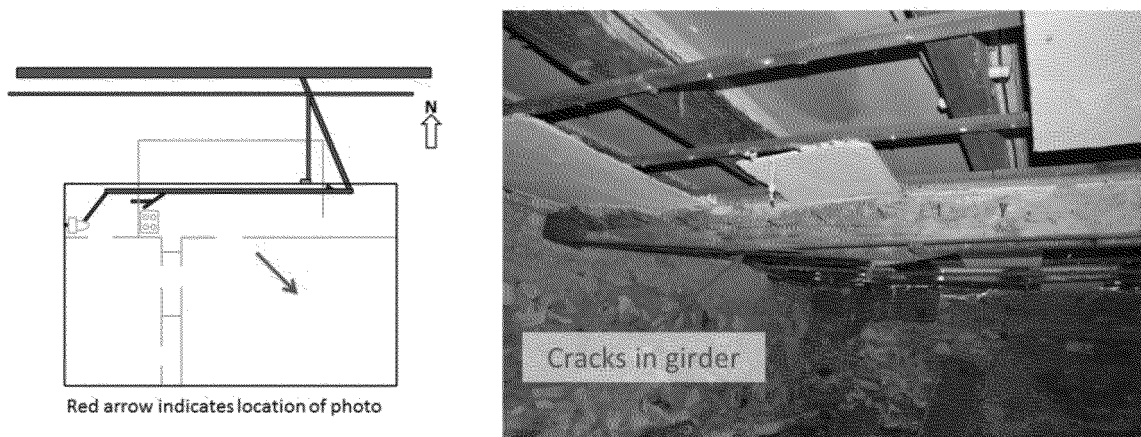
The basement area showed limited damage compared to the main floor. The perimeter walls did not show evidence of damage from the recent explosion and the windows' glasses were undamaged. The ceiling finishes had collapsed in several areas and two of the wooden beams showed longitudinal cracks (Figure 17).

An Exponent engineer deemed the first floor of the structure unsafe due to recent damage to joists and girder framing. Shoring of the first floor from the basement level was recommended in order to continue inspection on the first floor. Recommendations were also made to remove falling hazards from trees, neighboring bushes, and cantilevered portions of the structure.

Figure 17. Incident house basement. Ceiling girder with multiple longitudinal cracks. Photograph by Exponent on March 5, 2014.

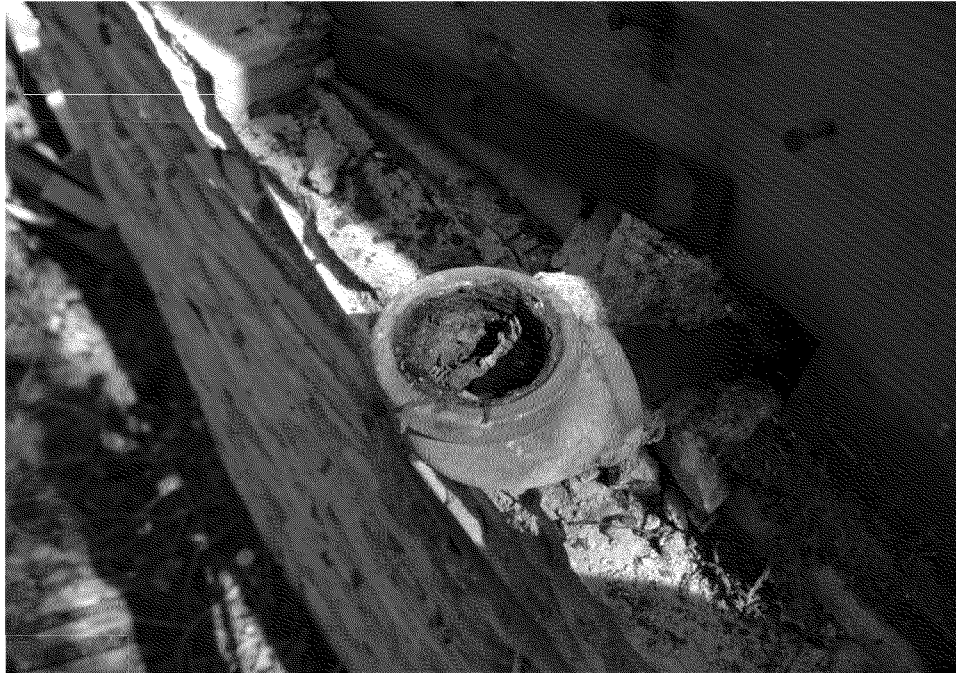
The sewage system of the house was visually inspected from the basement and through the remaining walls. Some of the sewage vent pipes had been blown off; inspection of the vents revealed the presence of debris inside them (Figure 18 and Figure 19).

Figure 19. Vent pipe (broken off) in the bathroom. Vent pipe likely broken off during the explosion. Photograph by Exponent on March 7, 2014.

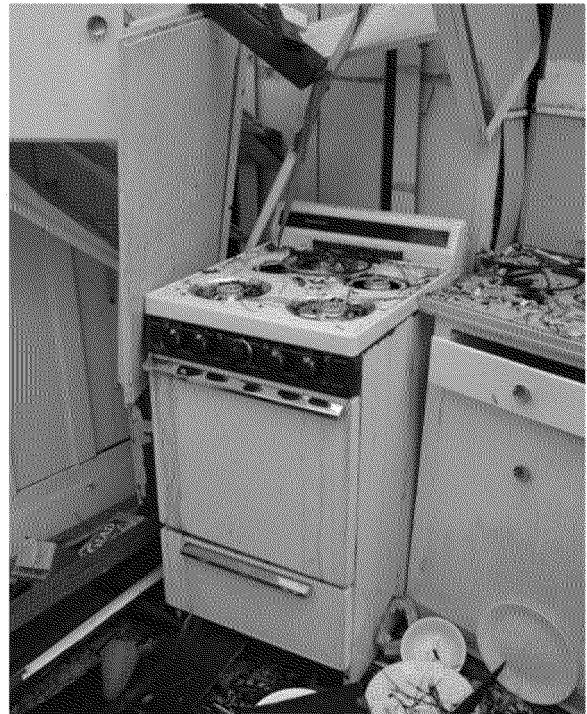
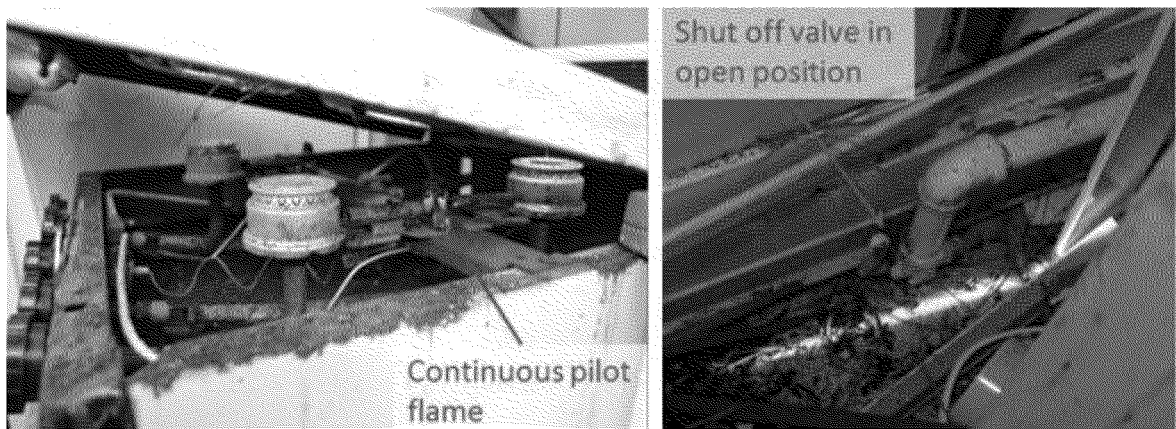
Stove: A kitchen stove was present in the subject house. The location of the stove is shown in Figure 20. The appliance shut-off valve for the stove was found in the open position and the stove was equipped with a continuous pilot flame (Figure 21). Based on these facts, the stove cannot be ruled out as a likely ignition source for the incident explosion.

Figure 20. Location of kitchen stove. Photograph by Exponent on March 6, 2014.

Figure 21. Kitchen stove components. Photographs by Exponent on March 6, 2014.

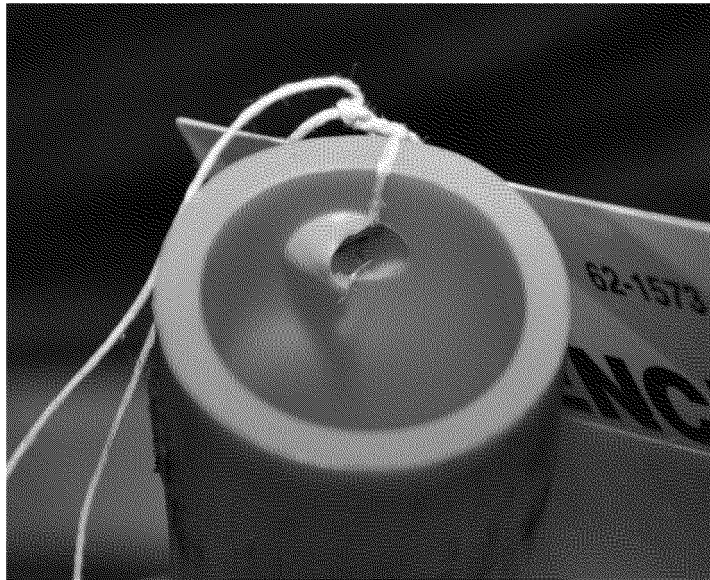
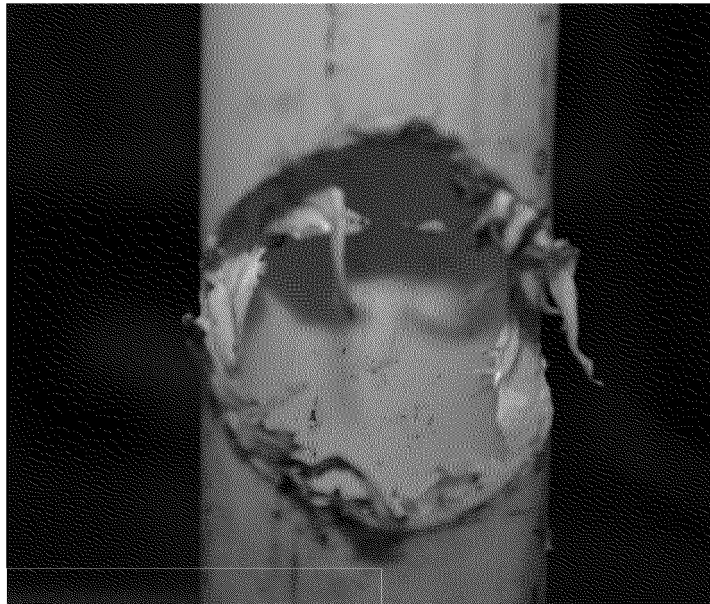
Gas leak: Inspection of the 2-inch gas main and inserted 1¼-inch plastic piping shows that there was a hole created in the plastic pipe after the Save-a-valve was tapped. This hole resulted in a pressurized natural gas release from the plastic pipe. The gas leak at this location may have started when the Save-a-valve was welded onto the steel pipe, before the Save-a-valve was tapped. A second hole was introduced into the plastic pipe when an M/2 line stopper fitting was tapped a short time after the first tapping operation. This second hole caused additional gas to leak.

pipes (Figure 28). The plastic line segment has two perforations that correspond to the Save-a-Valve and M/2 fittings (Figure 29). There are some markings printed along the exterior of the pipe. A portion of the writing is associated with the fabrication date; in this particular piece only the year is visible, 1997 (Figure 30).

Figure 29. Perforations in plastic gas line: Save-a-Valve fitting (top) and M/2 fitting (bottom). Photographs by Exponent on March 10, 2014.

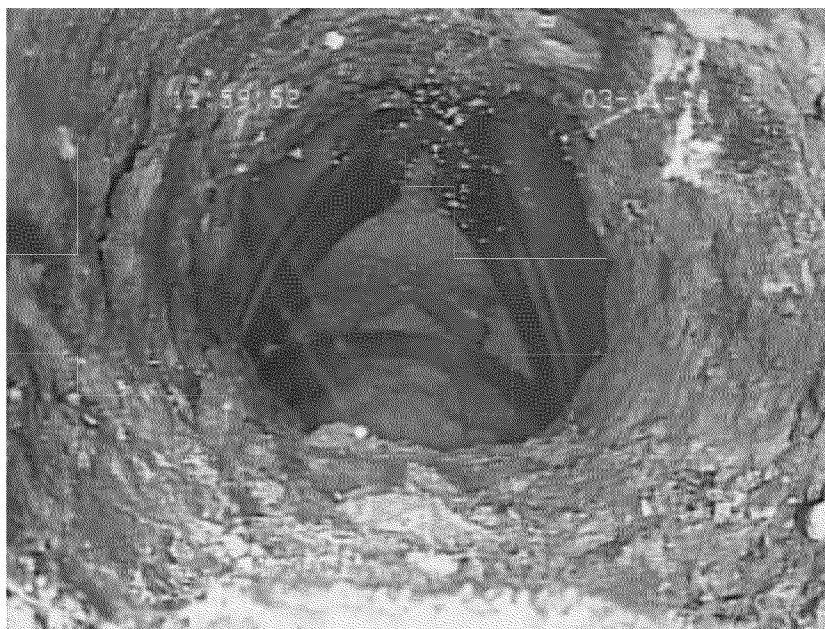
Gaps around the sewer lateral (at the break tap) and the sewer main were observed. The lateral was an approximately 4-inch cast iron pipe for the subject residence. As shown in Figure 36, the sewer lateral had debris accumulated around its interior perimeter and showed clear evidence of lack of recent use, including presence of spider webs, dryness and deterioration.

Figure 36. Sewer lateral conditions approximately 5 feet from tap with sewer main. Deterioration, spider webs and debris in cast iron pipe in area closest to camera. Separation and dislocation of lateral away from camera. Source: FES.

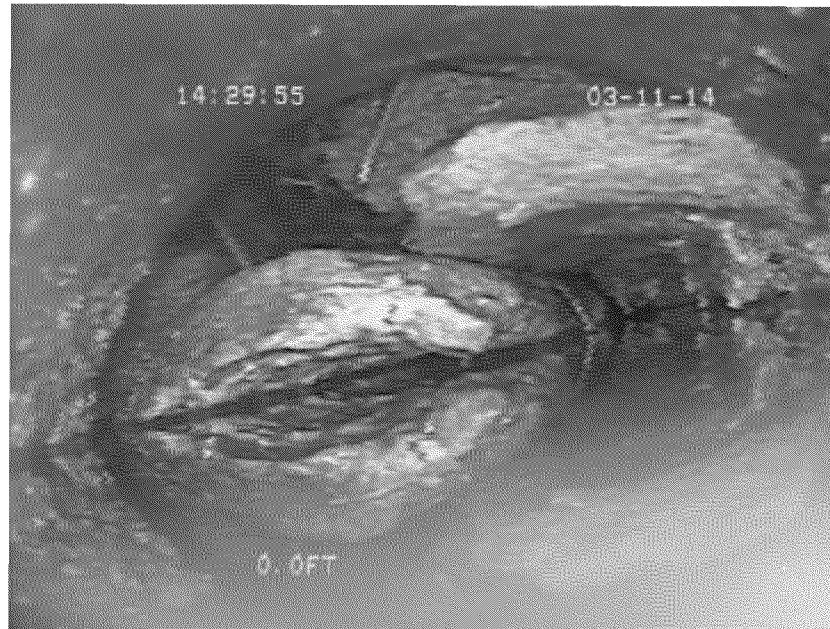
The sewer main south of the manhole along [Redacted] consisted of an unlined clay pipe, with an approximate diameter of 8 inches. A collapse was observed approximately 1½ to 2 feet

Figure 37. Collapse of sewer main along [Redacted] south of manhole. Standing water at bottom. Source: FES.

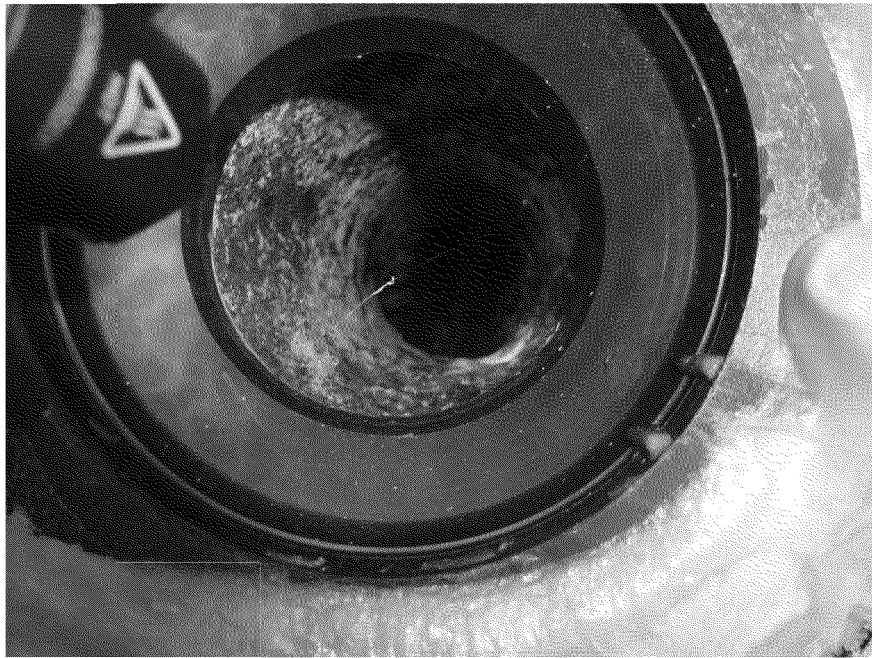
Figure 40. Sewer pipe riser below toilet. Cast iron pipe is dry, spider webs are visible. Photograph by Exponent on March 11, 2014.

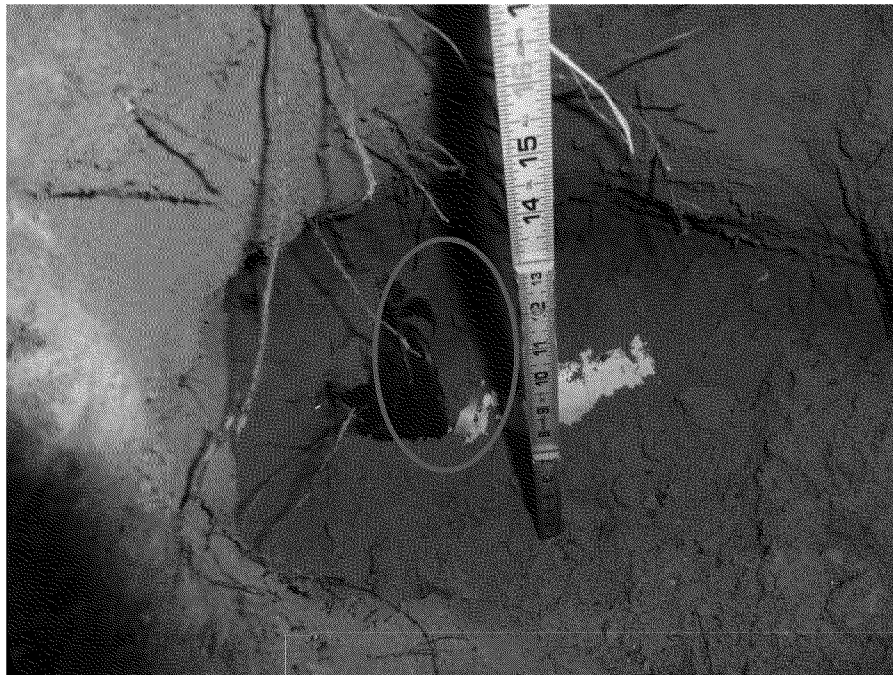
Figure 46. Sewer lateral offset joint (green oval), and white plastic segment of sewer lateral. Sand backfill surrounding sewer lateral. Photograph by Exponent on March 21, 2014.

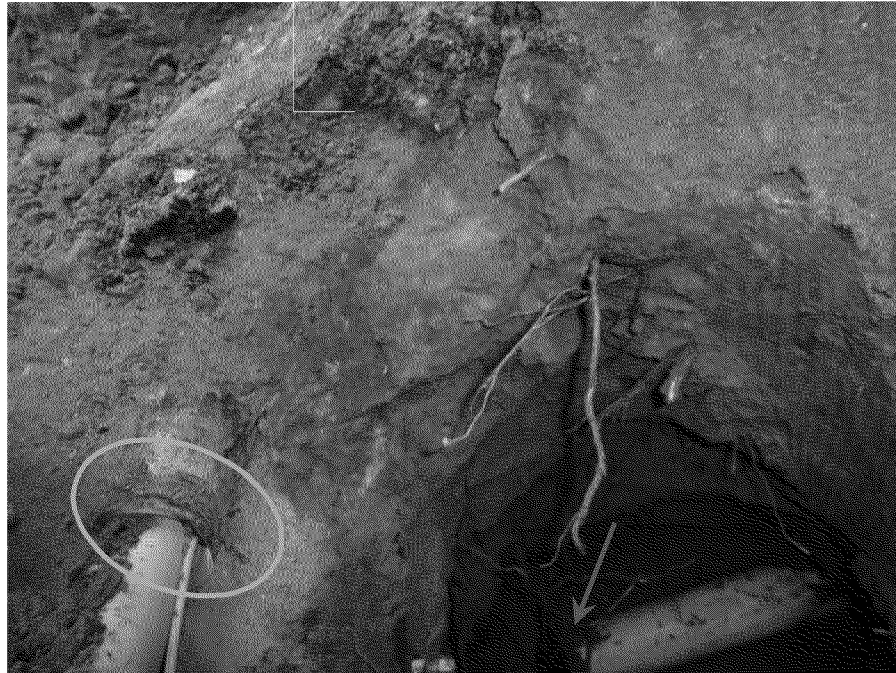
Flow through annular space: The released natural gas traveled through the annular space between the inserted plastic pipe and the steel pipe in both directions (east and west) along [Redacted] [Redacted], away from the plastic pipe leak. Upon reaching the end of the 2-inch steel pipe, the gas exited the annular space and flowed into the soil.

Figure 47. End of annular space in gas main along Redacted (yellow oval) in vicinity of sewer lateral offset joint (green arrow). Photograph by Exponent on March 21, 2014.

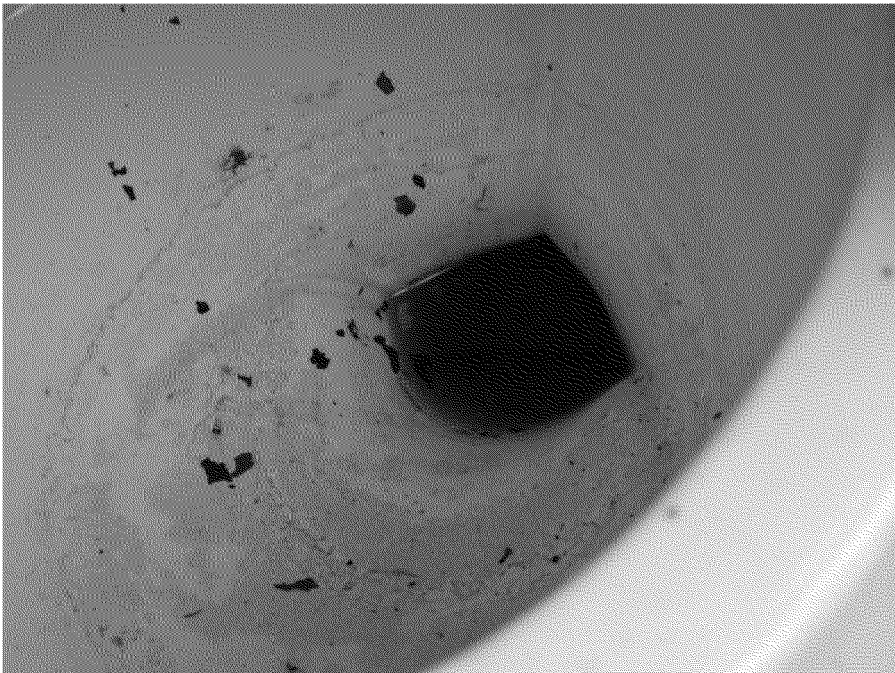
Figure 50. Low water level in the bathroom toilet bowl three days after explosion. Photograph by Exponent on March 6, 2014.
