**FINAL REPORT
VOLUME I
R-PG&E-20140117**

Pacific Gas and Electric Company

Tree Root Interference Assessment

January 17, 2014

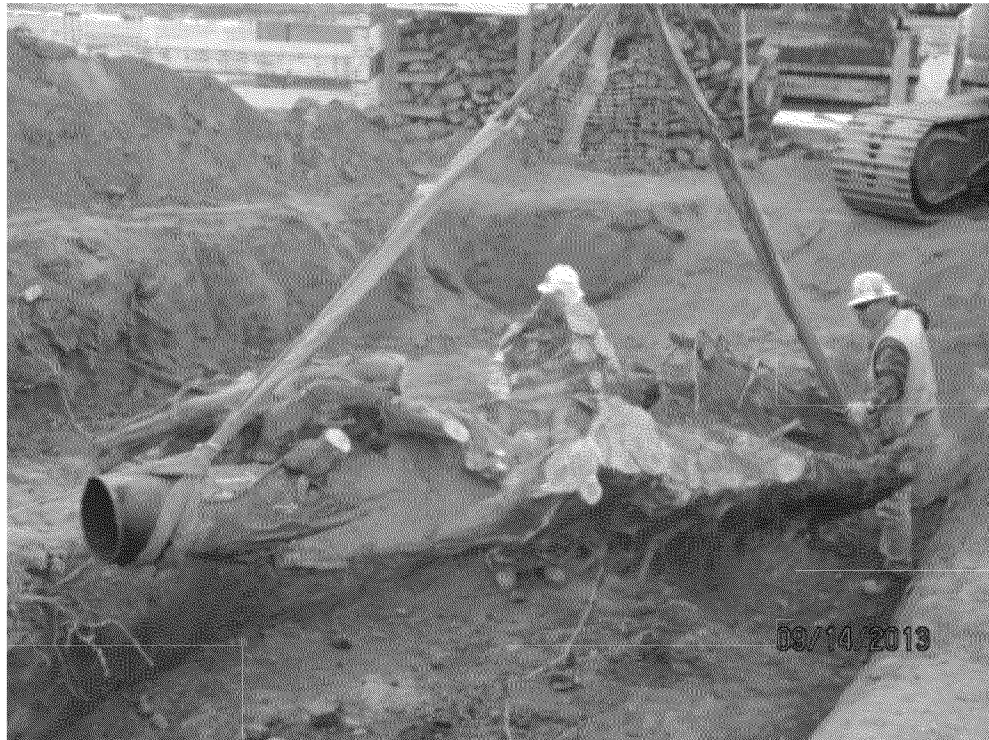
Figure 6. RWVIM-90-13 [Redacted]

Tree root and pipeline interactive conditions were reviewed relative to the potential for pipeline structural damage. An example of one location where the tree root ball was situated directly on top of the pipe and the tree roots encapsulated the buried pipe is presented in Figure 6 (RWVIM-90-13, Redacted Redacted)

The [Redacted] site provides evidence of what can occur when a tree root ball and root system is located in close proximity to a buried pipeline. A primary concern under these conditions is that weather (e.g., high force winds, flooding, seismic events) may cause tree and root movement, resulting in pipe damage. In addition, since the buried pipeline and tree root systems are interconnected, a lightning strike to the tree would most likely also impact the pipeline and provide an electrical path for the strike and may also provide a path for the electrical discharge.
