**Carmel Gas Incident**

April 2014

Doc. no. 1401752.000 - 4253

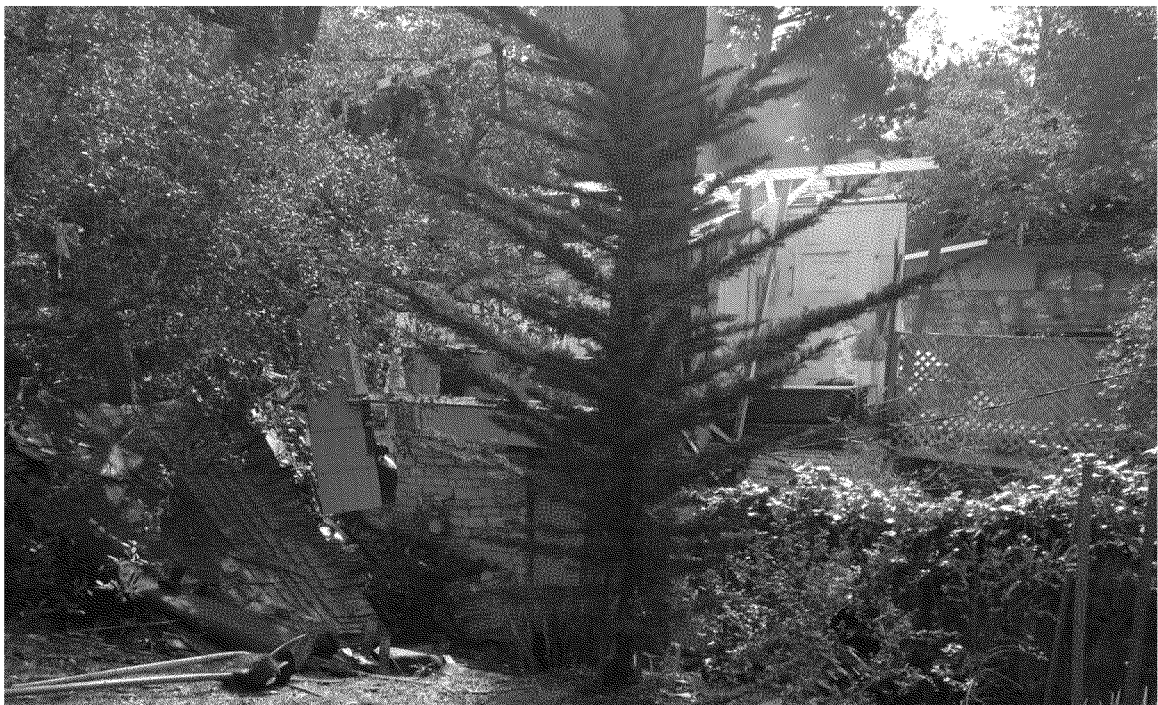
Figure 16. Photograph taken shortly after the explosion showing flames over bathroom toilet. Photograph provided to Exponent by PG&E.

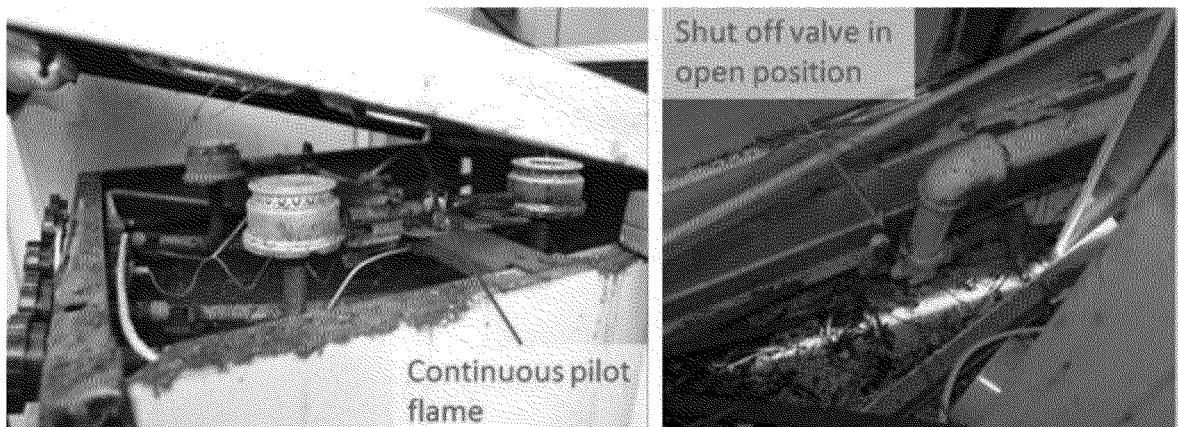
Figure 21. Kitchen stove components. Photographs by Exponent on March 6, 2014.

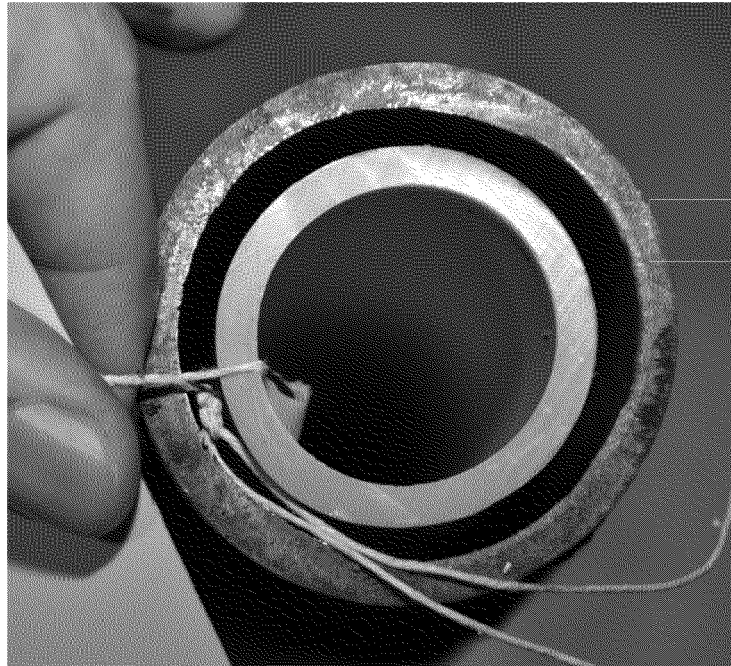
*Flow through annular space:* The released natural gas traveled through the annular space between the inserted plastic pipe and the steel pipe in both directions (east and west) along 3<sup>rd</sup> Avenue, away from the plastic pipe leak. Upon reaching the end of the 2-inch steel pipe, the gas exited the annular space and flowed into the soil.

Figure 28. Plastic gas line inserted into steel line. Photograph by Exponent on March 10, 2014.

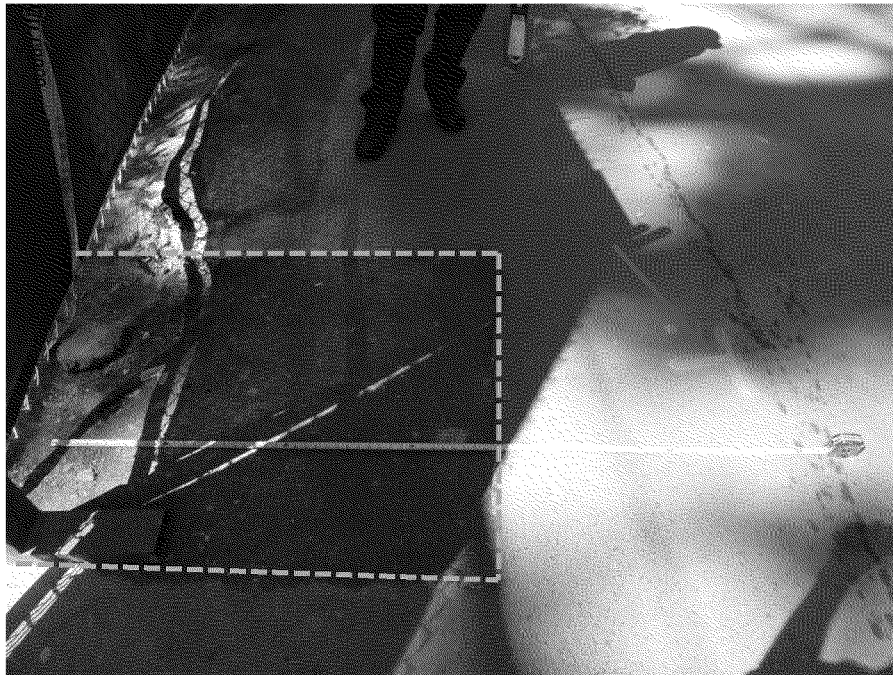
Along 3<sup>rd</sup> Avenue, approximately 50 feet west of the manhole at Guadalupe Street, a sewer lateral break tap-in at the sewer main was observed. The sewer main and sewer lateral are in close proximity to the gas service tee.

Along 3<sup>rd</sup> Avenue, approximately 50 feet west of the manhole at Guadalupe Street, a break tap-in was observed. This was the first lateral entry point from the aforementioned manhole. Figure 35 shows the street marking for the location of the sewer lateral and the asphalt patch performed by PG&E for the gas service line. As shown in this figure, the sewer line is in close proximity of the gas service tee.

Figure 35. Relative location of cold asphalt patch for gas service tee (dashed yellow lines) and sewer lateral tap-in connection to sewer main (green arrow) for subject residence. Residence is to the left in photograph. Photograph by Exponent on March 11, 2014.

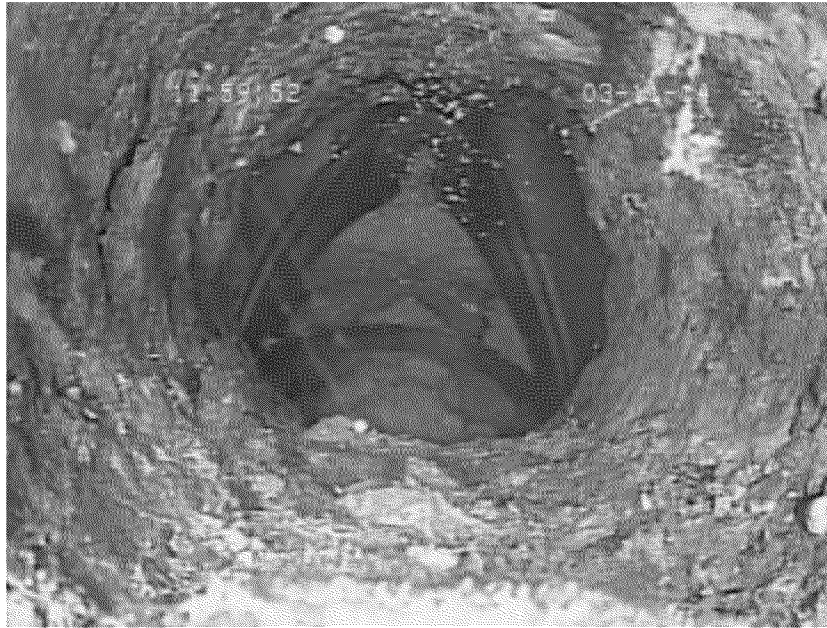
Gaps around the sewer lateral (at the break tap-in) and the sewer main were observed. The lateral was an approximately 4-inch cast iron pipe for the subject residence. As shown in Figure 36, the sewer lateral had debris accumulated around its interior perimeter and showed clear evidence of lack of recent use, including presence of spider webs, dryness and deterioration.

Figure 36. Sewer lateral conditions approximately 5 feet from tap-in with sewer main. Deterioration, spider webs and debris in cast iron pipe in area closest to camera. Separation and dislocation of lateral away from camera. Source: FES.

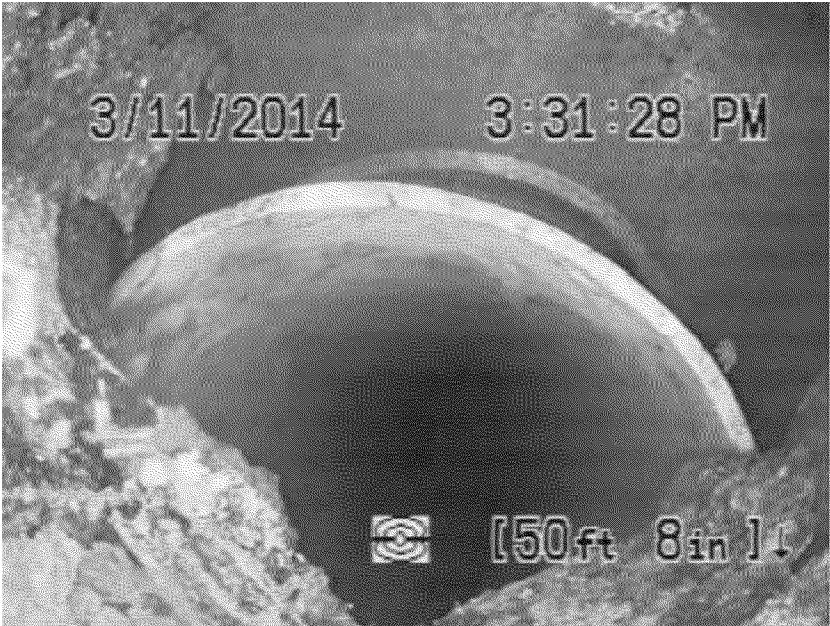
Figure 42. Dislocated joint between an apparently white plastic pipe and cast iron sewer lateral. Source: FES.

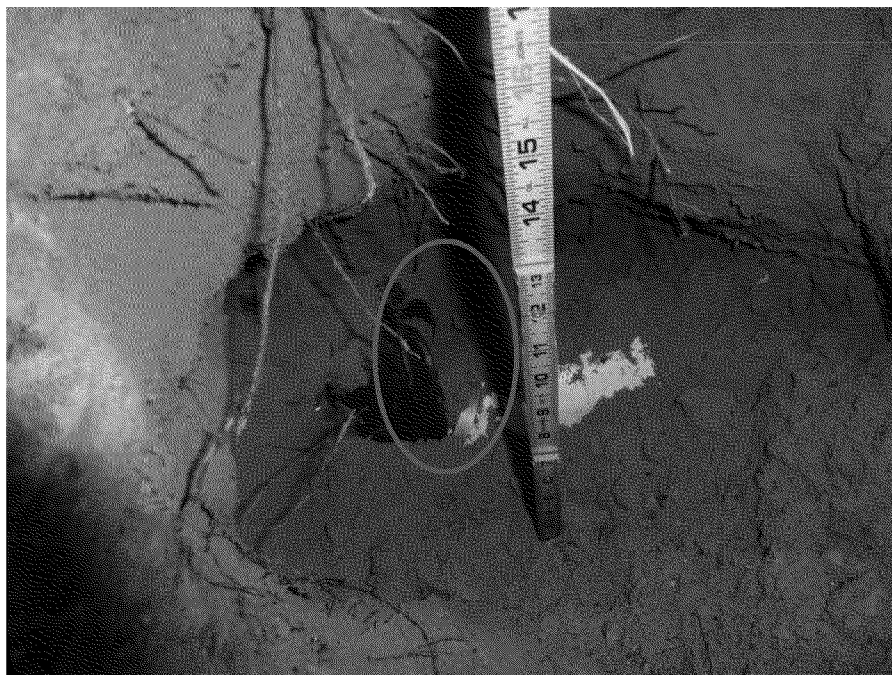
Figure 46. Sewer lateral offset joint (green oval), and white plastic segment of sewer lateral. Sand backfill surrounding sewer lateral. Photograph by Exponent on March 21, 2014.

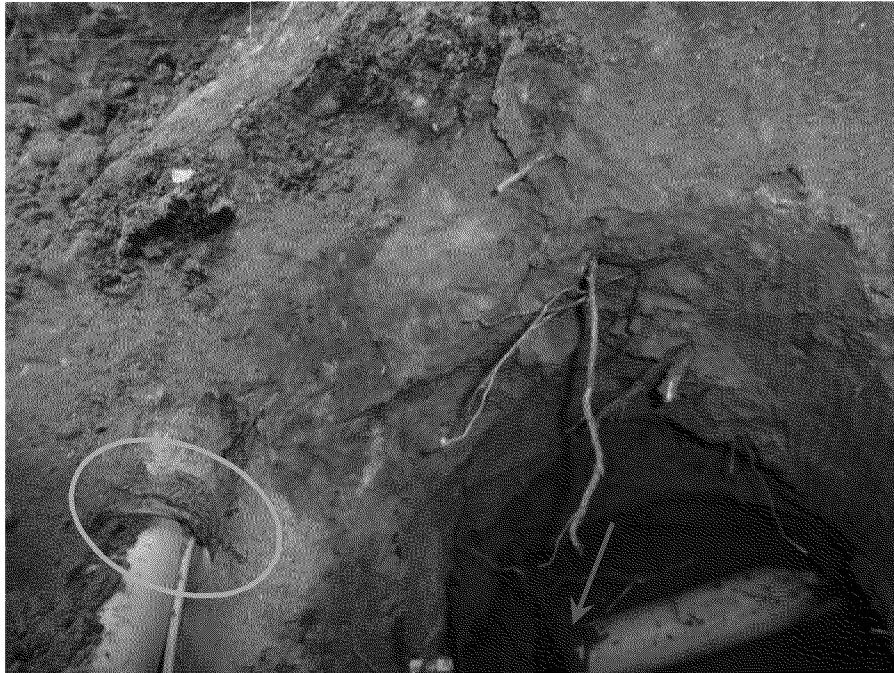
Figure 47. End of annular space in gas main along 3<sup>rd</sup> Avenue (yellow oval) in vicinity of sewer lateral offset joint (green arrow). Photograph by Exponent on March 21, 2014.
