**FINAL REPORT  
VOLUME I  
R-PG&E-20140117**

**Pacific Gas and Electric Company**

**Tree Root Interference Assessment**

**January 17, 2014**

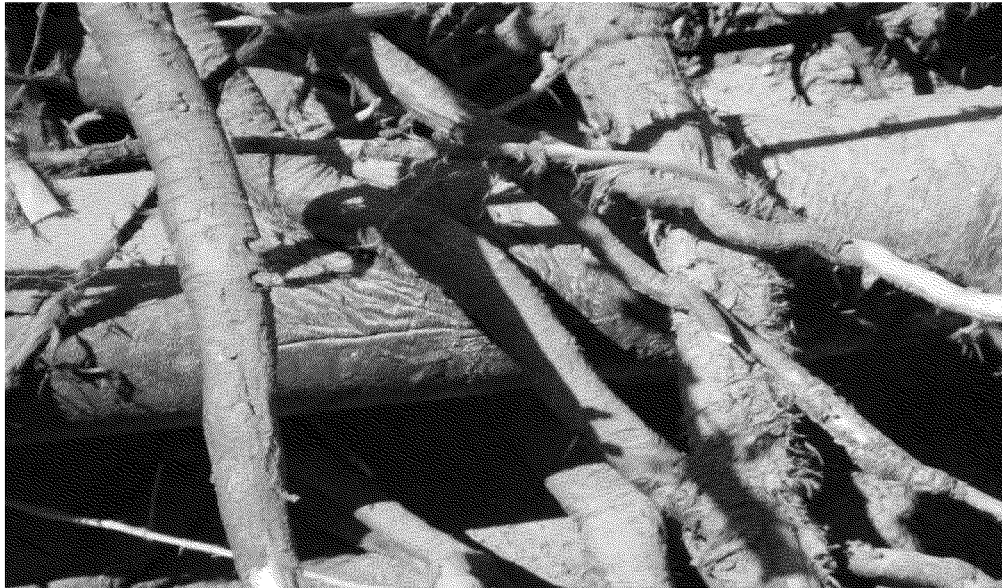
Figure 3. RWVIM-107-13 (Weber Lane)  
(CTE coating damage)

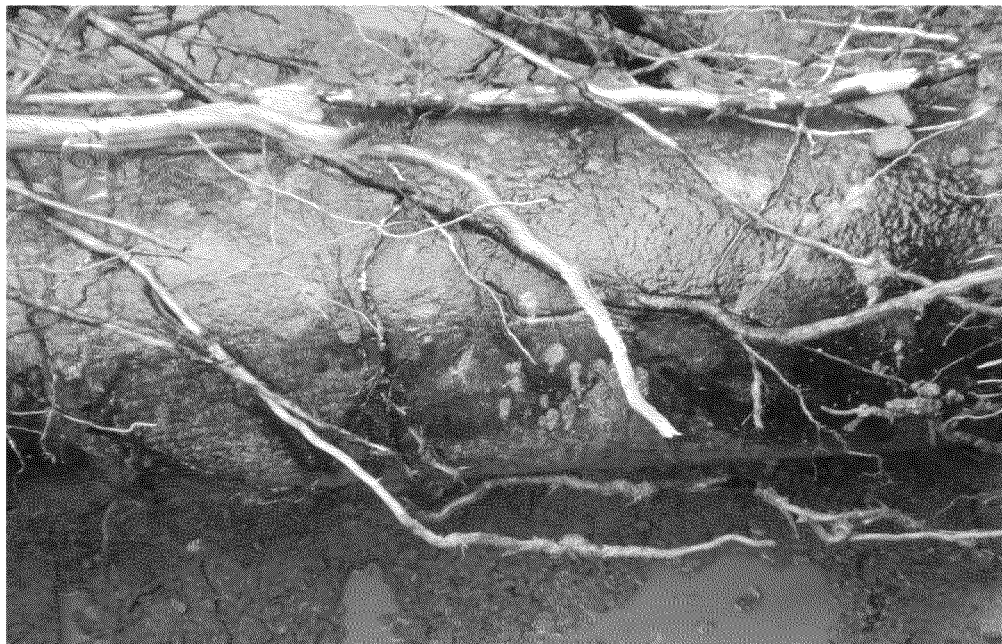
Figure 4. RWVIM-74-13 (Atascadero)  
(Tape coating damage)

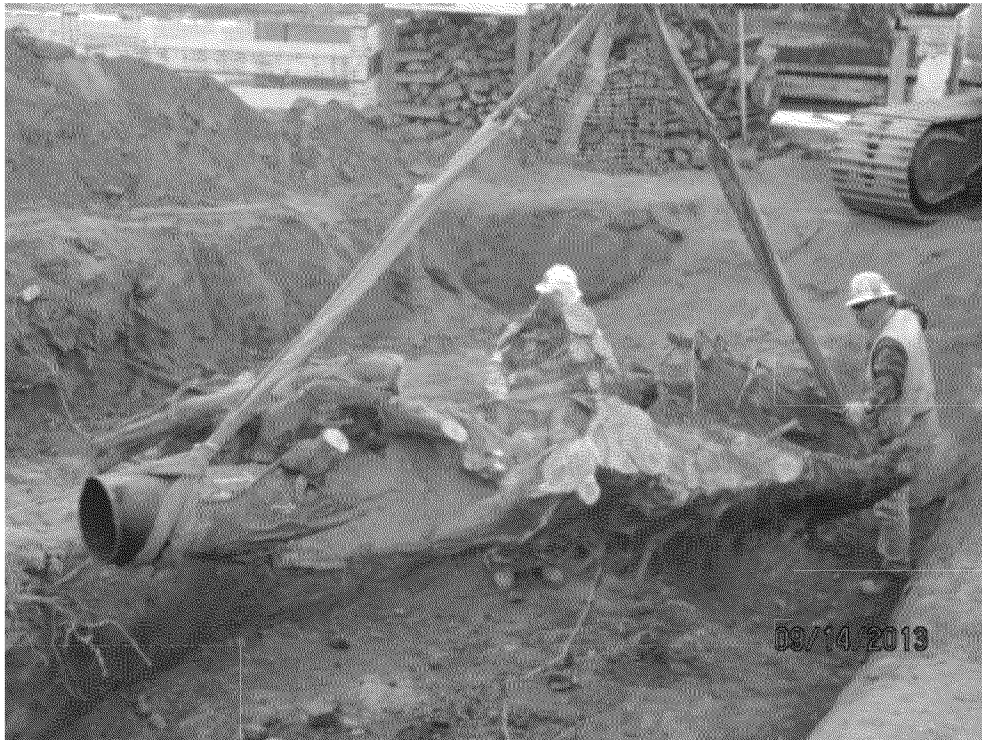
**Figure 6. RWVIM-90-13** Redacted

Tree root and pipeline interactive conditions were reviewed relative to the potential for pipeline structural damage. An example of one location where the tree root ball was situated directly on top of the pipe and the tree roots encapsulated the buried pipe is presented in Figure 6 (RWVIM-90-13, Redacted Redacted)

The Redacted site provides evidence of what can occur when a tree root ball and root system is located in close proximity to a buried pipeline. A primary concern under these conditions is that weather (e.g., high force winds, flooding, seismic events) may cause tree and root movement, resulting in pipe damage. In addition, since the buried pipeline and tree root systems are interconnected, a lightning strike to the tree would most likely also impact the pipeline and provide an electrical path for the strike and may also provide a path for the electrical discharge.
