Carmel Gas Incident

Prepared for

Sumeet Singh
Pacific Gas and Electric Company
6111 Bollinger Canyon Road
San Ramon, CA 94583

Doc. no. 1401752.000 - 4253

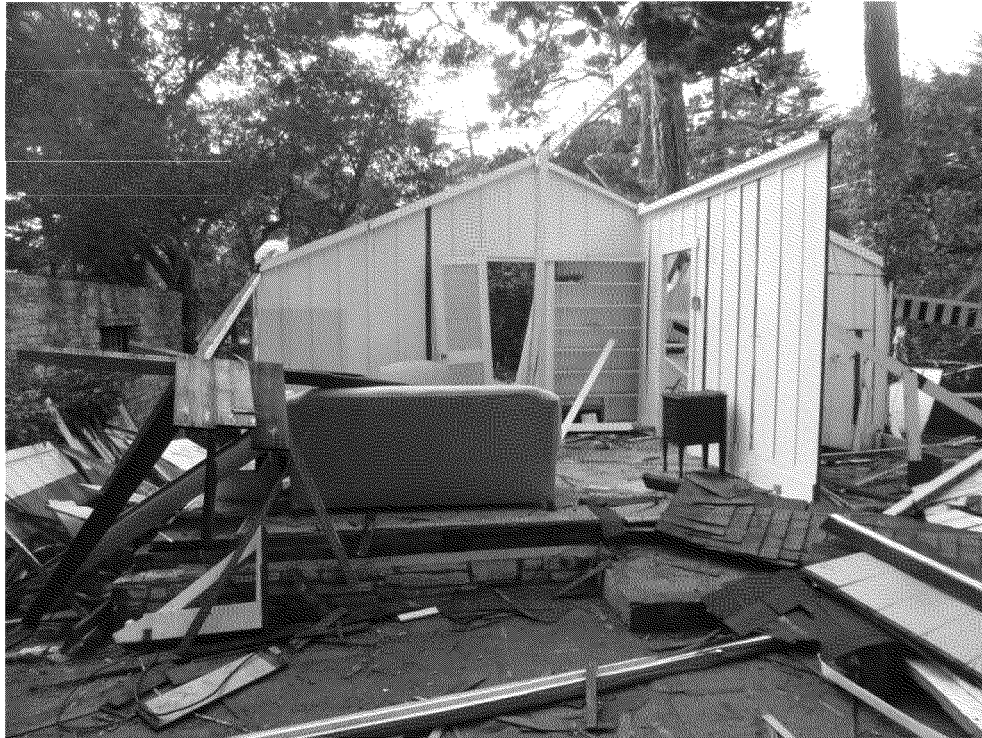
Exponent's initial site inspection of the house after the explosion, on March 4, 2014, revealed extensive low order damage to the first floor areas that were visible from the perimeter of the property. All exterior walls of the first floor had been blown out and the roof had been torn into pieces and scattered in the surrounding area. Only some of the interior walls remained in place (Figure 9 and Figure 10). Debris was scattered across the property and in nearby trees.

Figure 9. Incident house looking West from the entryway. Photograph by Exponent on March 4, 2014.

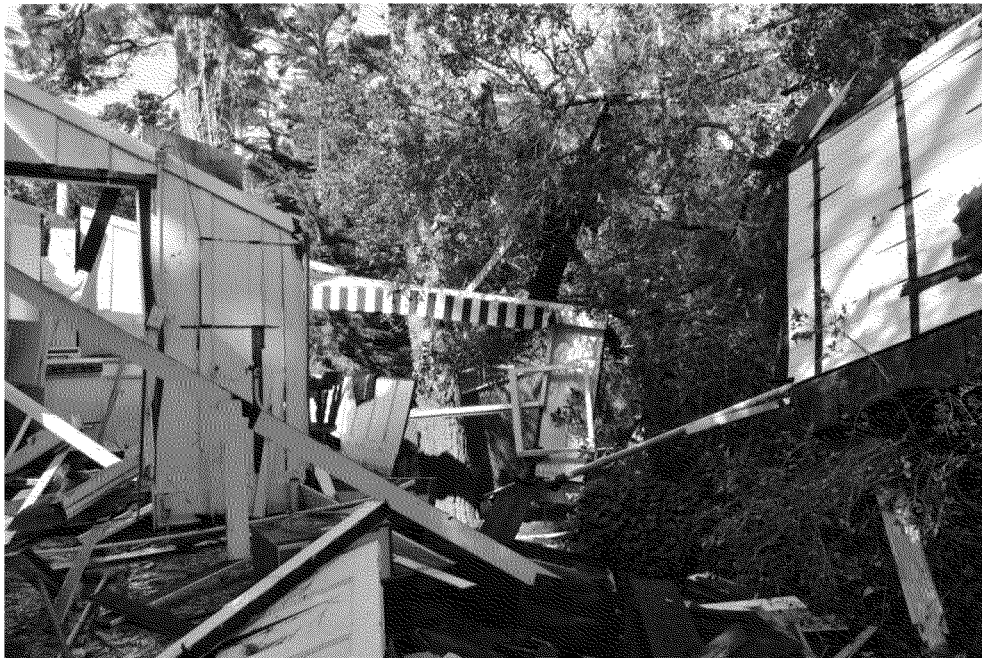
Figure 10. Incident house looking West into the laundry room. Roof section on right side of picture. Photograph by Exponent on March 4, 2014.

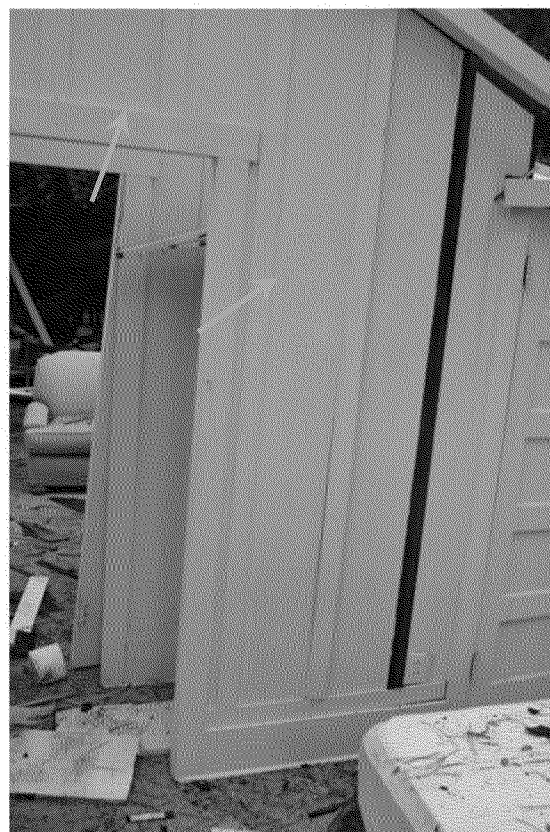
Exponent's interior inspections of the subject house⁹ discovered limited evidence of fire inside the house. Some of the paint on the walls of the living and bedrooms had signs of high temperature (blistering), but very few signs of sustained flame impingement (Figure 11 and Figure 12). Some of the debris showed a small amount of charring. The bathroom was the only place where clear signs of sustained fire were observable. There was a distinct fire pattern on the South wall next to the toilet and on the toilet bowl, toilet seat, and tank (Figure 13 through Figure 15). PG&E provided Exponent with a photograph taken shortly after the explosion (Figure 16). The photograph shows flames in the bathroom, matching the location of the observed fire patterns.

Figure 11. Interior walls and furniture. An unburned couch in the living room is visible in the background and the corner of an unburned mattress is visible in the foreground. Yellow arrows indicate some areas of wall blistering. Photograph by Exponent on March 6, 2014.

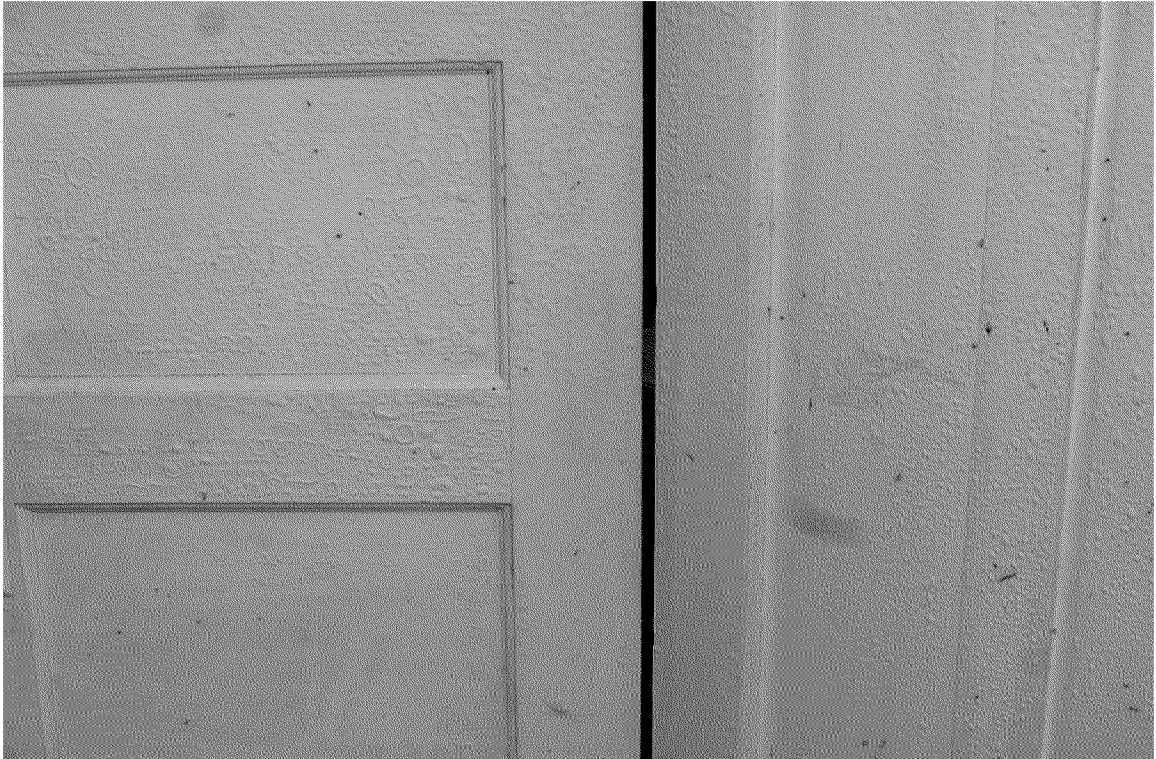
Figure 12. Close-up of the paint blistering on bedroom wall and door. Photograph by Exponent on March 7, 2014.

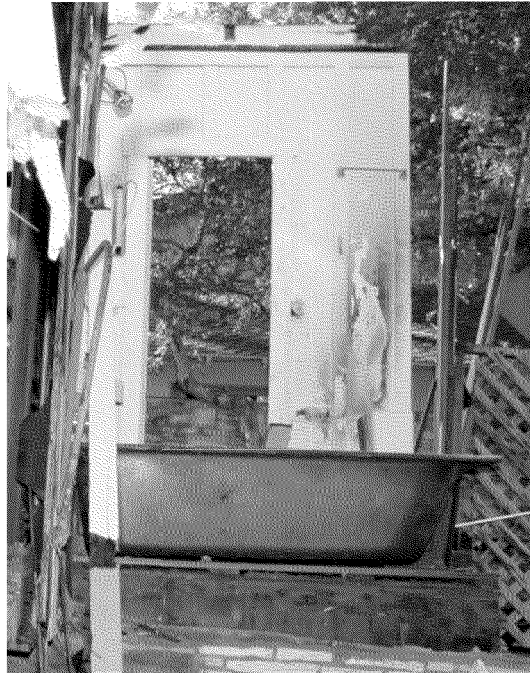
Figure 13. Fire pattern on bathroom wall, looking South from [Redacted]. Photograph by Exponent on March 7, 2014.

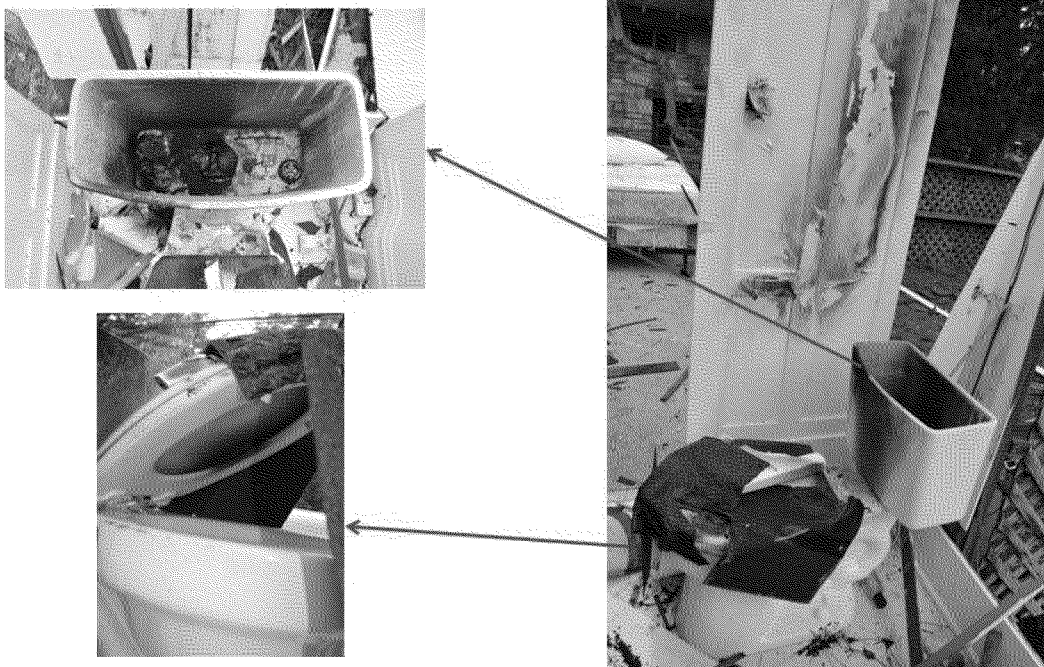
Figure 15. Damage to bathroom toilet. Burn marks below toilet seat and melted components inside toilet tank. Photographs by Exponent on March 6, 2014.

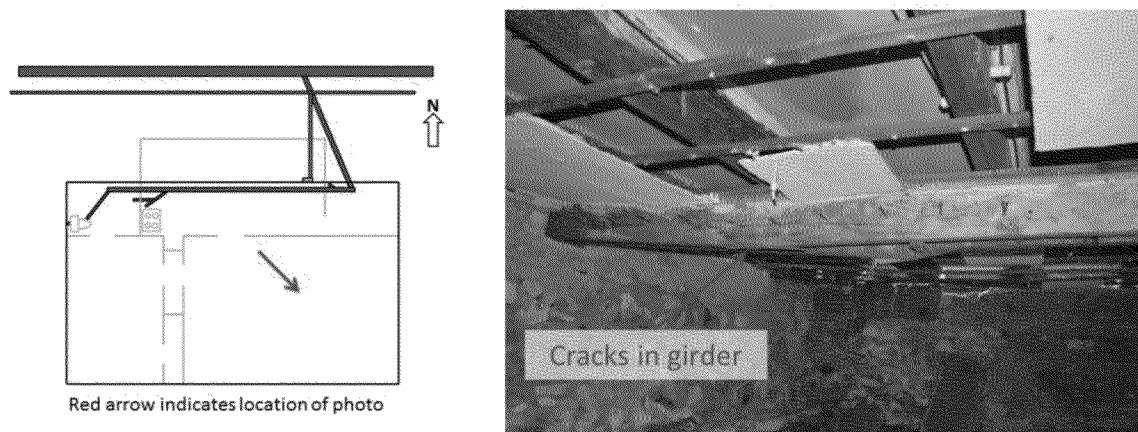
The basement area showed limited damage compared to the main floor. The perimeter walls did not show evidence of damage from the recent explosion and the windows glasses were undamaged. The ceiling finishes had collapsed in several areas and two of the wooden beams showed longitudinal cracks (Figure 17).

An Exponent engineer deemed the first floor of the structure unsafe due to recent damage to joists and girder framing. Shoring of the first floor from the basement level was recommended in order to continue inspection on the first floor. The elevated deck on the west side of the structure was not considered to be safe to walk on. Recommendations were also made to remove falling hazards from trees, neighboring bushes, and cantilevered portions of the structure.

Figure 17. Incident house basement. Ceiling girder with multiple longitudinal cracks. Photograph by Exponent on March 5, 2014.

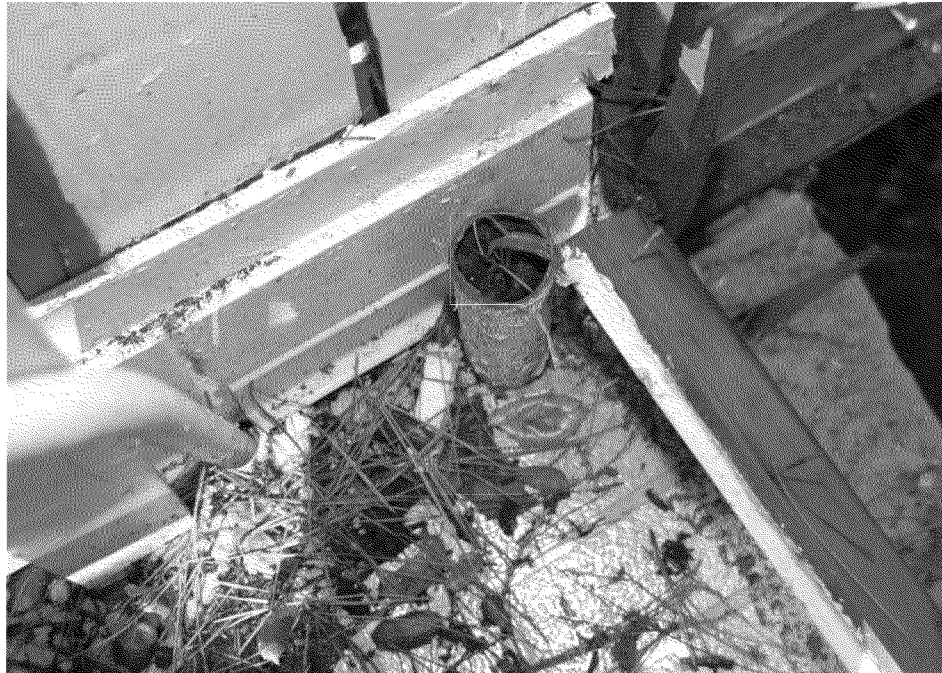
The sewage system of the house was visually inspected from the basement and through the remaining walls. Some of the sewage vent pipes had been blown off; inspection of the vents revealed the presence of debris inside them (Figure 18 and Figure 19).

Figure 18. Sewer vent pipe (broken off) in the laundry room. Photograph by Exponent on March 7, 2014.

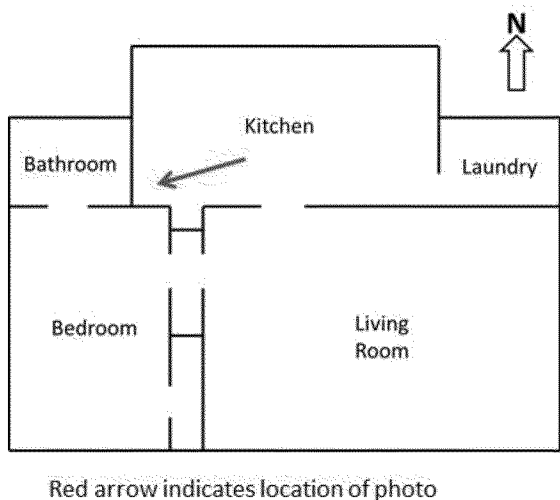
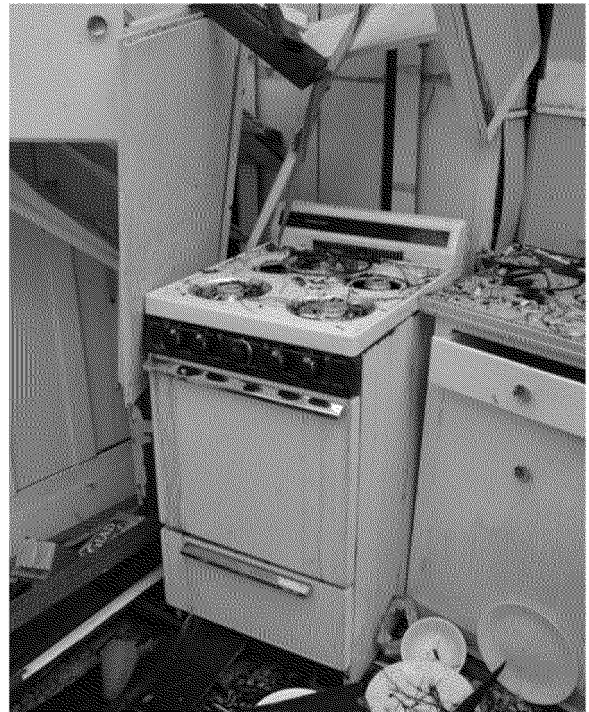
Figure 20. Location of kitchen stove. Photograph by Exponent on March 6, 2014.

Stove – A kitchen stove was present in the subject house. The location of the stove is shown in Figure 20. The appliance shut-off valve for the stove was found in the open position and the stove was equipped with a continuous pilot flame (Figure 21). Based on these facts, the stove cannot be ruled out as a likely ignition source for the incident explosion.

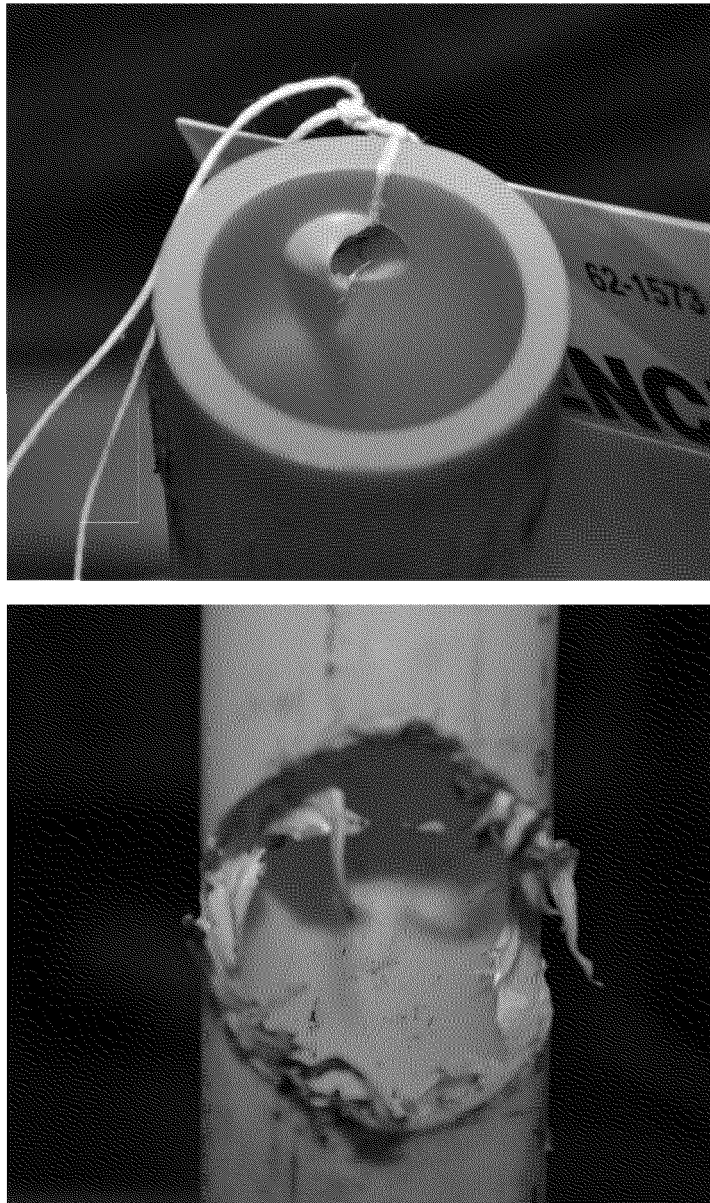
Gas leak: Inspection of the 2-inch gas main and inserted 1 ¼-inch plastic piping shows that there was a hole created in the plastic pipe after the Save-a-valve was tapped. This hole resulted in a pressurized natural gas release from the plastic pipe. A second hole was introduced into the plastic pipe when a M/2 line stopper fitting was tapped a short time after the first tapping operation. This second hole caused additional gas to leak.

Figure 29. Perforations in plastic gas line: Save-a-Valve fitting (top) and M/2 fitting (bottom). Photographs by Exponent on March 10, 2014.

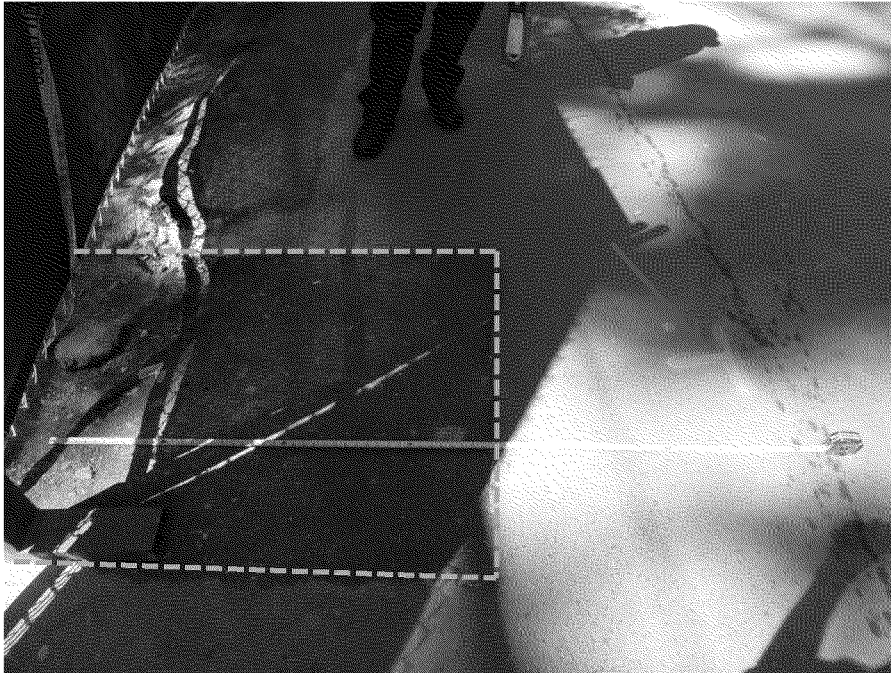
Along [Redacted] approximately 50 feet west of the manhole at [Redacted] a break tap-in was observed. This was the first lateral entry point from the aforementioned manhole. Figure 35 shows the street marking for the location of the sewer lateral and the asphalt patch performed by PG&E for the gas service line. As shown in this figure, the sewer line is in close proximity of the gas service tee.

Figure 35. Relative location of cold asphalt patch for gas service tee (dashed yellow lines) and sewer lateral tap-in connection to sewer main (green arrow) for subject residence. Residence is to the left in photograph. Photograph by Exponent on March 11, 2014.

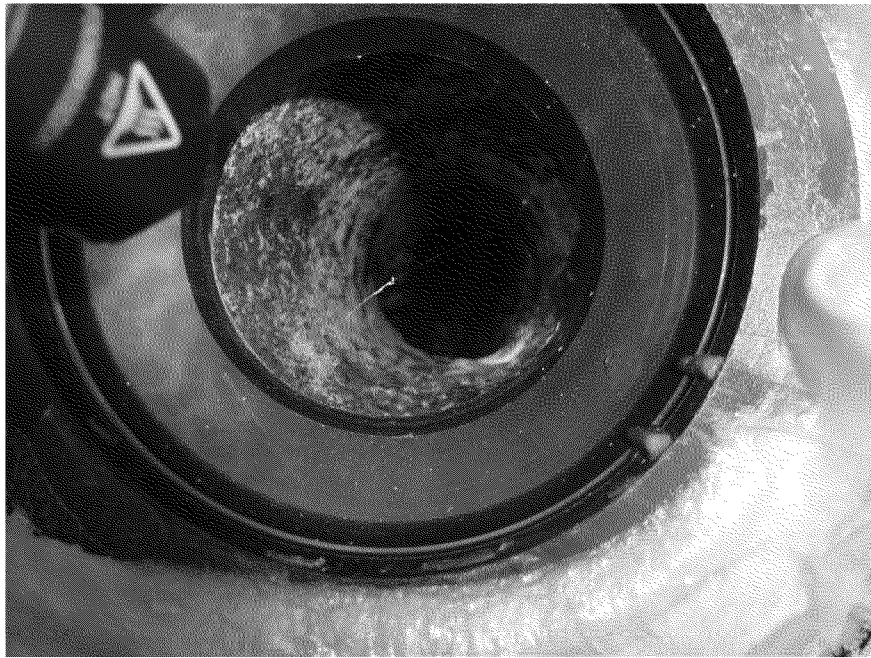
Figure 40. Sewer pipe raiser below toilet. Cast iron pipe is dry, spider webs are visible. Photograph by Exponent on March 11, 2014.

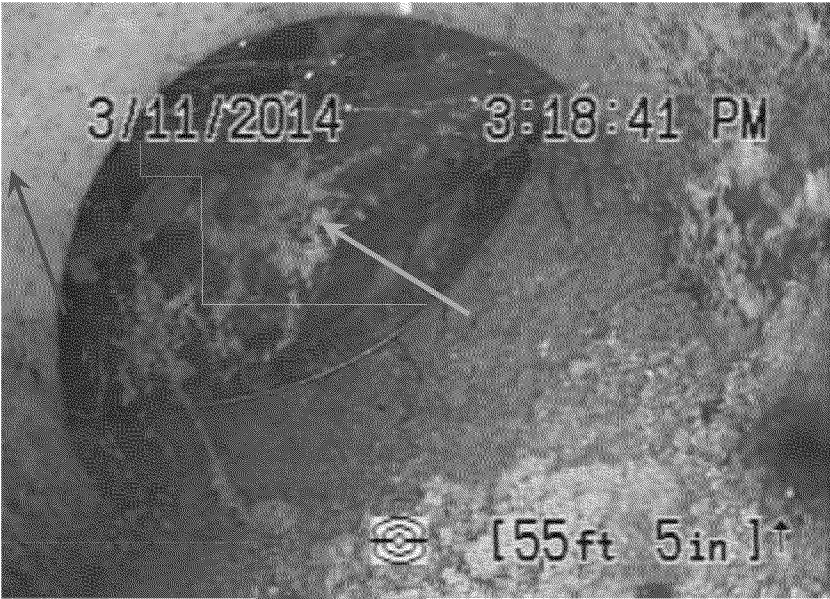
Figure 43. Sewer lateral joint offset at connection between white plastic pipe segment (green arrow) and apparent cast iron pipe (yellow arrow). Source: FES.

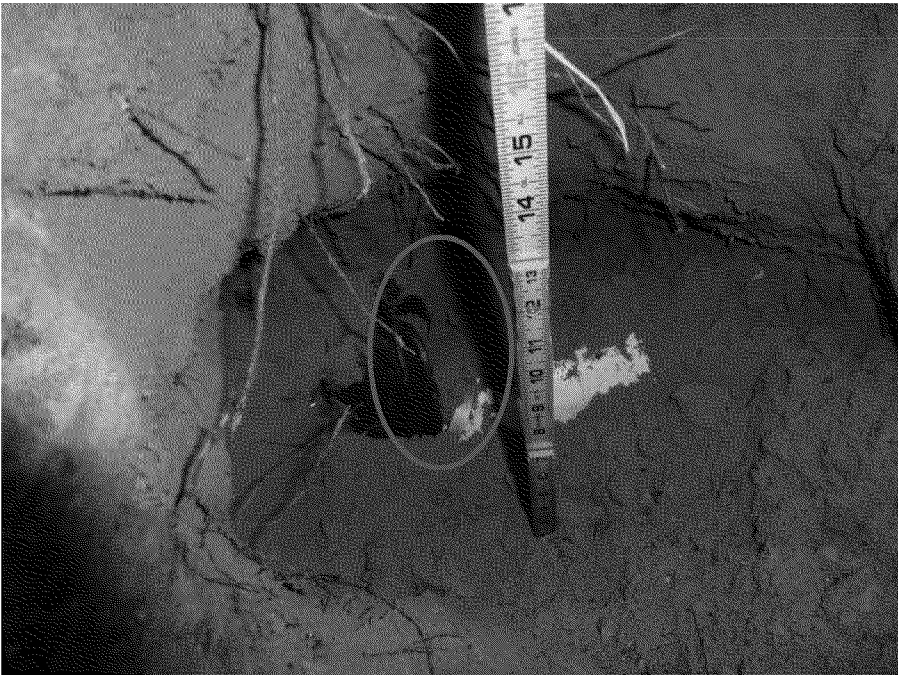
Figure 46. Sewer lateral offset joint (green oval), and white plastic segment of sewer lateral. Sand backfill surrounding sewer lateral. Photograph by Exponent on March 21, 2014.

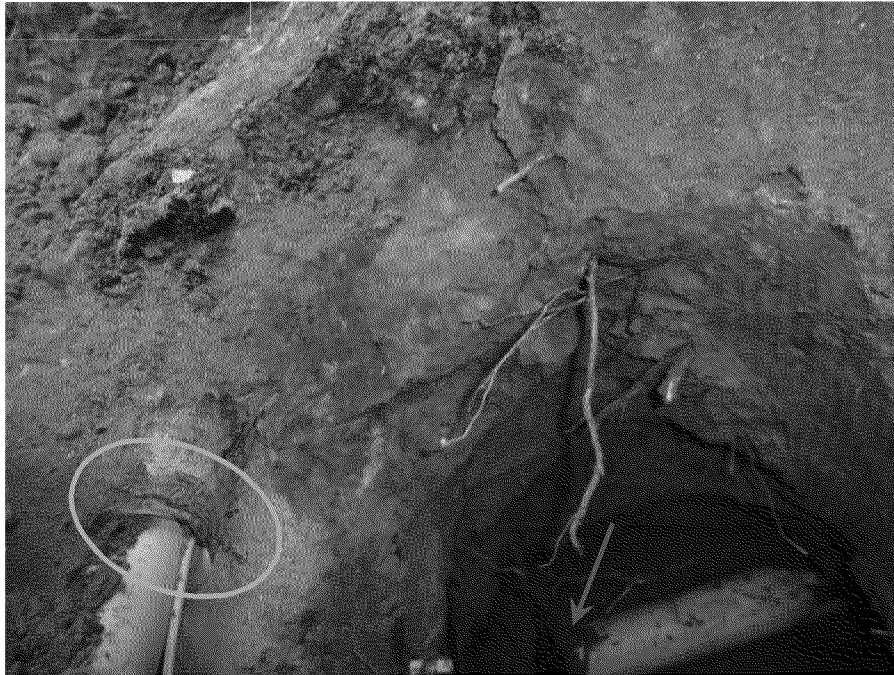
Flow through annular space: The released natural gas traveled through the annular space between the inserted plastic pipe and the steel pipe in both directions (east and west) along 3rd Avenue, away from the plastic pipe leak. Upon reaching the end of the 2-inch steel pipe, the gas exited the annular space and flowed into the soil.

Figure 47. End of annular space in gas main along Redacted (yellow oval) in vicinity of sewer lateral offset joint (green arrow). Photograph by Exponent on March 21, 2014.

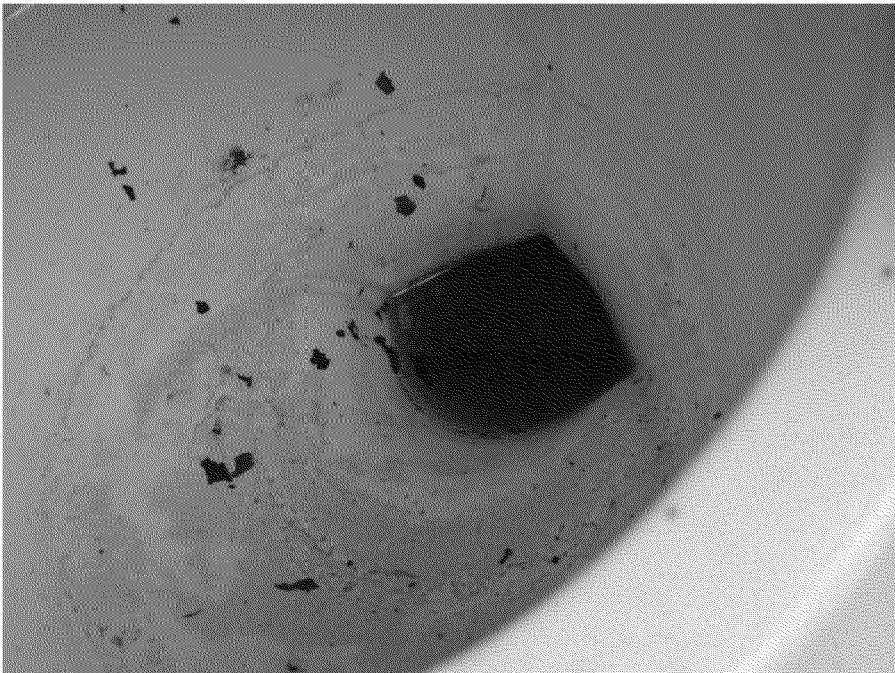
Figure 50. Low water level in the bathroom toilet bowl three days after explosion. Photograph by Exponent on March 6, 2014.
