**Carmel Gas Incident**

Doc. no. 1401752.000 - 4253

Pacific Gas and Electric (PG&E) has retained Exponent Failure Analysis Associates (Exponent) to conduct a failure analysis investigation of a gas leak and subsequent explosion on March 3, 2014 in Carmel-by-the-Sea (Carmel), California.

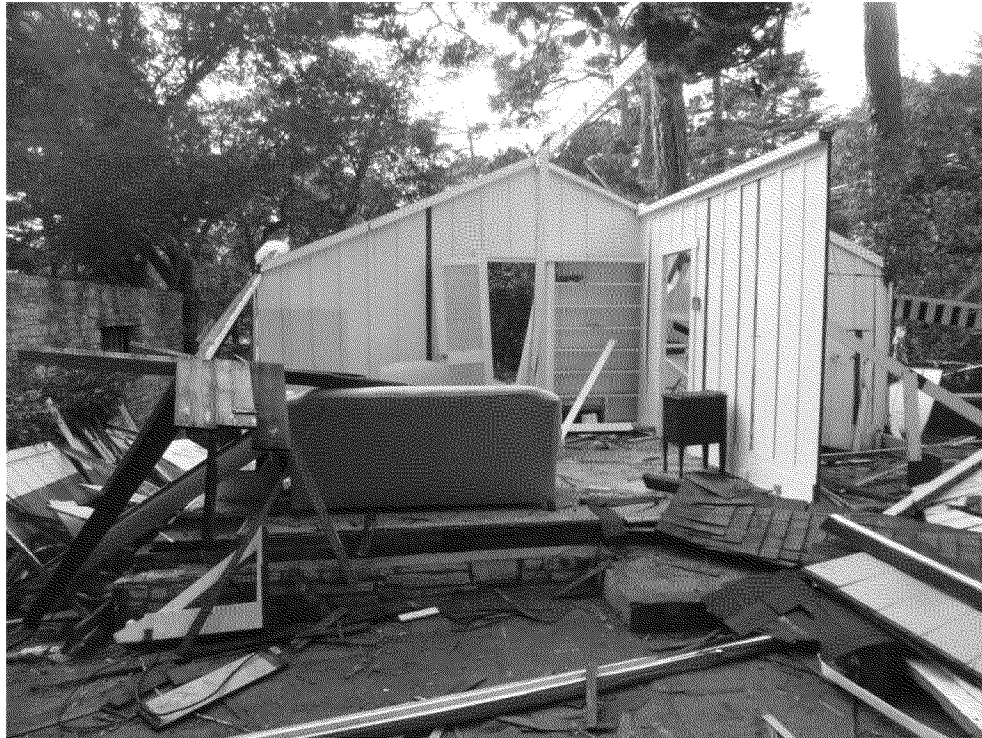
Exponent's initial site inspection of the house after the explosion, on March 4, 2014, revealed extensive low order damage to the first floor areas that were visible from the perimeter of the property. All exterior walls of the first floor had been blown out and the roof had been torn into pieces and scattered in the surrounding area. Only some of the interior walls remained in place (Figure 9 and Figure 10). Debris was scattered across the property and in nearby trees.

Figure 9. Incident house looking West from the entryway. Photograph by Exponent on March 4, 2014.

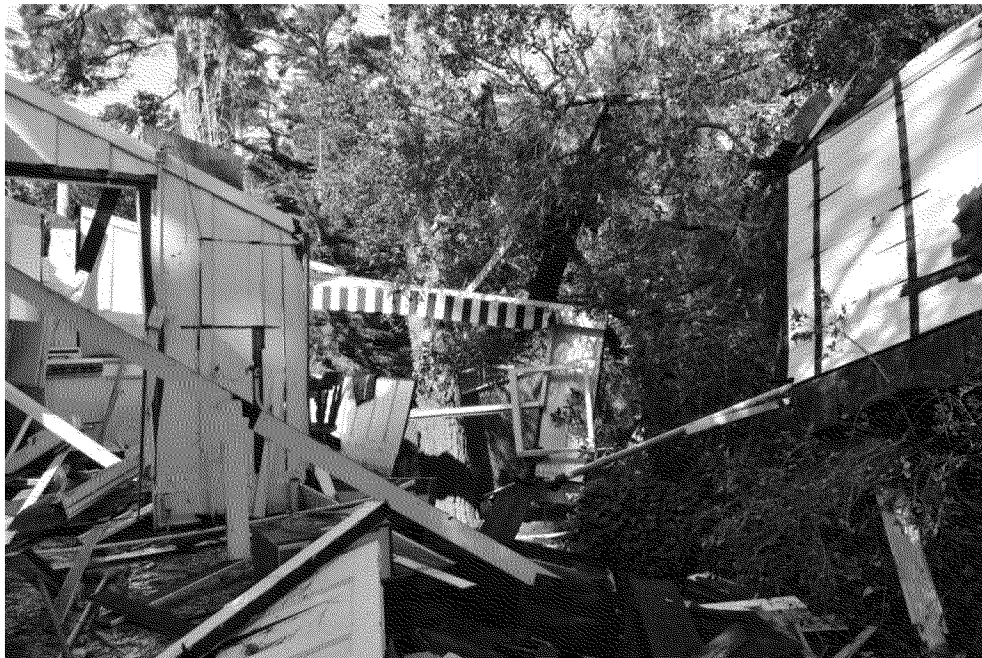
Figure 10. Incident house looking West into the laundry room. Roof section on right side of picture. Photograph by Exponent on March 4, 2014.

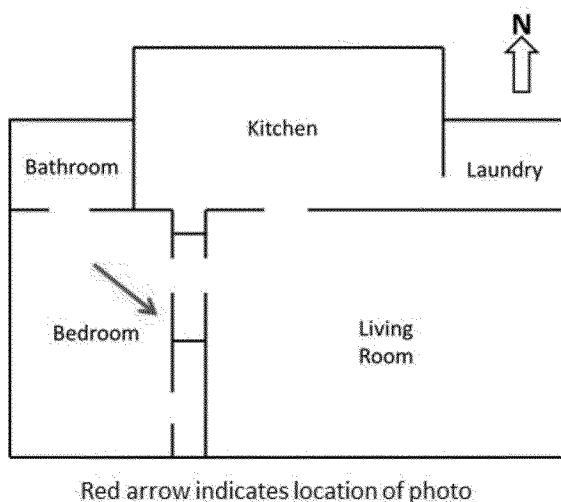
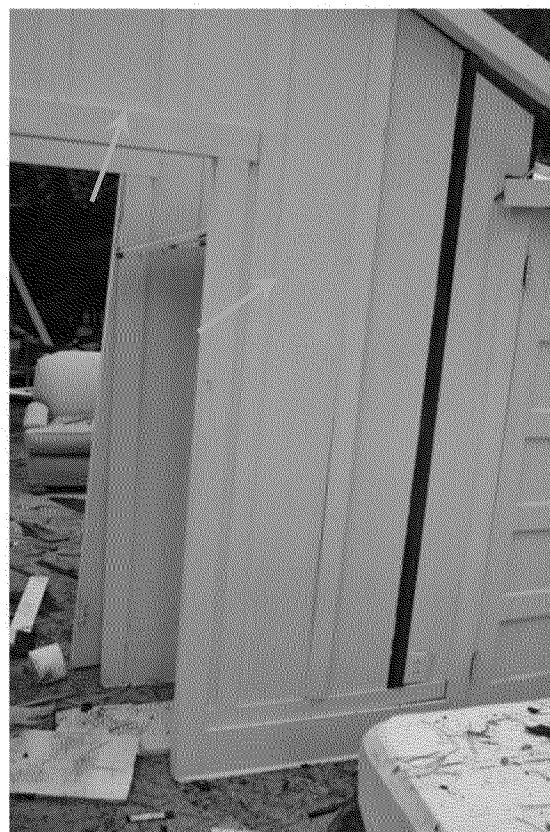
Exponent's interior inspections of the subject house<sup>9</sup> discovered limited evidence of fire inside the house. Some of the paint on the walls of the living and bedrooms had signs of high temperature (blistering), but very few signs of sustained flame impingement (Figure 11 and Figure 12). Some of the debris showed a small amount of charring. The bathroom was the only place where clear signs of sustained fire were observable. There was a distinct fire pattern on the South wall next to the toilet and on the toilet bowl, toilet seat, and tank (Figure 13 through Figure 15). PG&E provided Exponent with a photograph taken shortly after the explosion (Figure 16). The photograph shows flames in the bathroom, matching the location of the observed fire patterns.

Figure 11. Interior walls and furniture. An unburned couch in the living room is visible in the background and the corner of an unburned mattress is visible in the foreground. Yellow arrows indicate some areas of wall blistering. Photograph by Exponent on March 6, 2014.

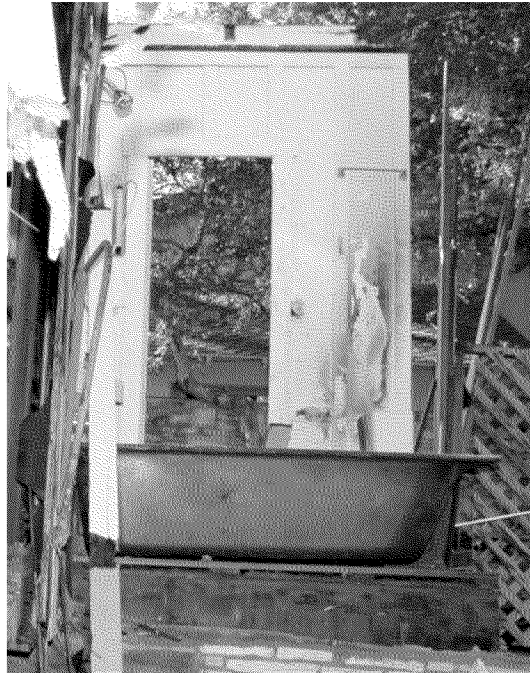
Figure 13. Fire pattern on bathroom wall, looking South from [Redacted] Photograph by Exponent on March 7, 2014.

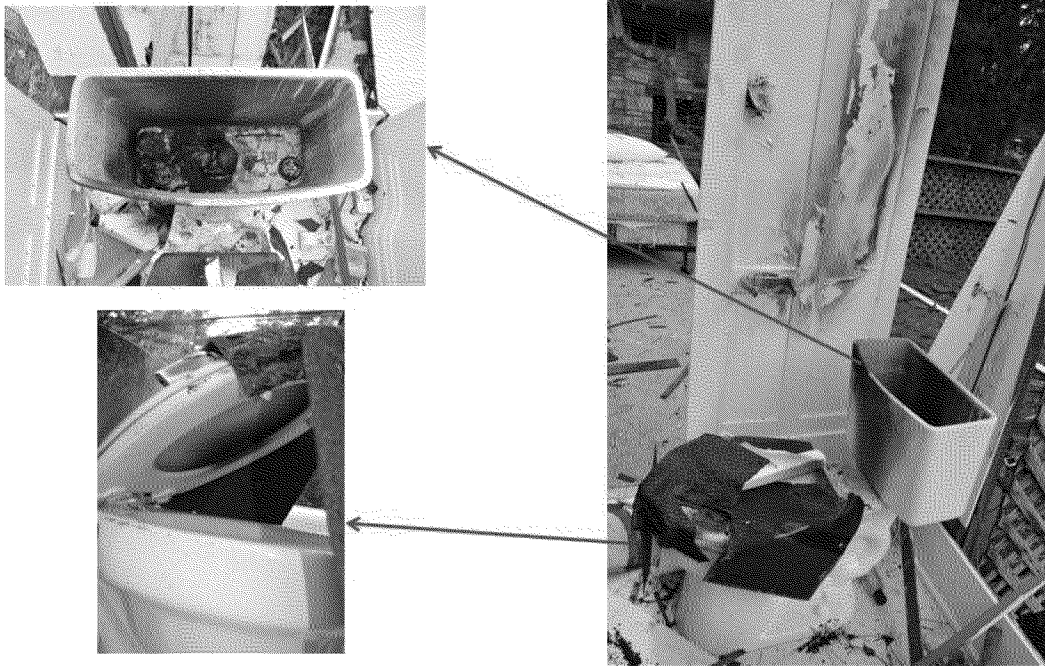
Figure 15. Damage to bathroom toilet. Burn marks below toilet seat and melted components inside toilet tank. Photographs by Exponent on March 6, 2014.

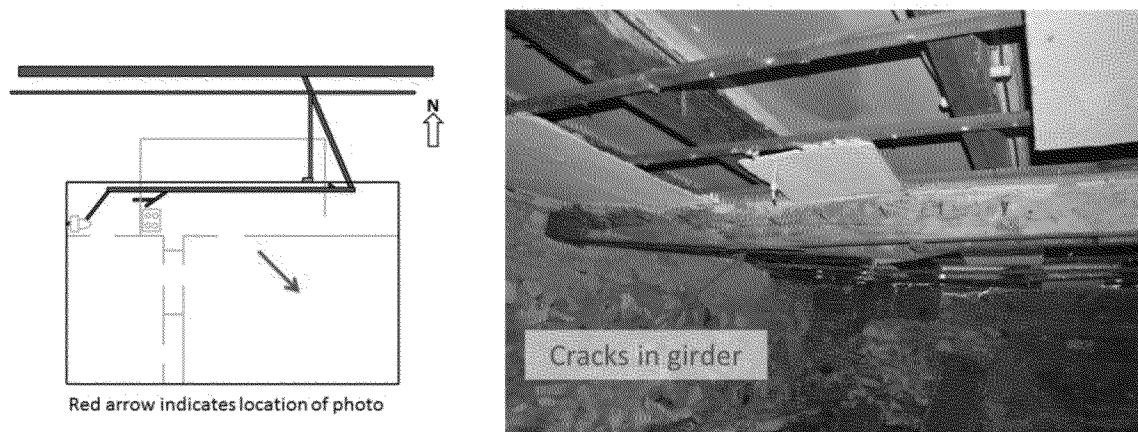
The basement area showed limited damage compared to the main floor. The perimeter walls did not show evidence of damage from the recent explosion and the windows glasses were undamaged. The ceiling finishes had collapsed in several areas and two of the wooden beams showed longitudinal cracks (Figure 17).

Figure 17. Incident house basement. Ceiling girder with multiple longitudinal cracks. Photograph by Exponent on March 5, 2014.

An Exponent engineer deemed the first floor of the structure unsafe due to recent damage to joists and girder framing. Shoring of the first floor from the basement level was recommended in order to continue inspection on the first floor. The elevated deck on the west side of the structure was not considered to be safe to walk on. Recommendations were also made to remove falling hazards from trees, neighboring bushes, and cantilevered portions of the structure.

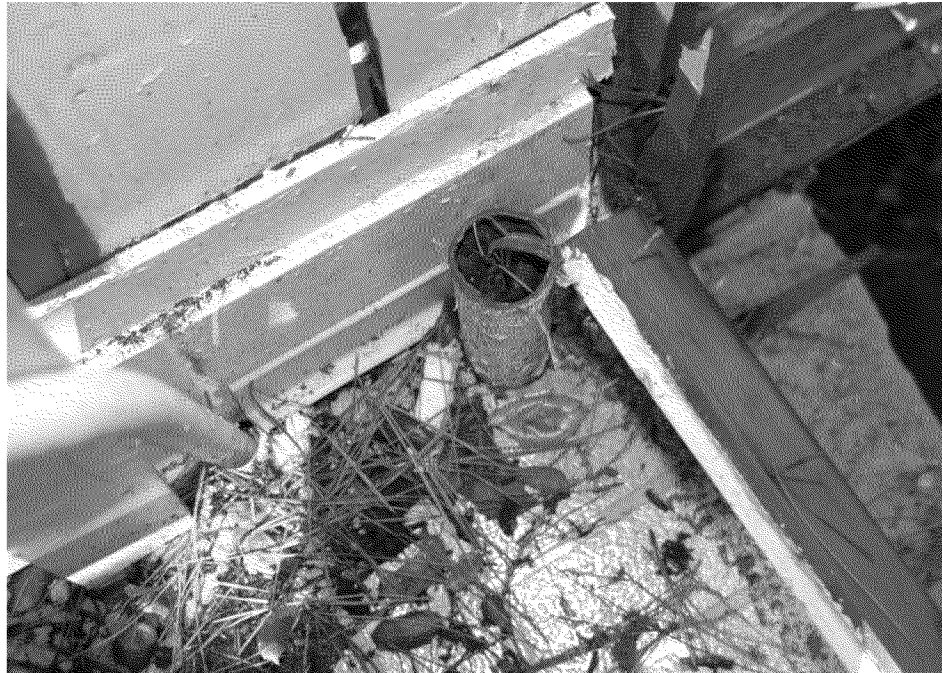
The sewage system of the house was visually inspected from the basement and through the remaining walls. Some of the sewage vent pipes had been blown off; inspection of the vents revealed the presence of debris inside them (Figure 18 and Figure 19).

Figure 18. Sewer vent pipe (broken off) in the laundry room. Photograph by Exponent on March 7, 2014.

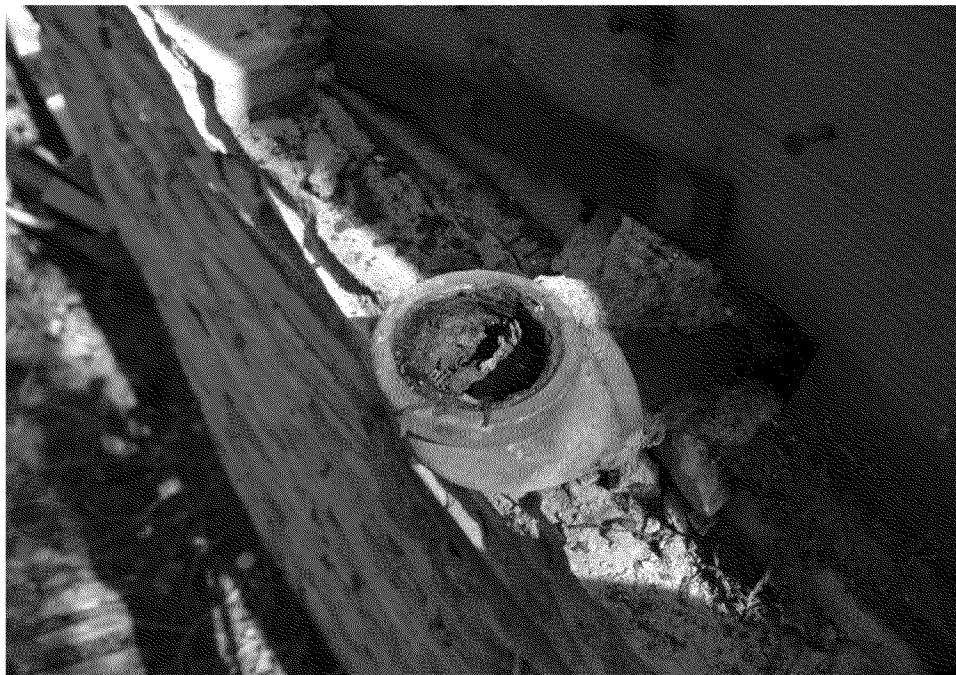
Figure 19. Vent pipe (broken off) in the bathroom. Photograph by Exponent on March 7, 2014.

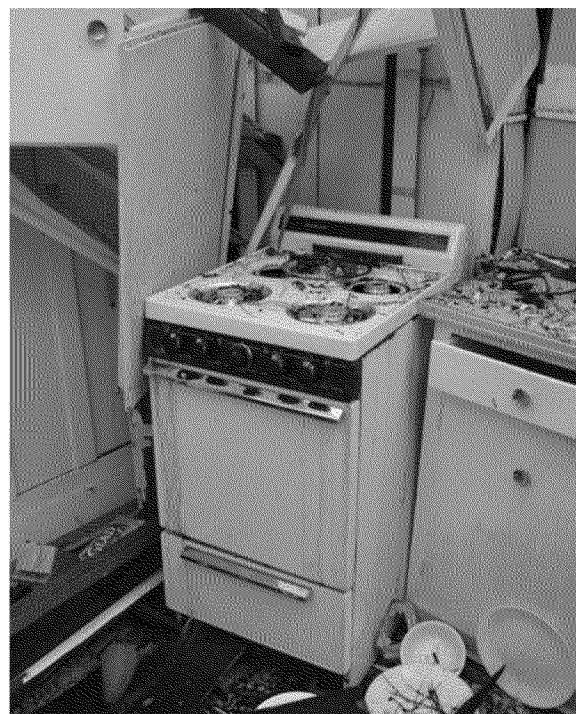
**Stove** – A kitchen stove was present in the subject house. The location of the stove is shown in Figure 20. The appliance shut-off valve for the stove was found in the open position and the stove was equipped with a continuous pilot flame (Figure 21). Based on these facts, the stove cannot be ruled out as a likely ignition source for the incident explosion.

Figure 20. Location of kitchen stove. Photograph by Exponent on March 6, 2014.

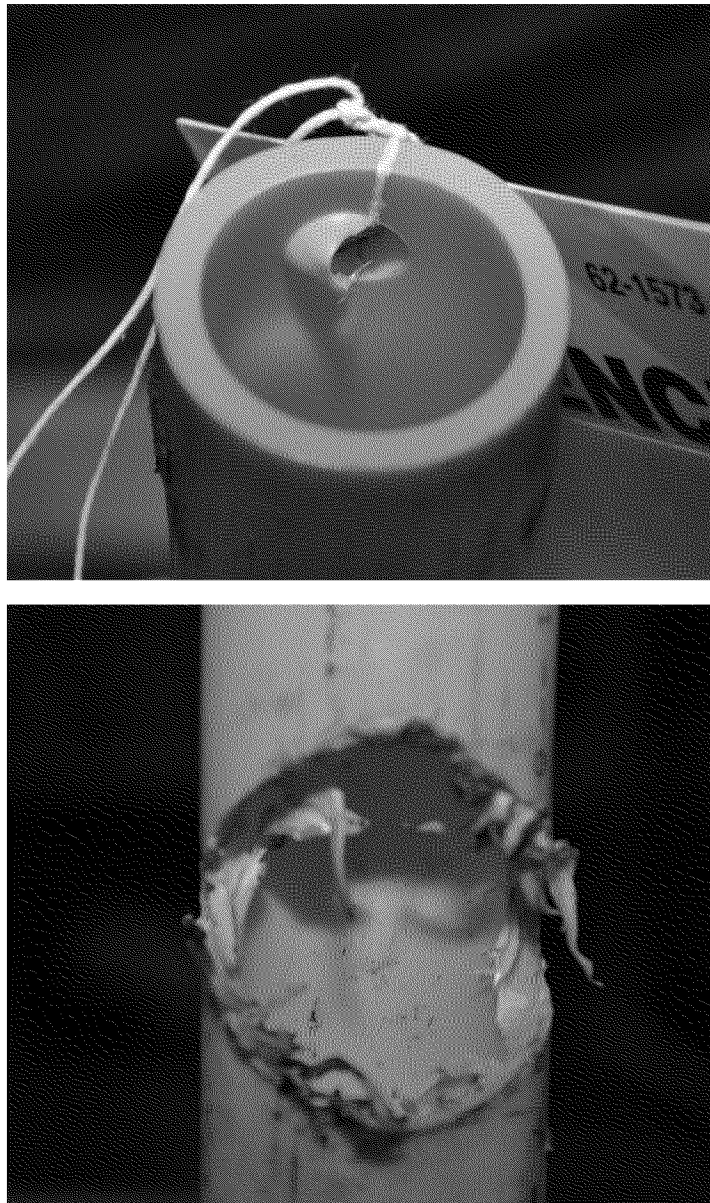
*Gas leak:* Inspection of the 2-inch gas main and inserted 1 ¼-inch plastic piping shows that there was a hole created in the plastic pipe after the Save-a-valve was tapped. This hole resulted in a pressurized natural gas release from the plastic pipe. A second hole was introduced into the plastic pipe when a M/2 line stopper fitting was tapped a short time after the first tapping operation. This second hole caused additional gas to leak.

Figure 29. Perforations in plastic gas line: Save-a-Valve fitting (top) and M/2 fitting (bottom). Photographs by Exponent on March 10, 2014.

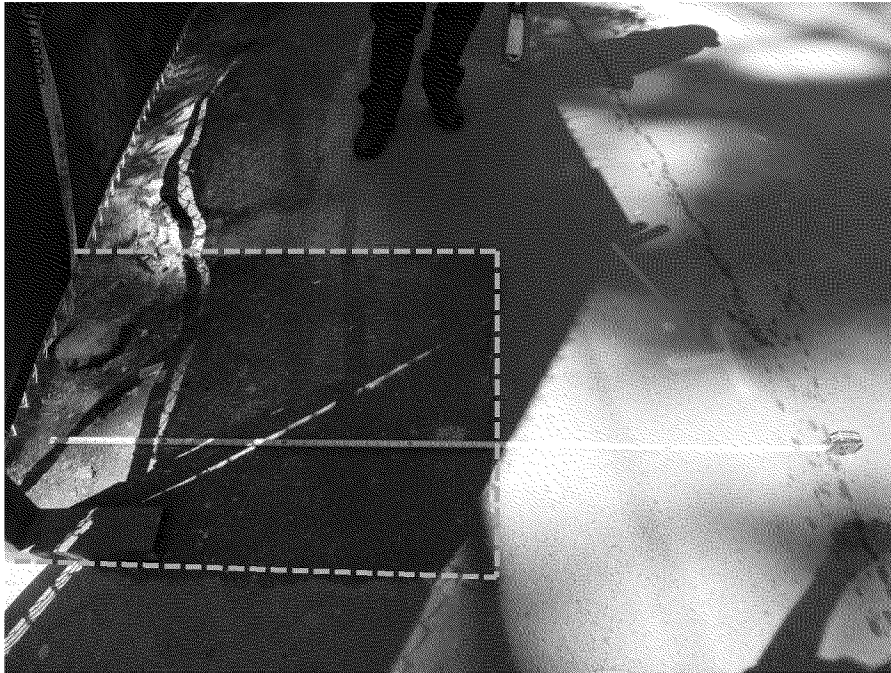
Along [Redacted], approximately 50 feet west of the manhole at [Redacted], a break tap-in was observed. This was the first lateral entry point from the aforementioned manhole. Figure 35 shows the street marking for the location of the sewer lateral and the asphalt patch performed by PG&E for the gas service line. As shown in this figure, the sewer line is in close proximity of the gas service tee.

Figure 35. Relative location of cold asphalt patch for gas service tee (dashed yellow lines) and sewer lateral tap-in connection to sewer main (green arrow) for subject residence. Residence is to the left in photograph. Photograph by Exponent on March 11, 2014.

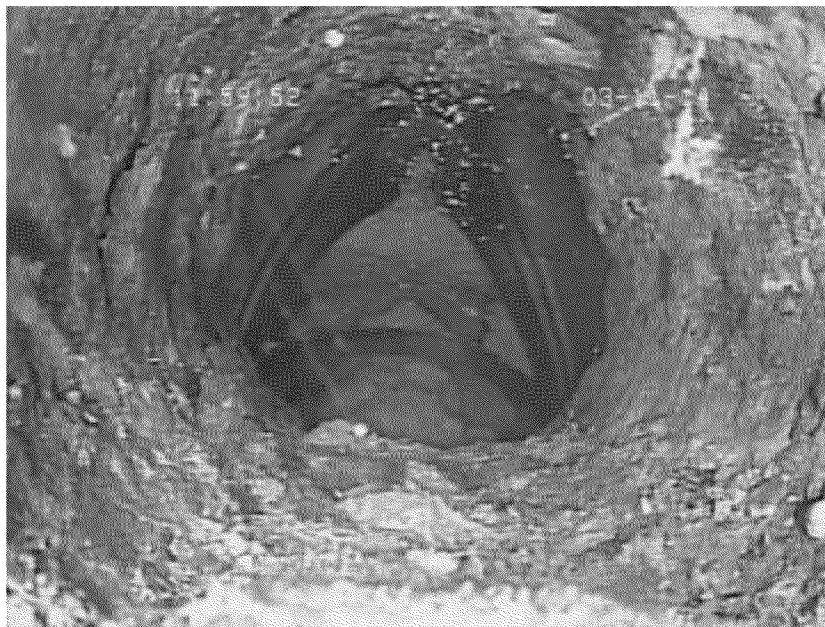
Gaps around the sewer lateral (at the break tap-in) and the sewer main were observed. The lateral was an approximately 4-inch cast iron pipe for the subject residence. As shown in Figure 36, the sewer lateral had debris accumulated around its interior perimeter and showed clear evidence of lack of recent use, including presence of spider webs, dryness and deterioration.

Figure 36. Sewer lateral conditions approximately 5 feet from tap-in with sewer main. Deterioration, spider webs and debris in cast iron pipe in area closest to camera. Separation and dislocation of lateral away from camera. Source: FES.

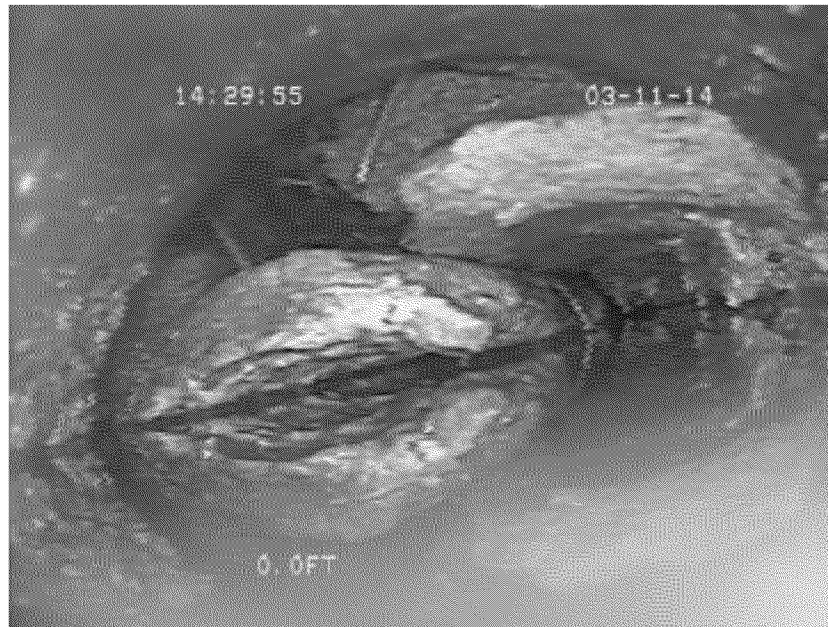
south of the manhole (Figure 37). Standing water was observed in the collapsed area. The area of the observed collapse appears to be aligned with the storm pipe system.

Figure 37. Collapse of sewer main along [Redacted], south of manhole. Standing water at bottom. Source: FES.

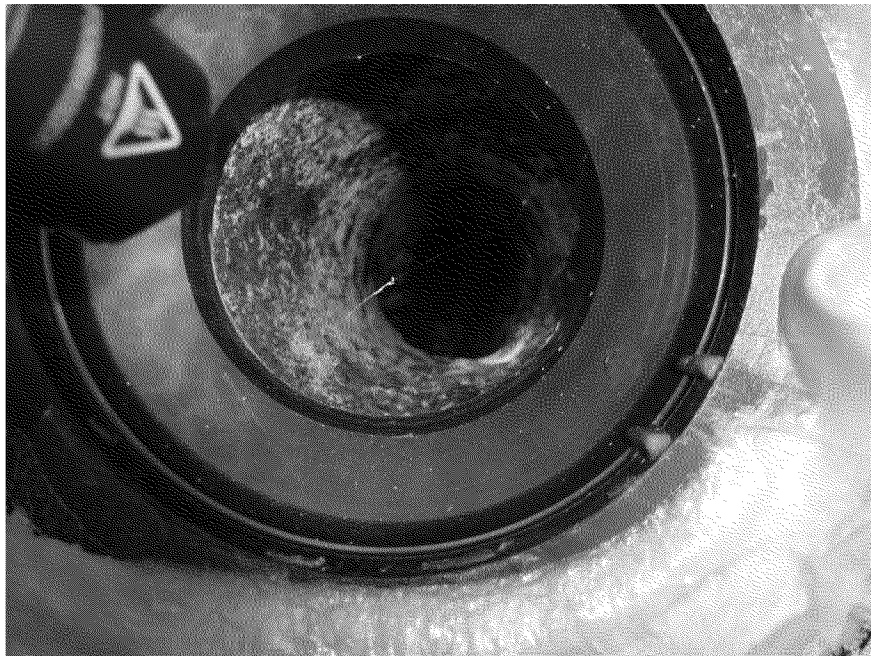
Figure 40. Sewer pipe raiser below toilet. Cast iron pipe is dry, spider webs are visible. Photograph by Exponent on March 11, 2014.

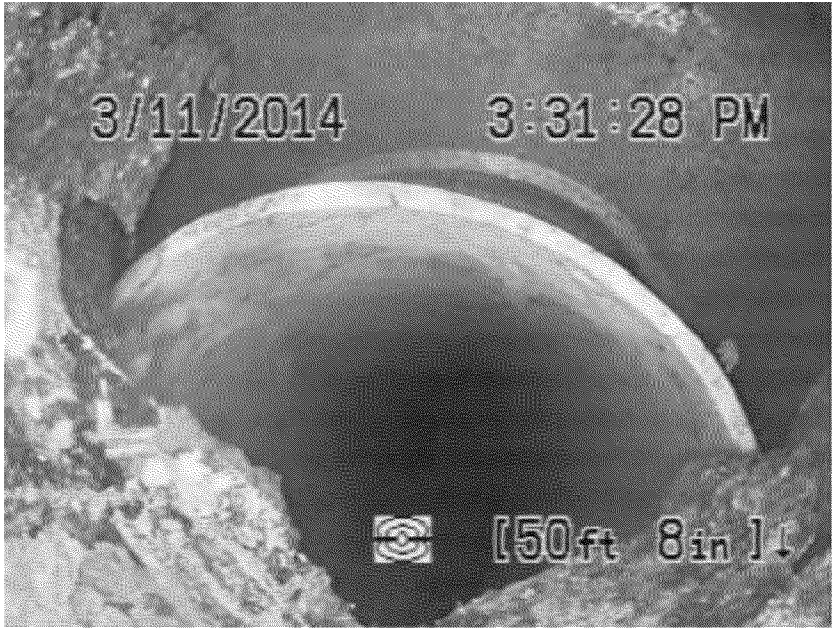
Figure 42. Dislocated joint between an apparently white plastic pipe and cast iron sewer lateral. Source: FES.

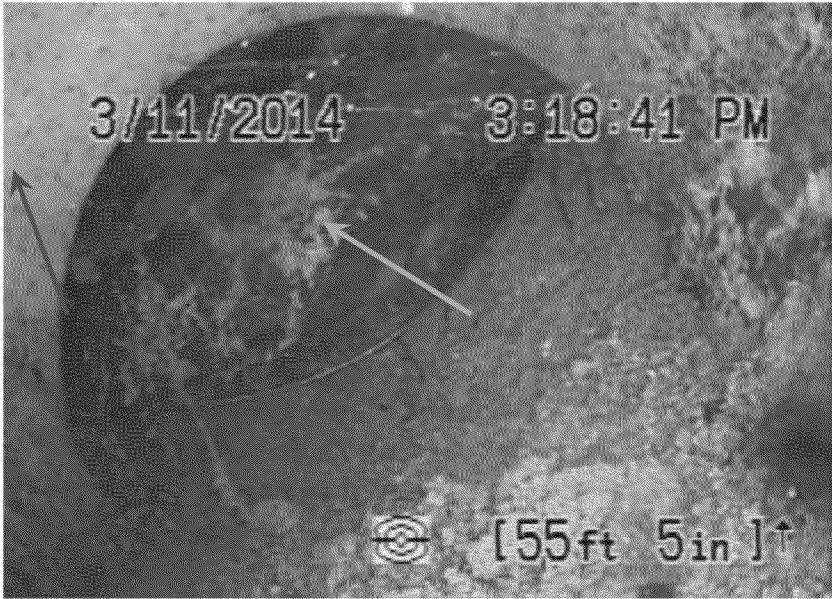
Figure 43. Sewer lateral joint offset at connection between white plastic pipe segment (green arrow) and apparent cast iron pipe (yellow arrow). Source: FES.

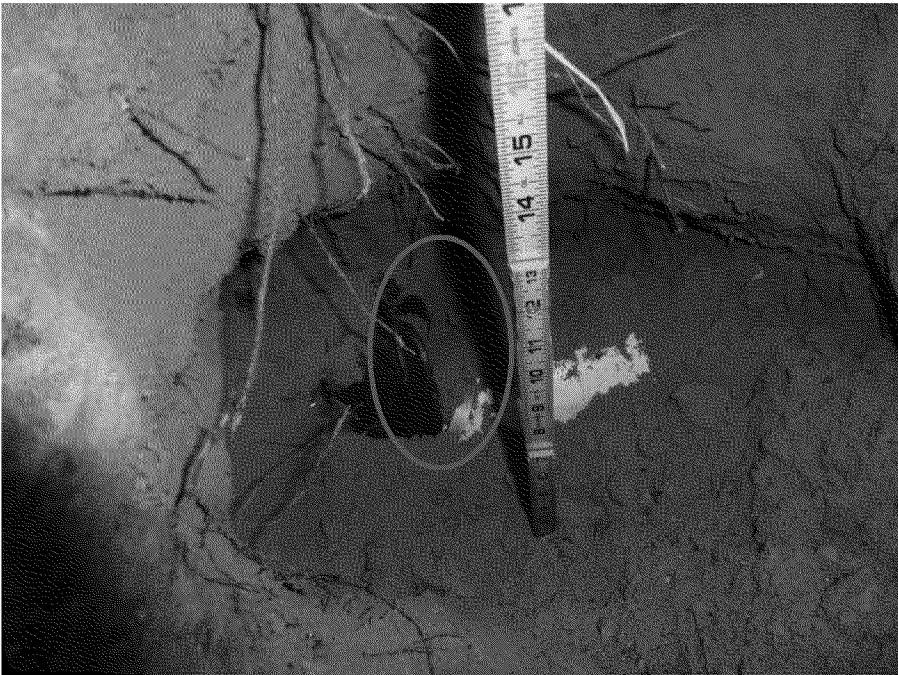
Figure 46. Sewer lateral offset joint (green oval), and white plastic segment of sewer lateral. Sand backfill surrounding sewer lateral. Photograph by Exponent on March 21, 2014.

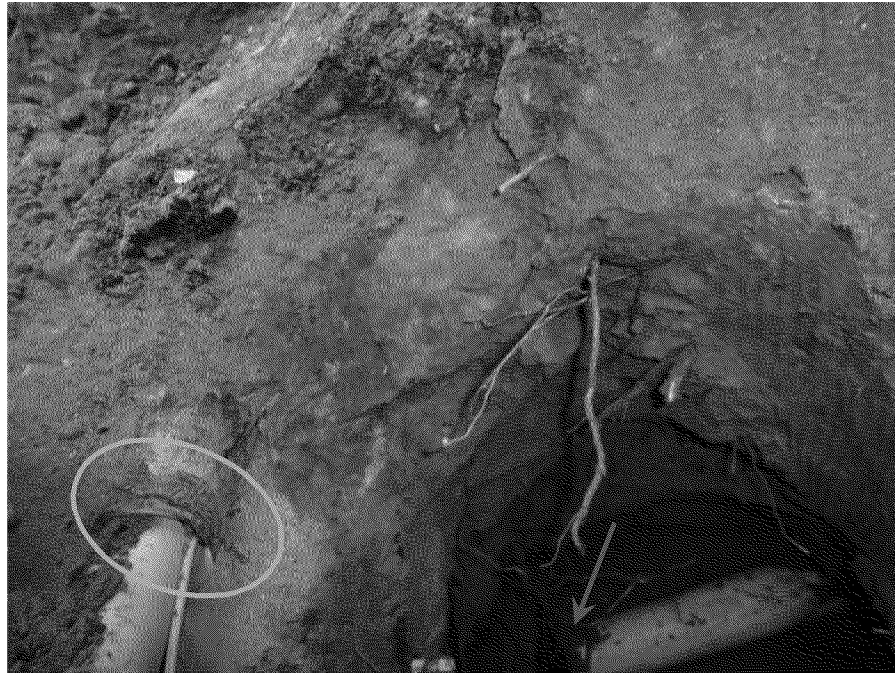
Figure 47. End of annular space in gas main along 3<sup>rd</sup> Avenue (yellow oval) in vicinity of sewer lateral offset joint (green arrow). Photograph by Exponent on March 21, 2014.

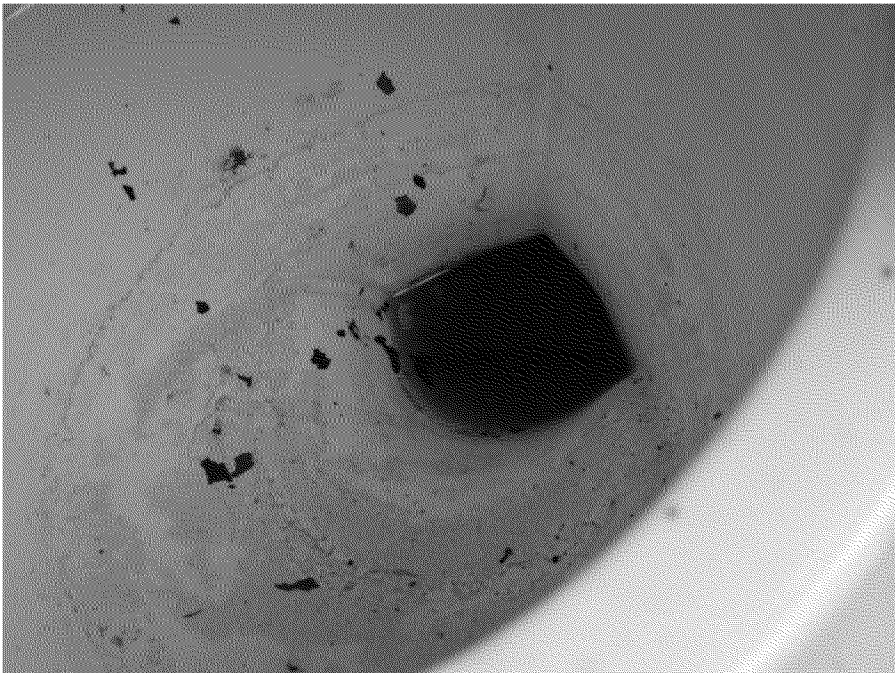
Figure 50. Low water level in the bathroom toilet bowl three days after explosion. Photograph by Exponent on March 6, 2014.
