Exponent<sup>®</sup>

**Carmel Gas Incident**

April 2014

Doc. no. 1401752.000 - 4253

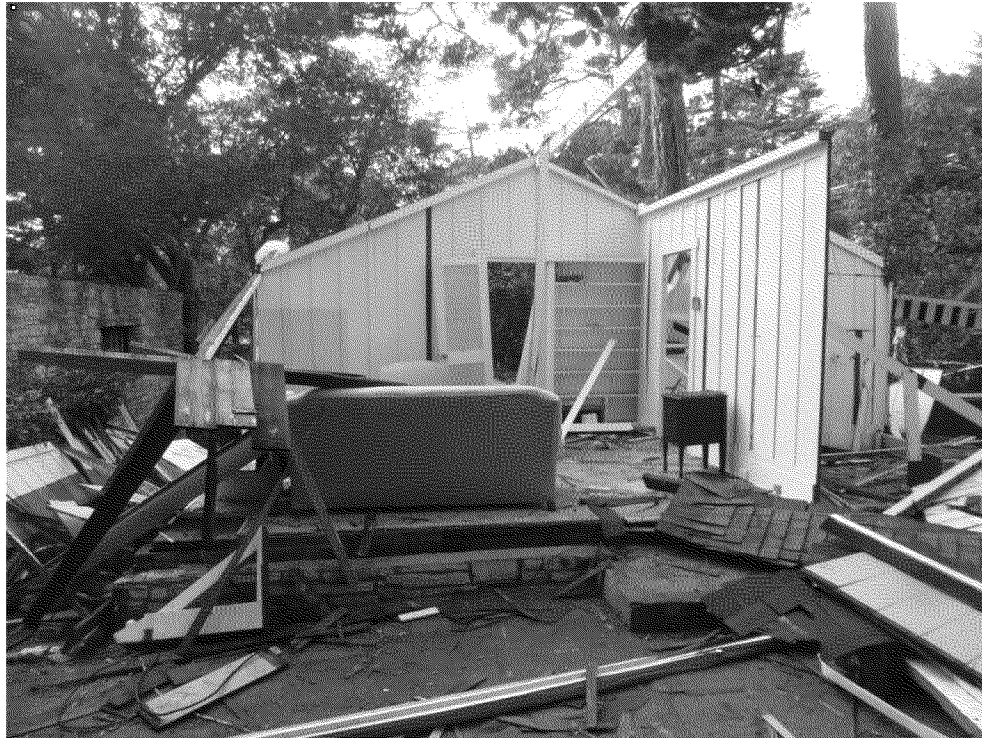
Exponent’s initial site inspection of the house after the explosion, on March 4, 2014, revealed extensive low order damage to the first floor areas that were visible from the perimeter of the property. All exterior walls of the first floor had been blown out and the roof had been torn into pieces and scattered in the surrounding area. Only some of the interior walls remained in place (Figure 9 and Figure 10). Debris was scattered across the property and in nearby trees.

Figure 9. Incident house looking West from the entryway. Photograph by Exponent on March 4, 2014.

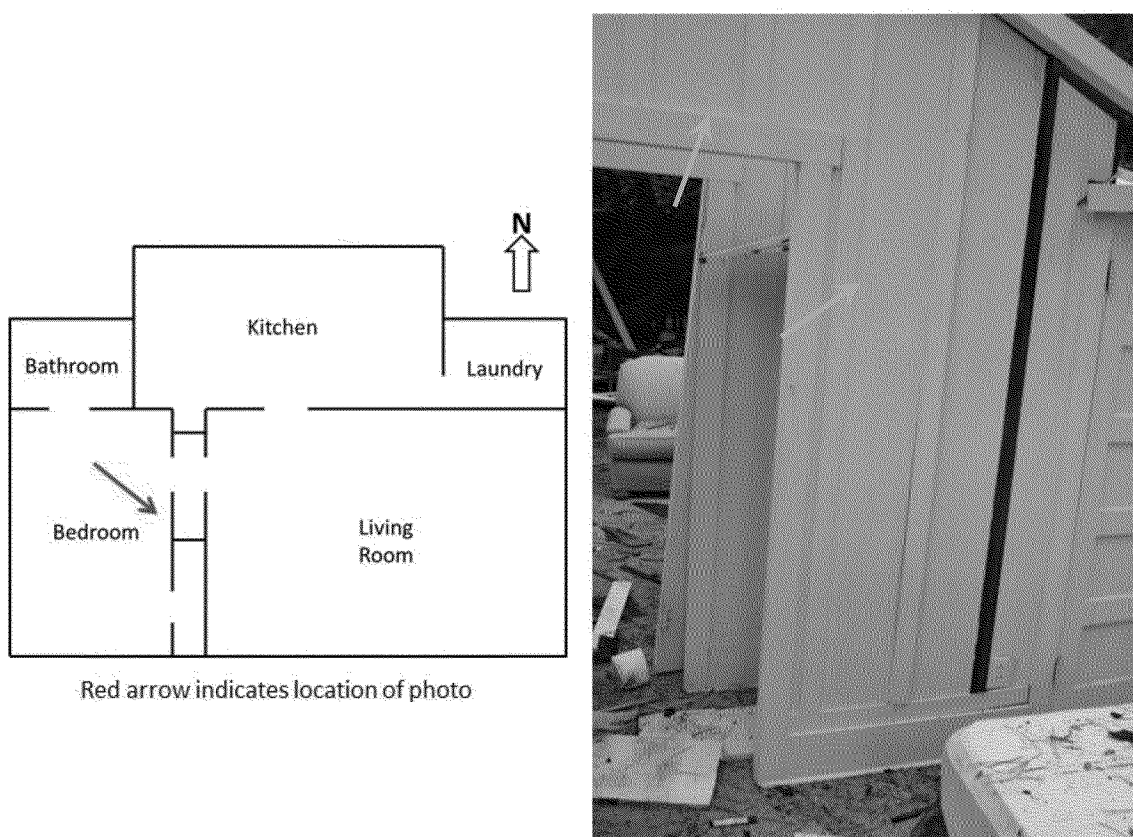
Exponent's interior inspections of the subject house<sup>9</sup> discovered limited evidence of fire inside the house. Some of the paint on the walls of the living and bedrooms had signs of high temperature (blistering), but very few signs of sustained flame impingement (Figure 11 and Figure 12). Some of the debris showed a small amount of charring. The bathroom was the only place where clear signs of sustained fire were observable. There was a distinct fire pattern on the South wall next to the toilet and on the toilet bowl, toilet seat, and tank (Figure 13 through Figure 15). PG&E provided Exponent with a photograph taken shortly after the explosion (Figure 16). The photograph shows flames in the bathroom, matching the location of the observed fire patterns.

Figure 11. Interior walls and furniture. An unburned couch in the living room is visible in the background and the corner of an unburned mattress is visible in the foreground. Yellow arrows indicate some areas of wall blistering. Photograph by Exponent on March 6, 2014.

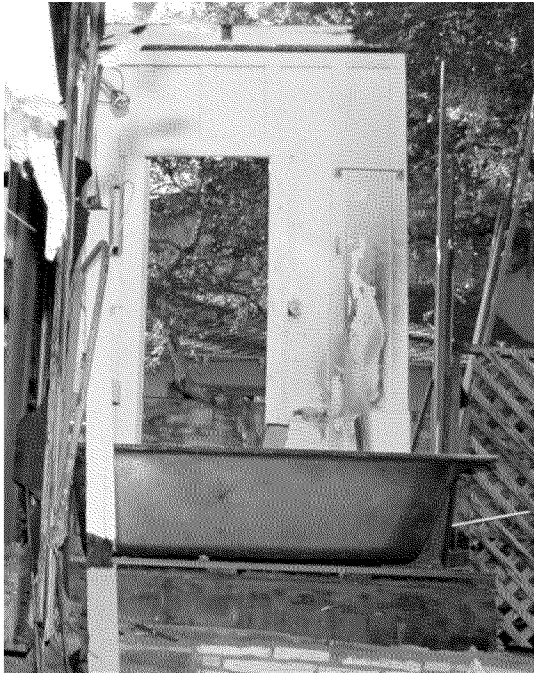
Figure 13. Fire pattern on bathroom wall, looking South from [Redacted]. Photograph by Exponent on March 7, 2014.

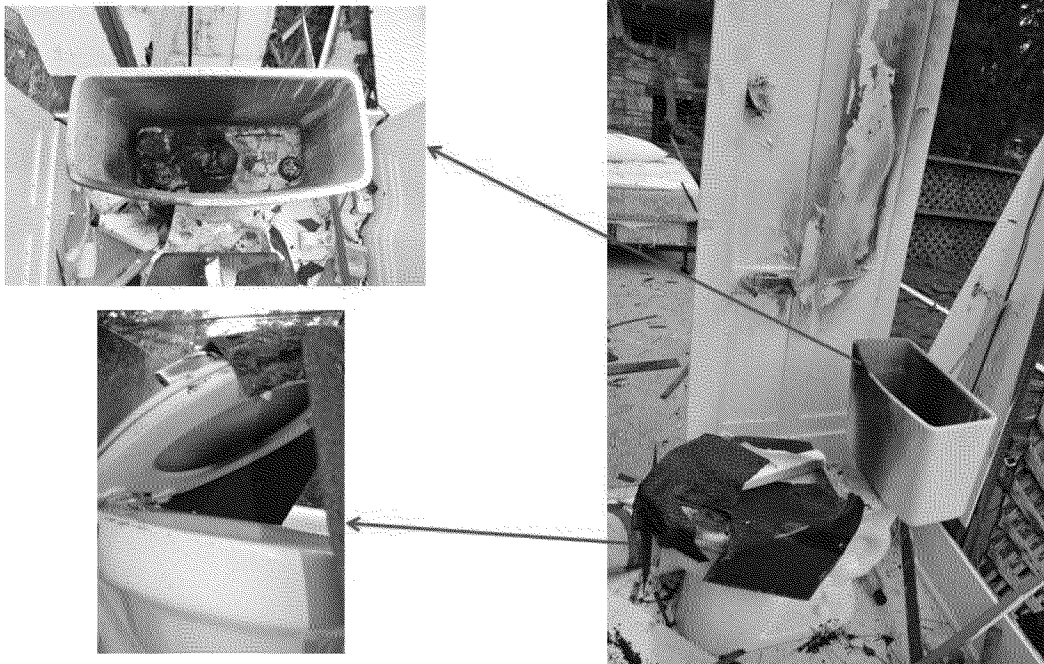
Figure 15. Damage to bathroom toilet. Burn marks below toilet seat and melted components inside toilet tank. Photographs by Exponent on March 6, 2014.

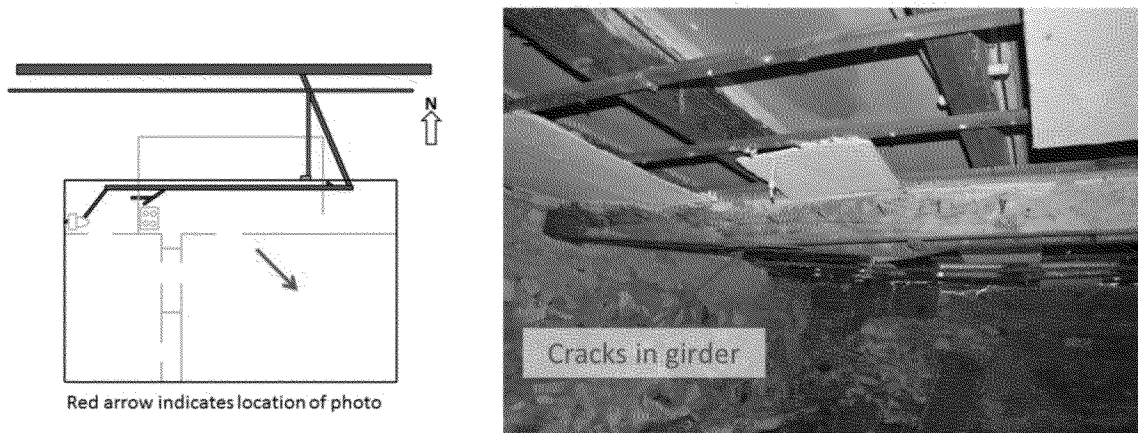
The basement area showed limited damage compared to the main floor. The perimeter walls did not show evidence of damage from the recent explosion and the windows glasses were undamaged. The ceiling finishes had collapsed in several areas and two of the wooden beams showed longitudinal cracks (Figure 17).

An Exponent engineer deemed the first floor of the structure unsafe due to recent damage to joists and girder framing. Shoring of the first floor from the basement level was recommended in order to continue inspection on the first floor. The elevated deck on the west side of the structure was not considered to be safe to walk on. Recommendations were also made to remove falling hazards from trees, neighboring bushes, and cantilevered portions of the structure.

Figure 17. Incident house basement. Ceiling girder with multiple longitudinal cracks. Photograph by Exponent on March 5, 2014.

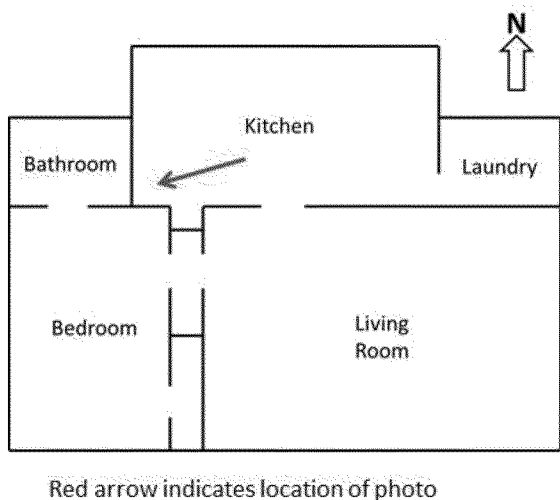
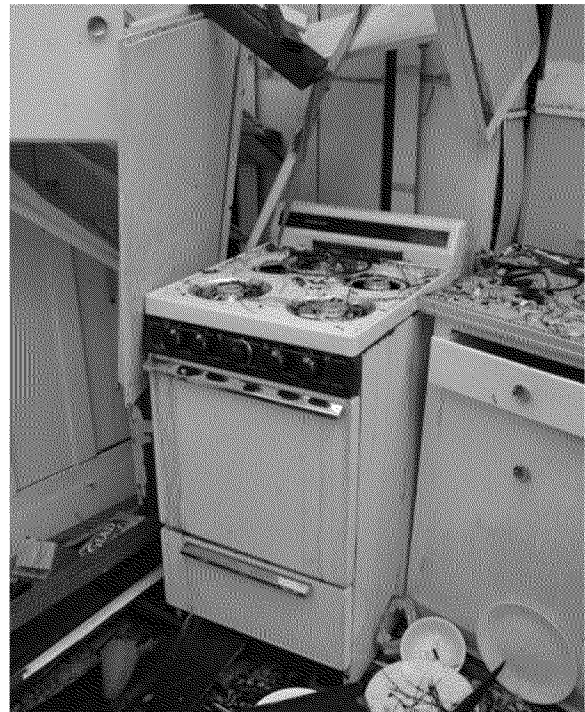
**Stove** – A kitchen stove was present in the subject house. The location of the stove is shown in Figure 20. The appliance shut-off valve for the stove was found in the open position and the stove was equipped with a continuous pilot flame (Figure 21). Based on these facts, the stove cannot be ruled out as a likely ignition source for the incident explosion.

Figure 20. Location of kitchen stove. Photograph by Exponent on March 6, 2014.

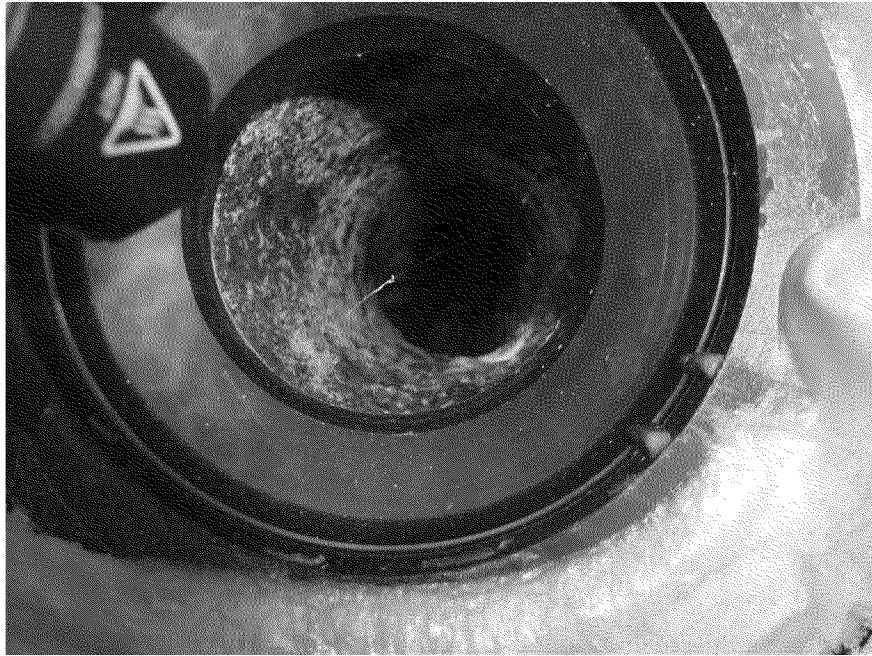
Figure 40. Sewer pipe raiser below toilet. Cast iron pipe is dry, spider webs are visible. Photograph by Exponent on March 11, 2014.

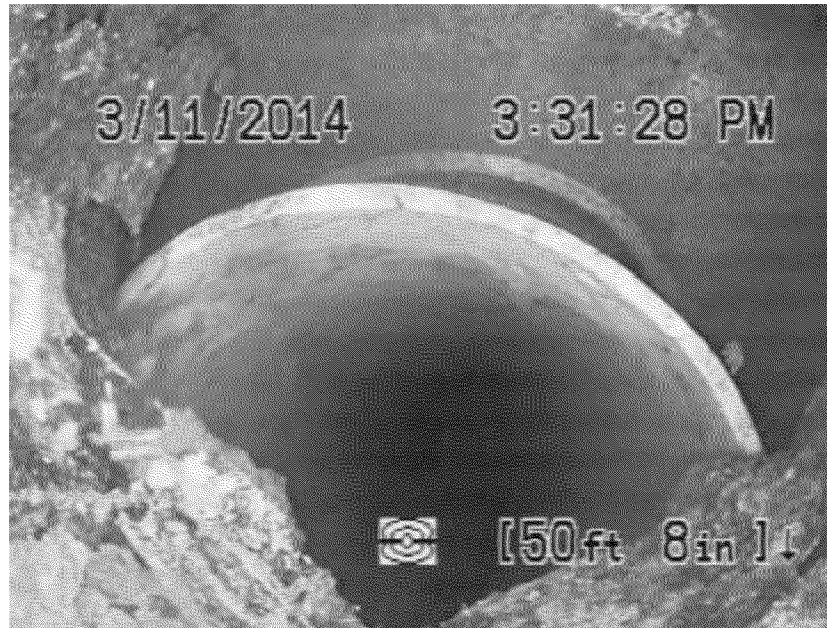
Figure 42. Dislocated joint between an apparently white plastic pipe and cast iron sewer lateral. Source: FES.

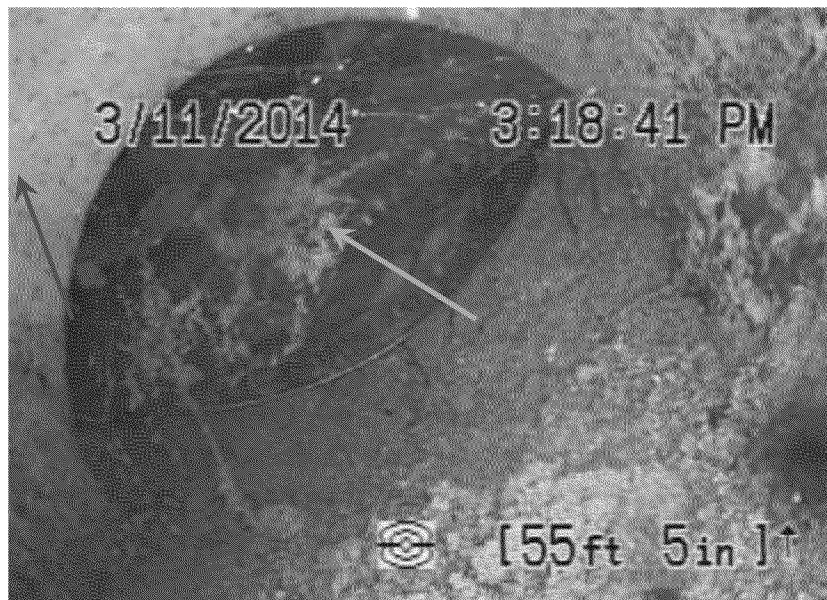
Figure 43. Sewer lateral joint offset at connection between white plastic pipe segment (green arrow) and apparent cast iron pipe (yellow arrow). Source: FES.

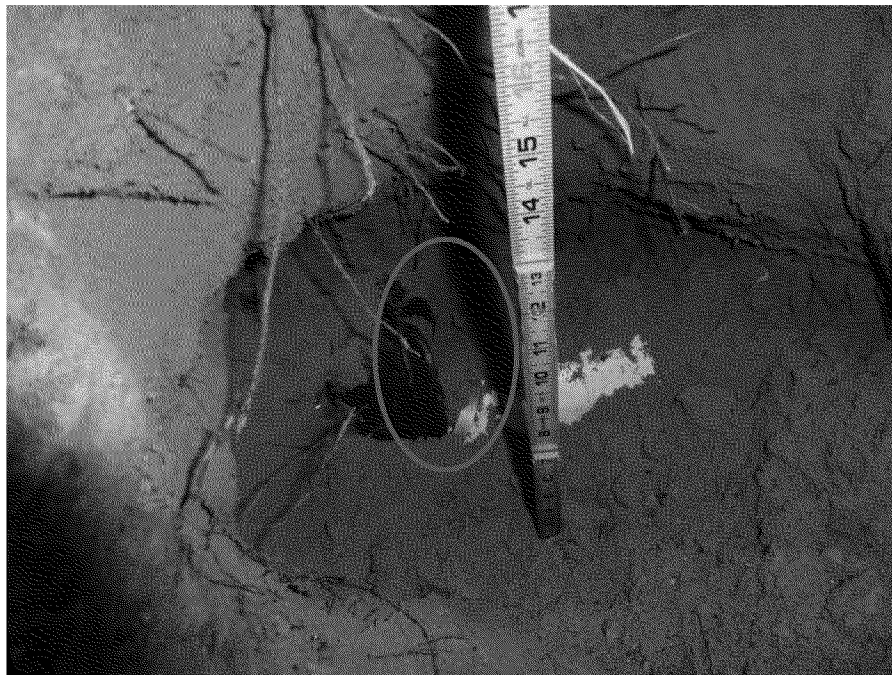
Figure 46. Sewer lateral offset joint (green oval), and white plastic segment of sewer lateral. Sand backfill surrounding sewer lateral. Photograph by Exponent on March 21, 2014.

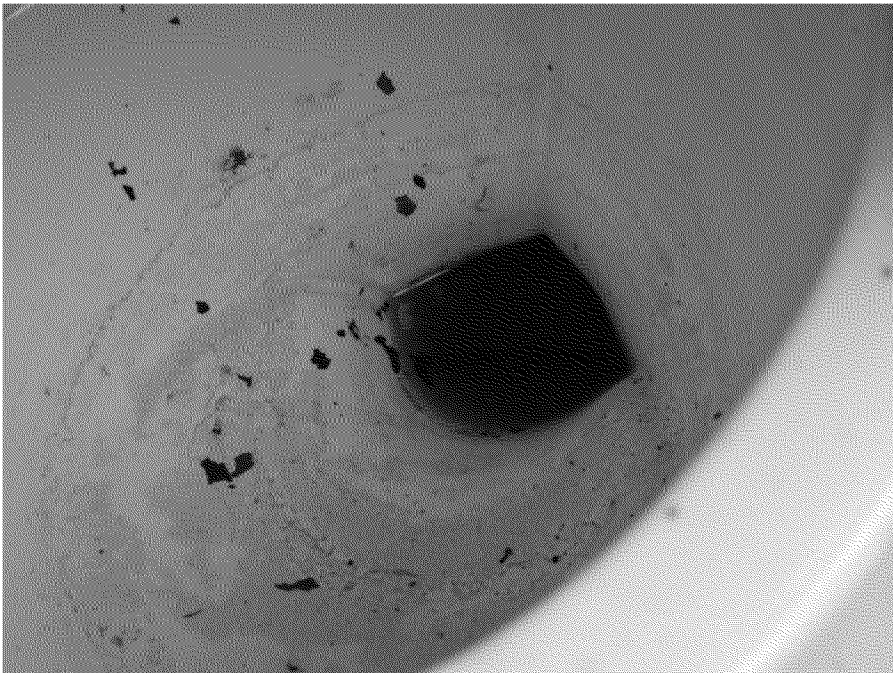
Figure 50. Low water level in the bathroom toilet bowl three days after explosion. Photograph by Exponent on March 6, 2014.
