PG&E Metcalf Incident and Substation Security

Raymond Fugere, PE
Safety and Enforcement Division

Objective: Provide an overview of the April 16, 2013 Metcalf Incident and Substation Security

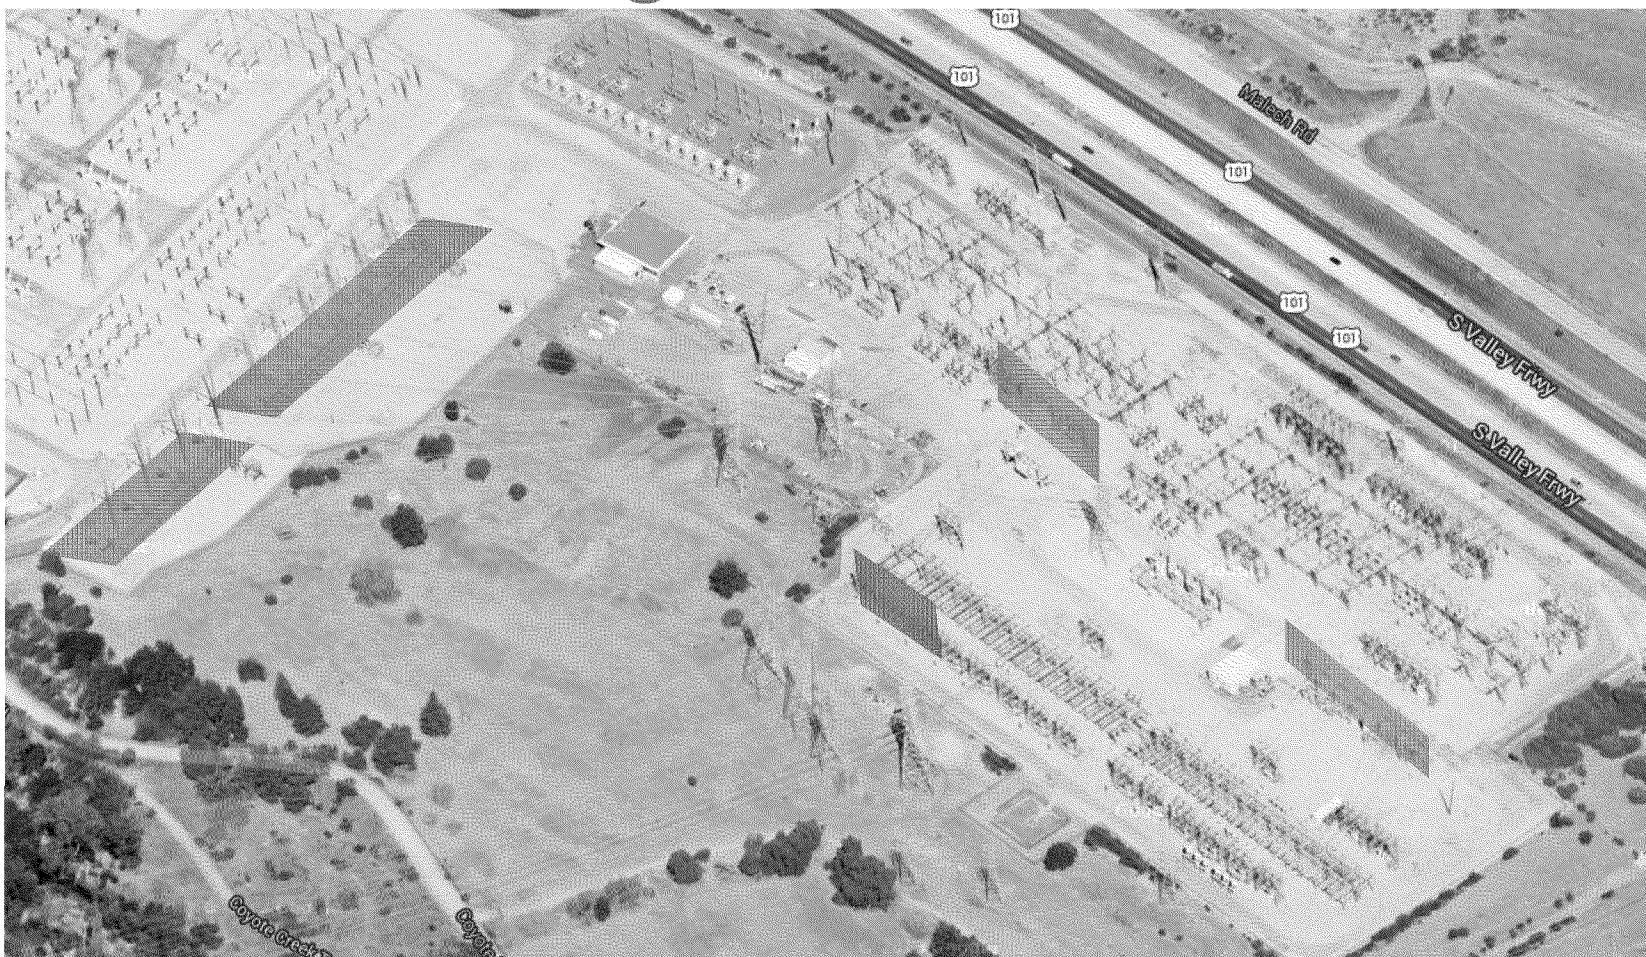
Damage to Substation

- 500kV Yard
 - 10 transformers
- 230kV Yard
 - 7 transformers
- 115kV Yard
 - 6 circuit breakers
- Total of 52,000 gallons of oil
- \$15.4 in restoration costs
- No outages
