RE: PG&E DRAFT Supplemental Information Report & Materials

At the request of PG&E, Exponent conducted an investigation of the gas leak and subsequent explosion on March 3, 2014 in Carmel-by-the-Sea (Carmel), California. Exponent investigated specific issues relevant to this incident, as requested by the client. Exponent submitted its report to PG&E on April 25, 2014. The scope of services performed during the investigation was focused on the cause of the incident and did not address actions taken by PG&E and other parties with respect to the incident.

Pacific Gas and Electric (PG&E) retained Exponent Failure Analysis Associates (Exponent) to conduct a failure analysis investigation of a gas leak and subsequent explosion on March 3, 2014 in Carmel-by-the-Sea (Carmel), California. Exponent's report was submitted to PG&E on April 25, 2014, and discussed at a City Council Meeting at Carmel city offices on May 6, 2014. Subsequent to that meeting, PG&E requested that Exponent supplement its report to address specific questions raised at the meeting. This supplemental report includes the following:

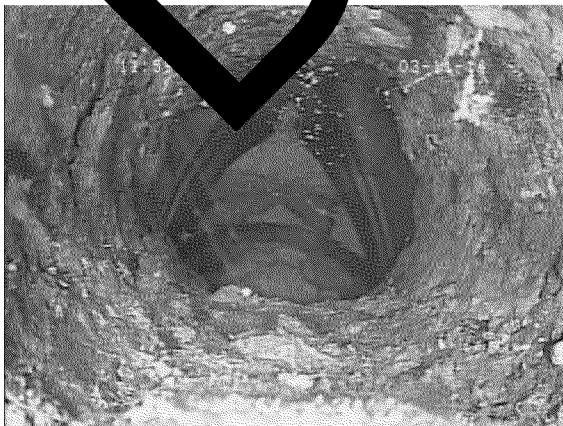
Figure 5. Collapsed main and offset joint
