RE: PG&E DRAFT Supplemental Information Report & Materials

PG&E Supplemental Information

Pacific Gas and Electric (PG&E) retained Exponent Failure Analysis Associates (Exponent) to conduct a failure analysis investigation of a gas leak and subsequent explosion on March 3, 2014 in Carmel-by-the-Sea (Carmel), California. Exponent's report was submitted to PG&E on April 25, 2014, and discussed at a City Council Meeting at Carmel city offices on May 6, 2014. Subsequent to that meeting, PG&E requested that Exponent supplement its report to address specific questions raised at the meeting. This supplemental report includes the following:

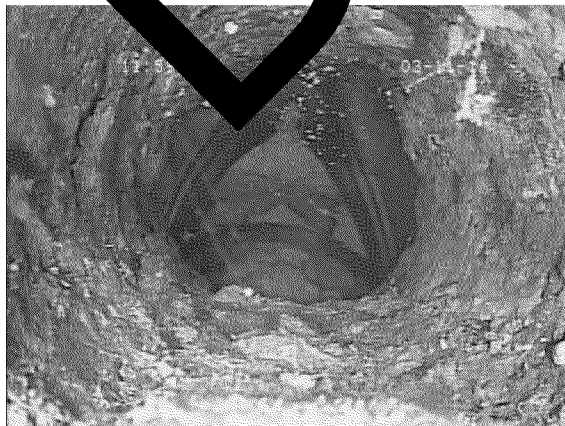
Figure 5. Collapsed main and offset joint

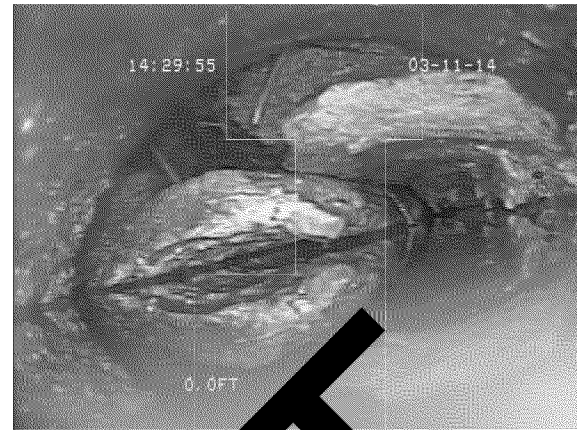
Figure 8. Collapsed main and water in sag

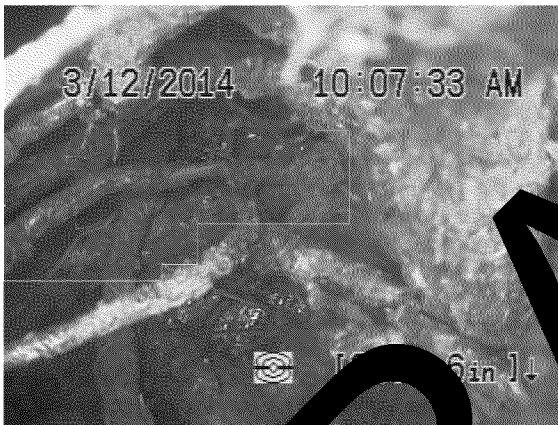
Figure 9. Lateral blocked by roots

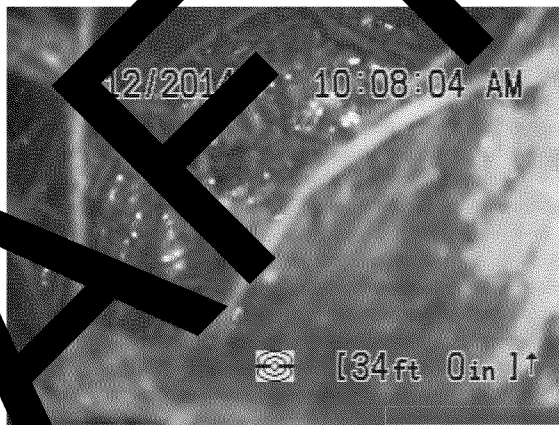
Figure 10. Roots over shiny apparent cap
