RE: PG&E DRAFT Supplemental Information Report & Materials

At the request of PG&E, Exponent conducted an investigation of the gas leak and subsequent explosion on March 3, 2014 in Carmel-by-the-Sea (Carmel), California. Exponent investigated specific issues relevant to this incident, as requested by the client. Exponent submitted its report to PG&E on April 25, 2014. The scope of services performed during the investigation was focused on the cause of the incident and did not address actions taken by PG&E and other parties with respect to the incident.

Pacific Gas and Electric (PG&E) retained Exponent Failure Analysis Associates (Exponent) to conduct a failure analysis investigation of a gas leak and subsequent explosion on March 3, 2014 in Carmel-by-the-Sea (Carmel), California. Exponent's report was submitted to PG&E on April 25, 2014, and discussed at a City Council Meeting at Carmel city offices on May 6, 2014. Subsequent to that meeting, PG&E requested that Exponent supplement its report to address specific questions raised at the meeting. This supplemental report includes the following:

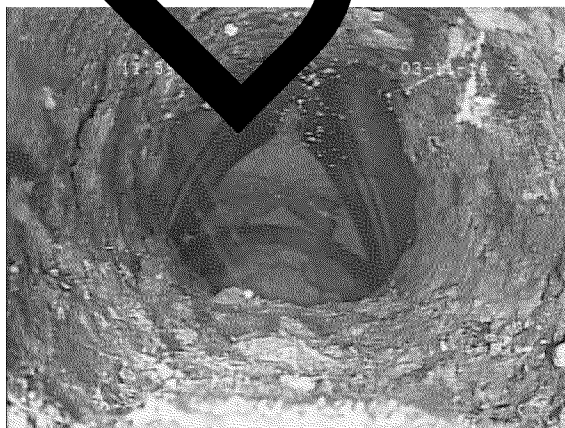
Figure 5. Collapsed main and offset joint

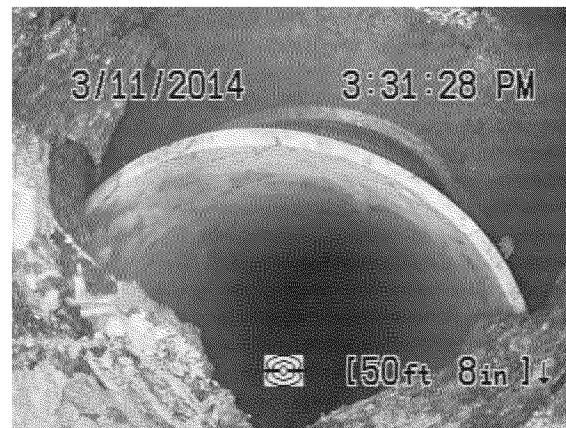
Figure 6. Offset joint 50 ft. from entry on property

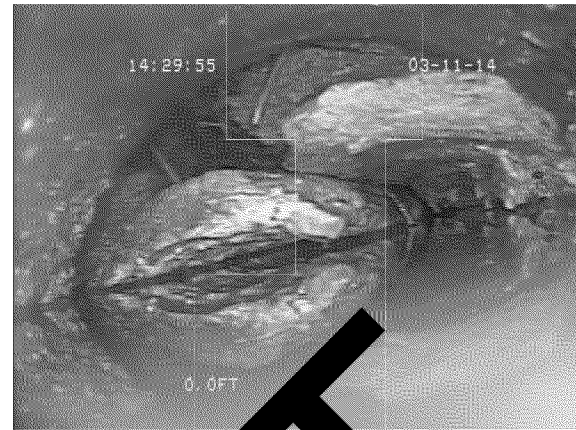
Figure 8. Collapse of main and water in sag
