RE: PG&E DRAFT Supplemental Information Report & Materials

PG&E Supplemental Information

At the request of PG&E, Exponent conducted an investigation of the gas leak and subsequent explosion on March 3, 2014 in Carmel-by-the-Sea (Carmel), California. Exponent investigated specific issues relevant to this incident, as requested by the client. Exponent submitted its report to PG&E on April 25, 2014. The scope of services performed during the investigation was focused on the cause of the incident and did not address actions taken by PG&E and other parties with respect to the incident.

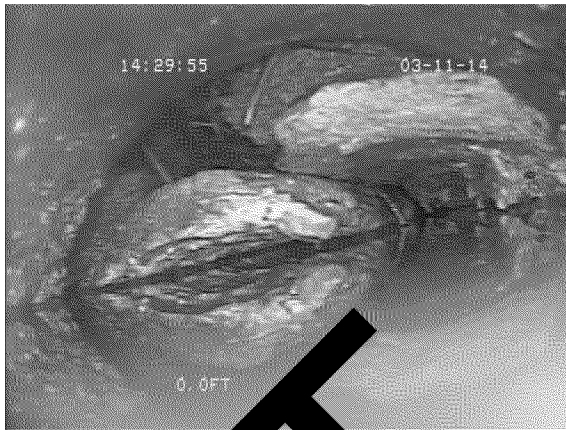
Figure 8. Collapsed main and water in sag

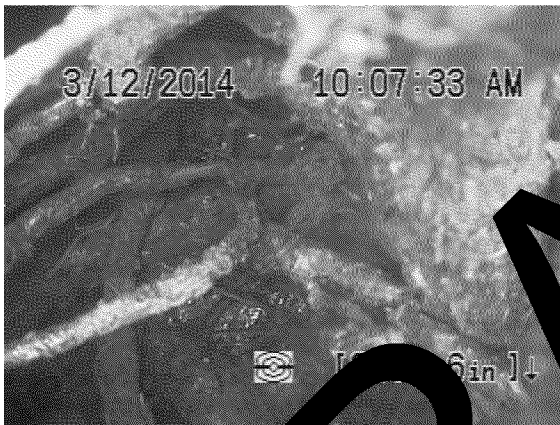
Figure 9. Lateral blocked by roots

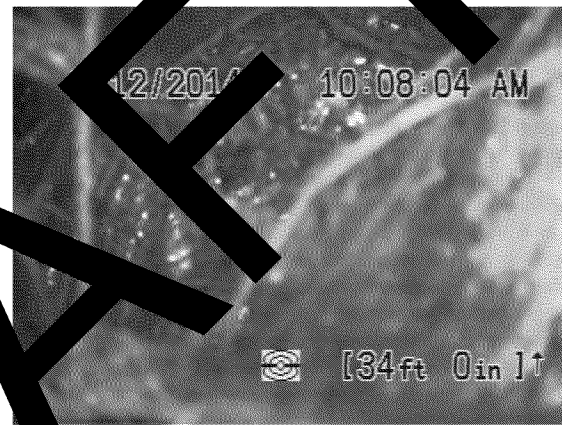
Figure 10. Roots over shiny apparent cap
