RE: PG&E DRAFT Supplemental Information Report & Materials

Pacific Gas and Electric (PG&E) retained Exponent Failure Analysis Associates (Exponent) to conduct a failure analysis investigation of a gas leak and subsequent explosion on March 3, 2014 in Carmel-by-the-Sea (Carmel), California. Exponent's report was submitted to PG&E on April 25, 2014, and discussed at a City Council Meeting at Carmel city offices on May 6, 2014. Subsequent to that meeting, PG&E requested that Exponent supplement its report to address specific questions raised at the meeting. This supplemental report includes the following:

Depictions of the sewer inspection area and the affected sewer main pipe segments in the blocks adjoining the intersection of 3rd Ave. and Guadalupe St. in Carmel, CA

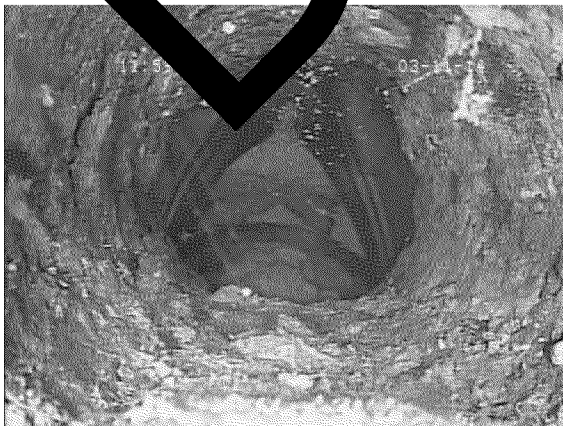
Figure 5. Collapsed main and offset joint

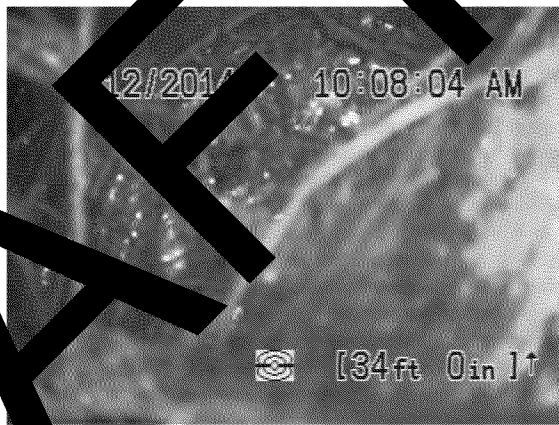
Figure 10. Roots over shiny apparent cap
