July 8, 2014

**RE: PG&E DRAFT Supplemental Information Report & Materials**

At the request of PG&E, Exponent conducted an investigation of the gas leak and subsequent explosion on March 3, 2014 in Carmel-by-the-Sea (Carmel), California. Exponent investigated specific issues relevant to this incident, as requested by the client. Exponent submitted its report to PG&E on April 25, 2014. The scope of services performed during the investigation was focused on the cause of the incident and did not address actions taken by PG&E and other parties with respect to the incident.

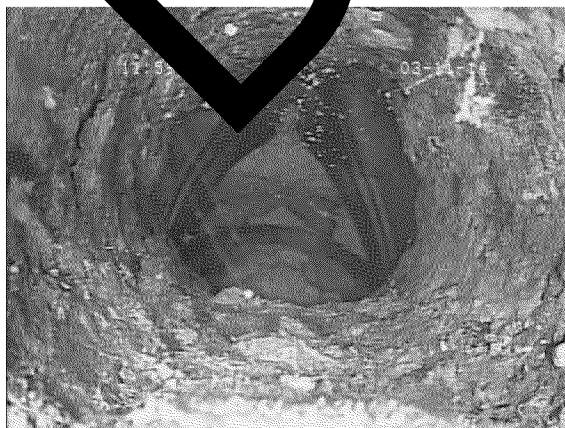
Figure 5. Collapsed main and offset joint

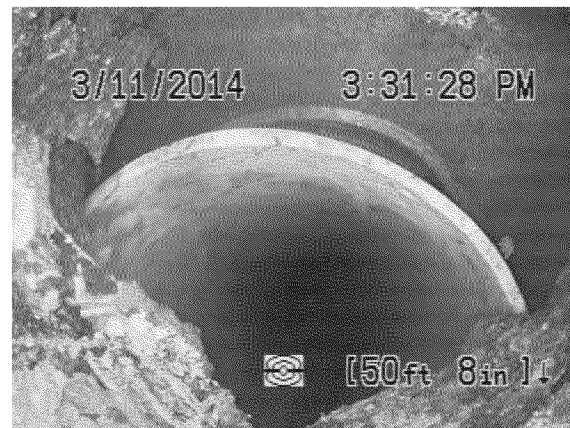
Figure 6. Offset joint 50 ft. from entry on property

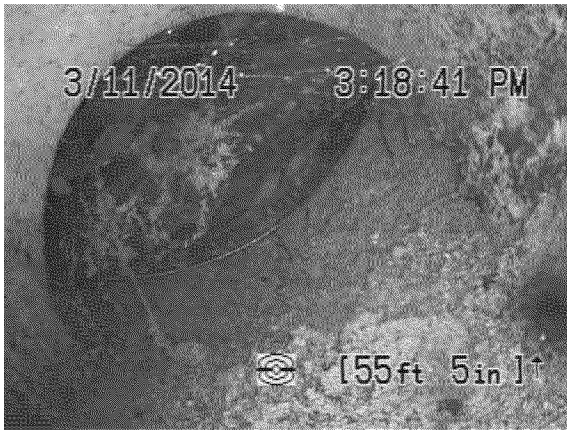
Figure 7. Lateral bend 55 ft. from entry

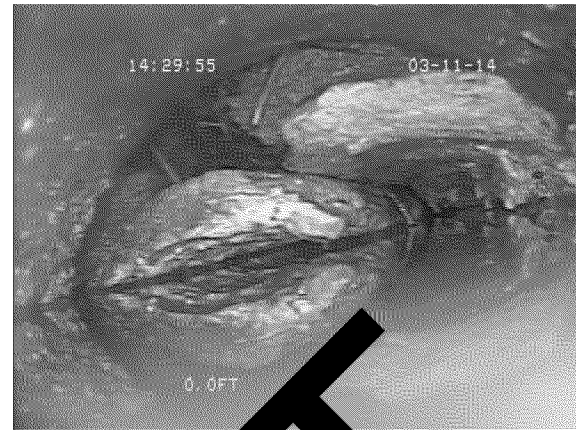
Figure 8. Collapsed main and water in sag

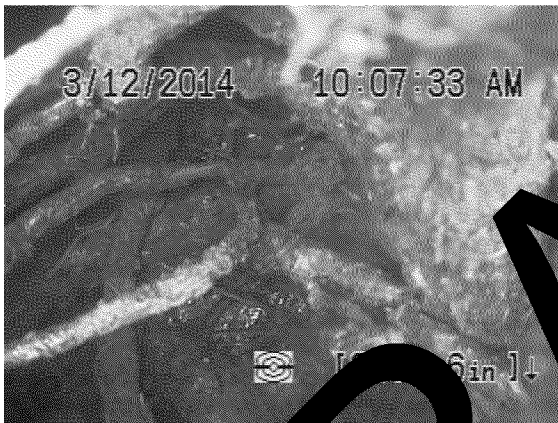
Figure 9. Lateral blocked by roots

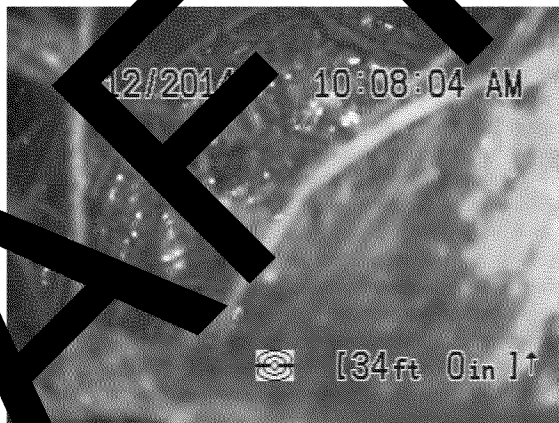
Figure 10. Roots over shiny apparent cap
