RE: PG&E DRAFT Supplemental Information Report & Materials

At the request of PG&E, Exponent conducted an investigation of the gas leak and subsequent explosion on March 3, 2014 in Carmel-by-the-Sea (Carmel), California. Exponent investigated specific issues relevant to this incident, as requested by the client. Exponent submitted its report to PG&E on April 25, 2014. The scope of services performed during the investigation was focused on the cause of the incident and did not address actions taken by PG&E and other parties with respect to the incident.

Pacific Gas and Electric (PG&E) retained Exponent Failure Analysis Associates (Exponent) to conduct a failure analysis investigation of a gas leak and subsequent explosion on March 3, 2014 in Carmel-by-the-Sea (Carmel), California. Exponent's report was submitted to PG&E on April 25, 2014, and discussed at a City Council Meeting at Carmel city offices on May 6, 2014. Subsequent to that meeting, PG&E requested that Exponent supplement its report to address specific questions raised at the meeting. This supplemental report includes the following:

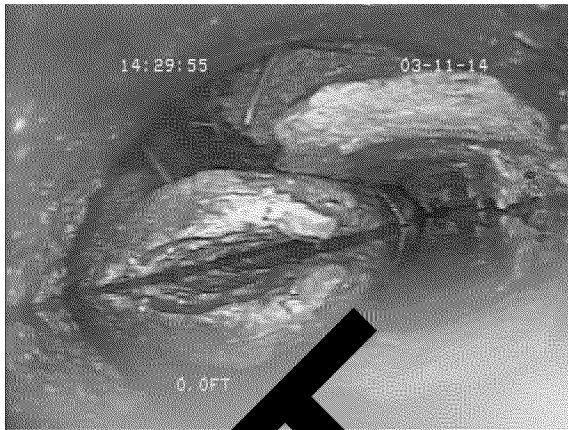
Figure 8. Collapsed main and water in sag
