RE: PG&E DRAFT Supplemental Information Report & Materials

Pacific Gas and Electric (PG&E) retained Exponent Failure Analysis Associates (Exponent) to conduct a failure analysis investigation of a gas leak and subsequent explosion on March 3, 2014 in Carmel-by-the-Sea (Carmel), California. Exponent's report was submitted to PG&E on April 25, 2014, and discussed at a City Council Meeting at Carmel city offices on May 6, 2014. Subsequent to that meeting, PG&E requested that Exponent supplement its report to address specific questions raised at the meeting. This supplemental report includes the following:

Inadequate verification of system status and configuration when performing work on a live line.

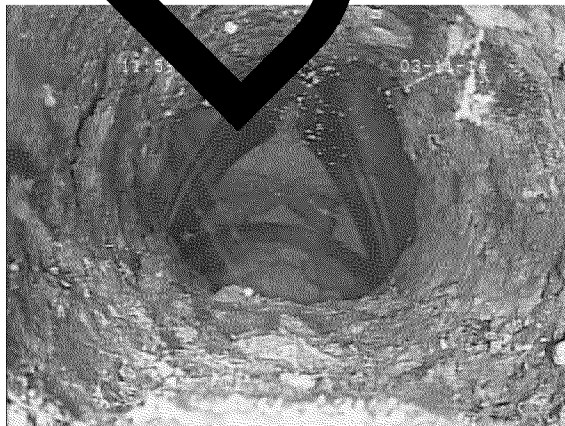
Figure 5. Collapsed main and offset joint

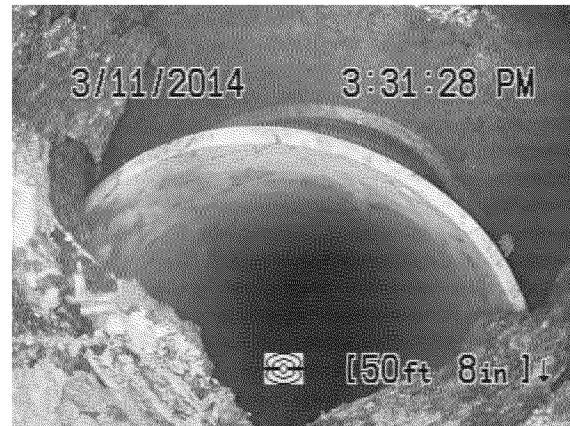
Figure 6. Offset joint 50 ft. from entry on property

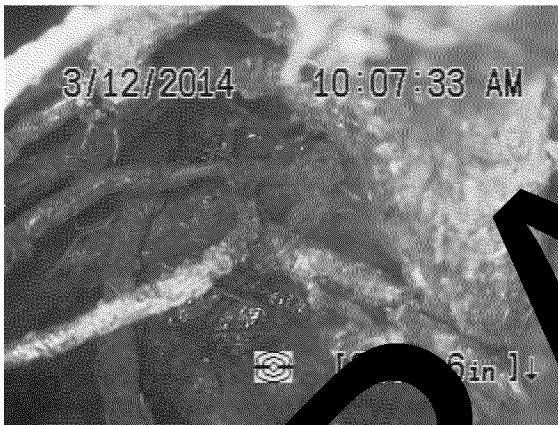
Figure 9. Lateral blocked by roots

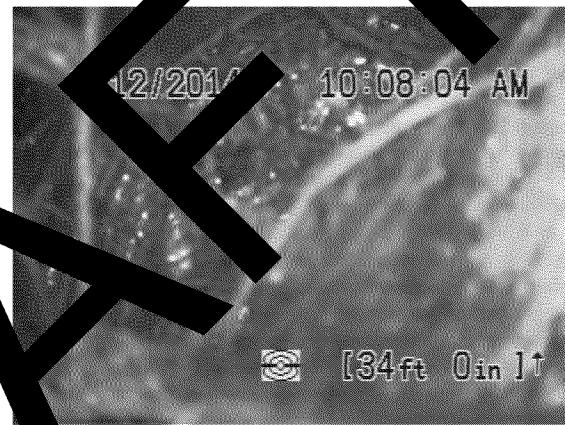
Figure 10. Roots over shiny apparent cap
